**Overview:**

The 3.41 acre site is located at 0S761 Old York Road and was formally a trailer park with a small management office (building #1) and a two car garage (building #2). The site is located in unincorporated York Township, DuPage County, Illinois, and currently falls under DuPage County permitting requirements.

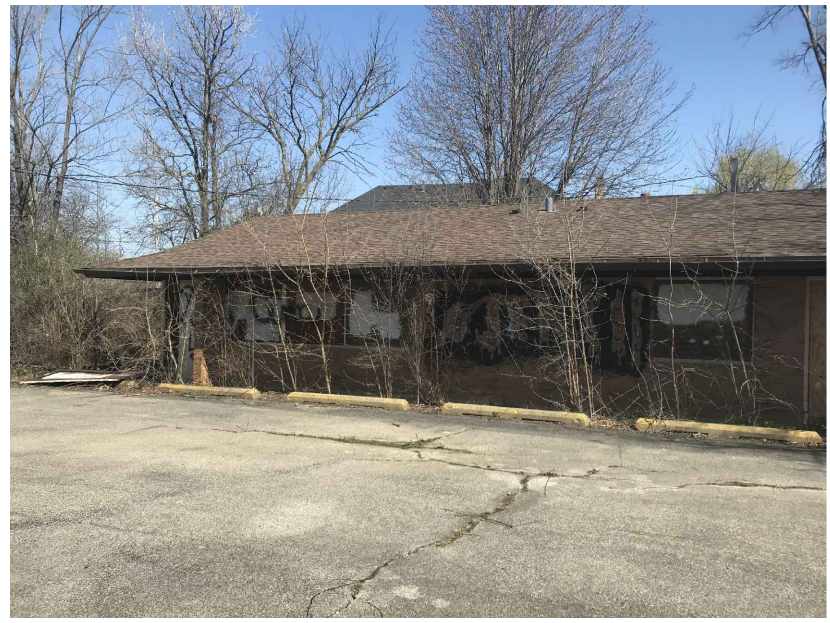
Building #1

The existing caretaker building/club house may be a good future restroom and storage area for the site if the building is found structurally sound.

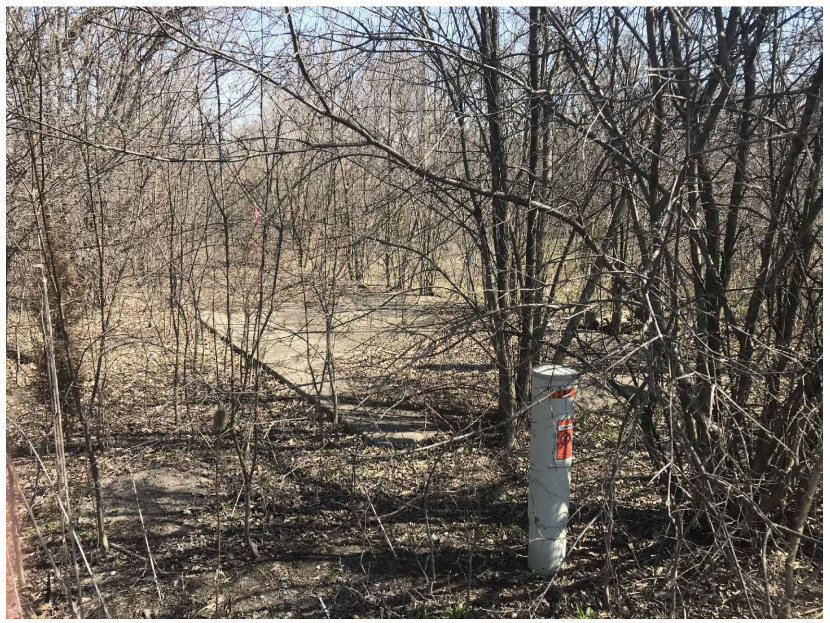
Trailer Pad with Utilities

Initial site investigation indicates existing water lines and remnants of utilities including electric and sewer remain on the site but abandoned from current use at the existing trailer pads. Utilities to the buildings are currently not working and condition is unknown.

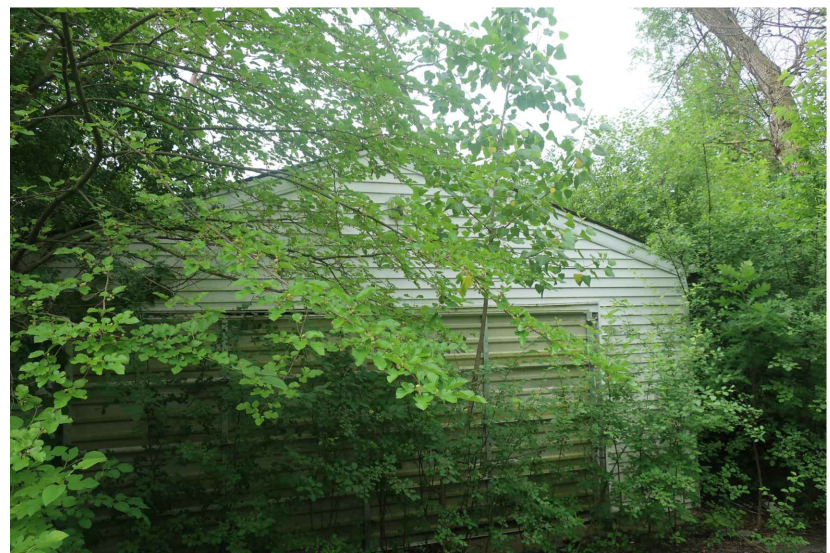
Building #2

The existing garage is centrally located on the site and appears to have a sagging roof line. It may be best to remove this building unless a good reuse is found that Building #1 cannot meet.

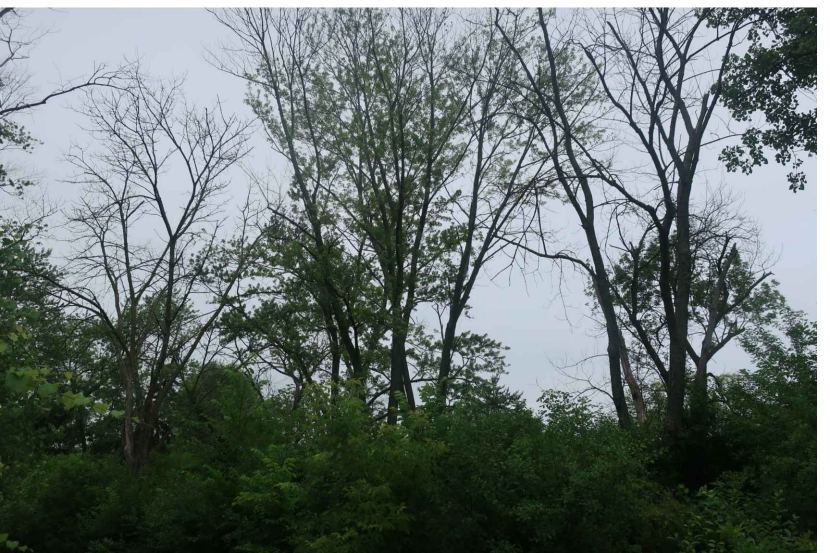
Dead Trees to be Removed

The existing vegetation is overgrown and thick with understory brush. Clearing out the invasive plant species will enhance site lines and shape views throughout the site. The higher quality trees have been identified and are shown in red on the map. Most other trees are in poor condition, dead, or are undesired invasive species.

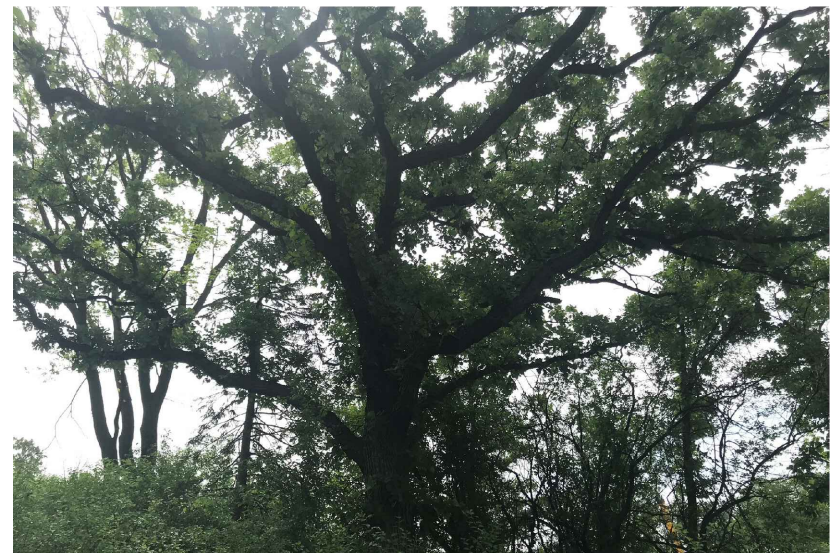
Mature Oaks to be Preserved
