# Table of Contents

# Executive Summary

# Project Description

Dewberry Architects Inc. (DAI) were commissioned on June 17, 2019, by the Elmhurst Park District to complete a facility assessment for the Redeemer Center at 345 Kenilworth Avenue in Elmhurst, Illinois. The facility assessment serves as a roadmap that establishes a direction for the facility's future, while maintaining the flexibility needed to respond to changing needs, conditions and resources.

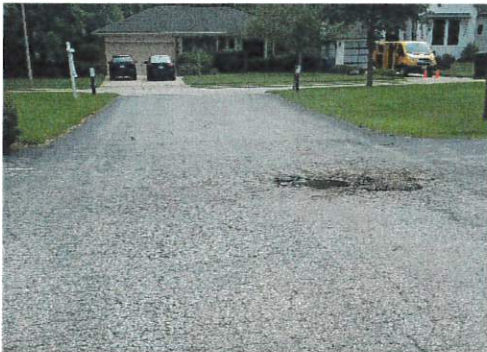
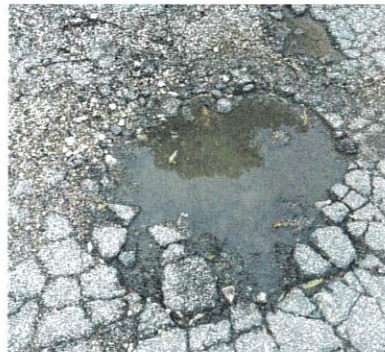
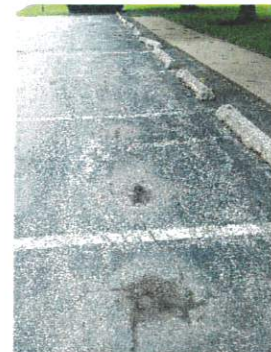
## Asphalt Paving

The parking lot is in poor condition. Small block cracking and alligator cracking are found throughout the pavement. There are multiple potholes located in the paved area. Pavement warping implies that the sub-base has settled over time causing an uneven surface. The entrance aprons are also made of asphalt and show signs of aging and pavement sub-base failure. All of the striping is white in color.

**Remove and replace all paving asphalt and stone full depth.** The 3 entrance aprons shall be replaced with concrete instead of asphalt.

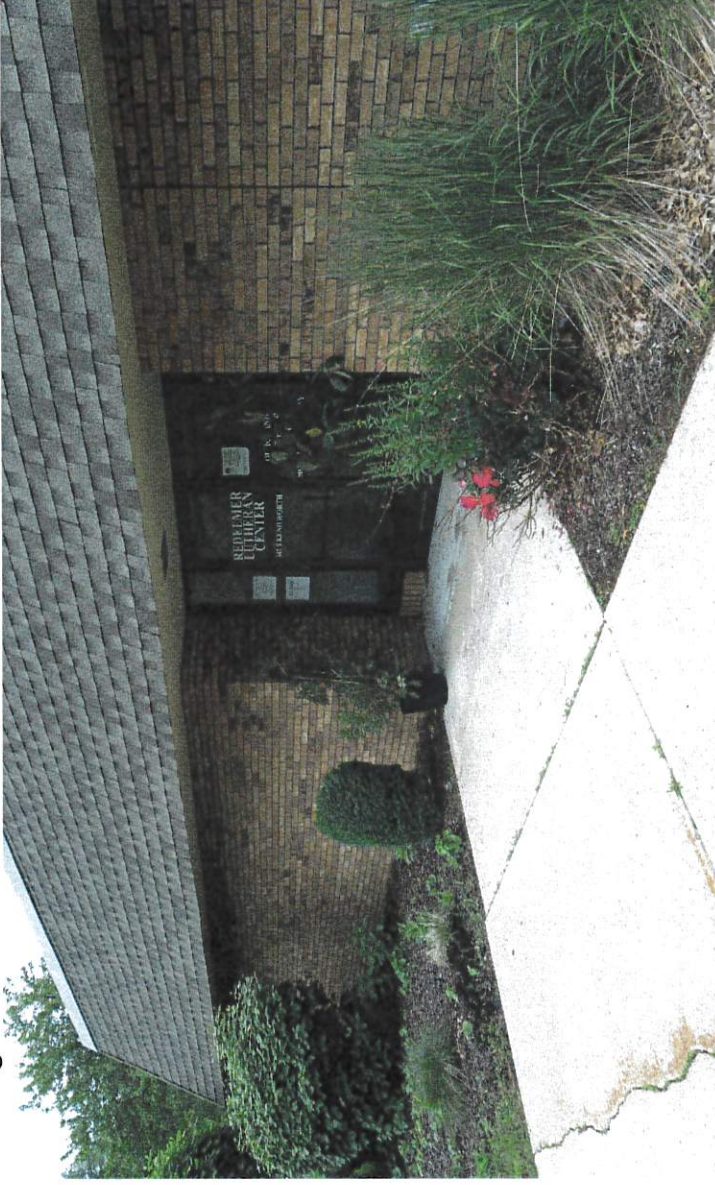
The concrete entrances are decaying and need replacement.

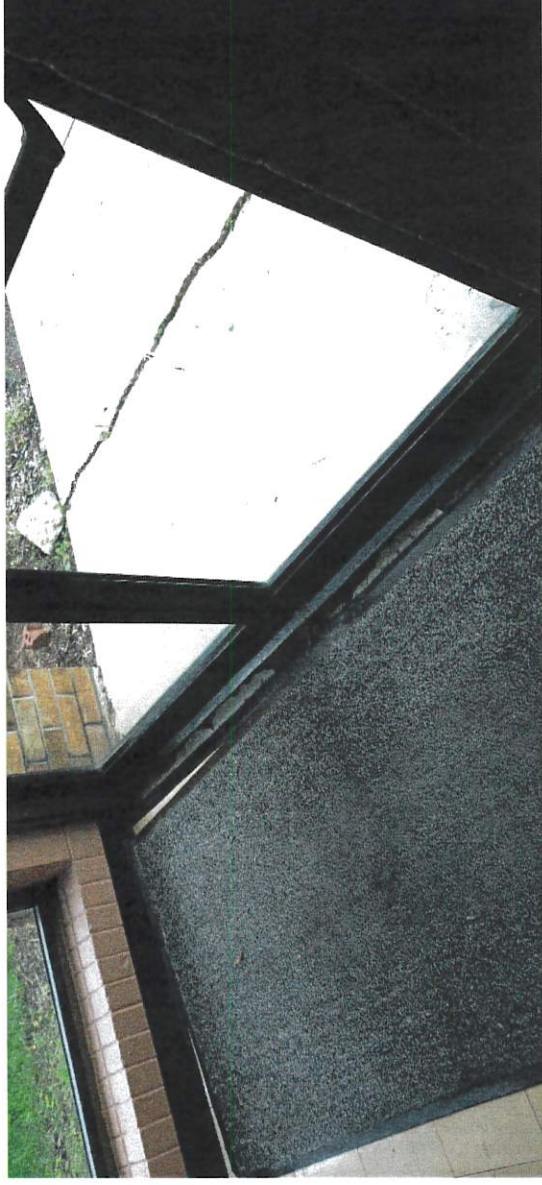
Floor deterioration at exterior door threshold.

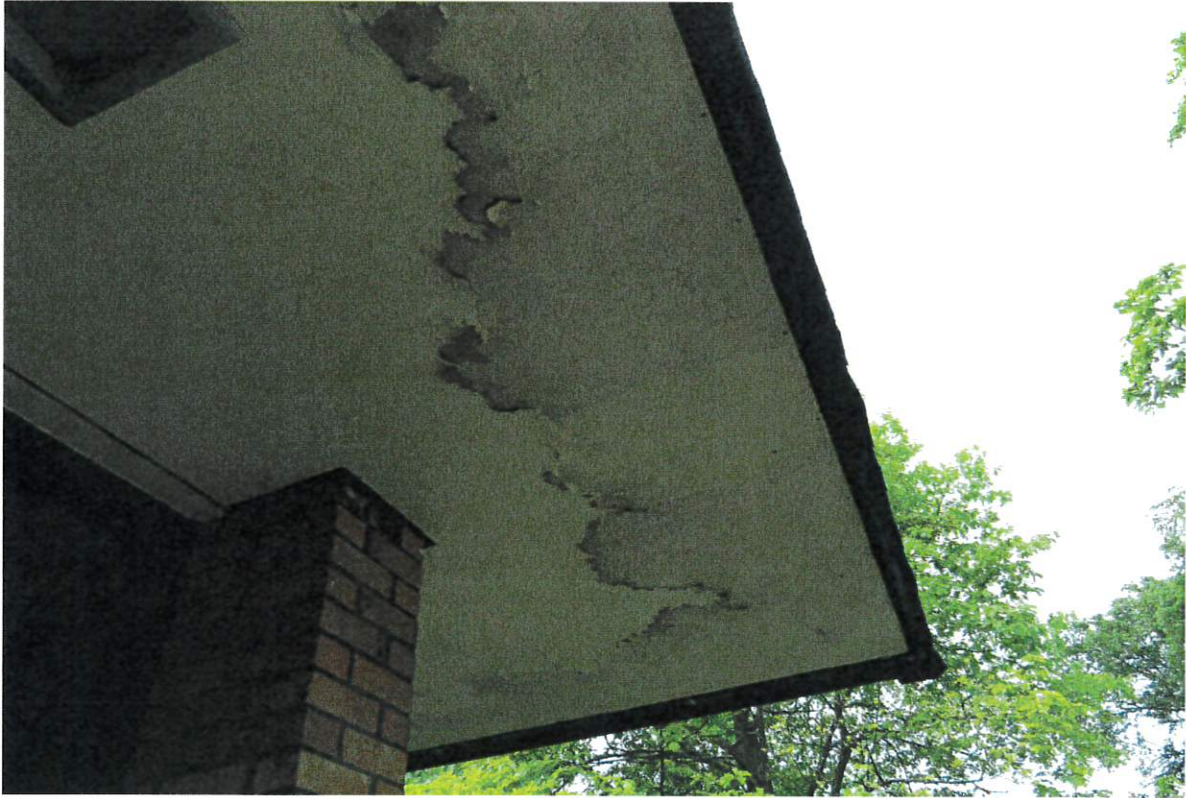
The perimeter soffits need repair and or replacement.

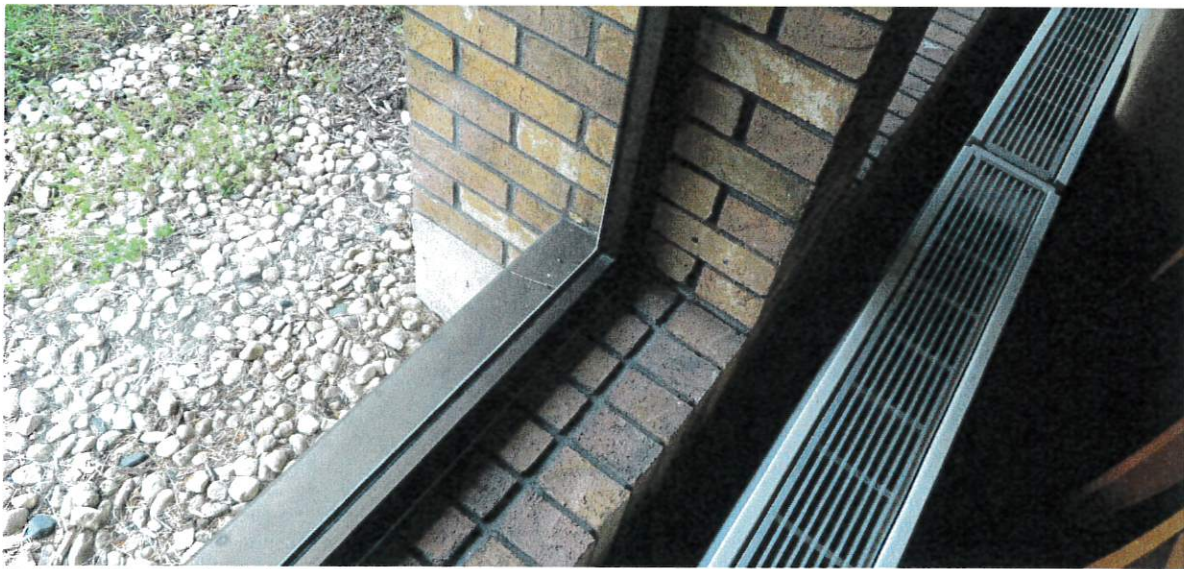
Exterior doors and windows are single pane and need replacement.

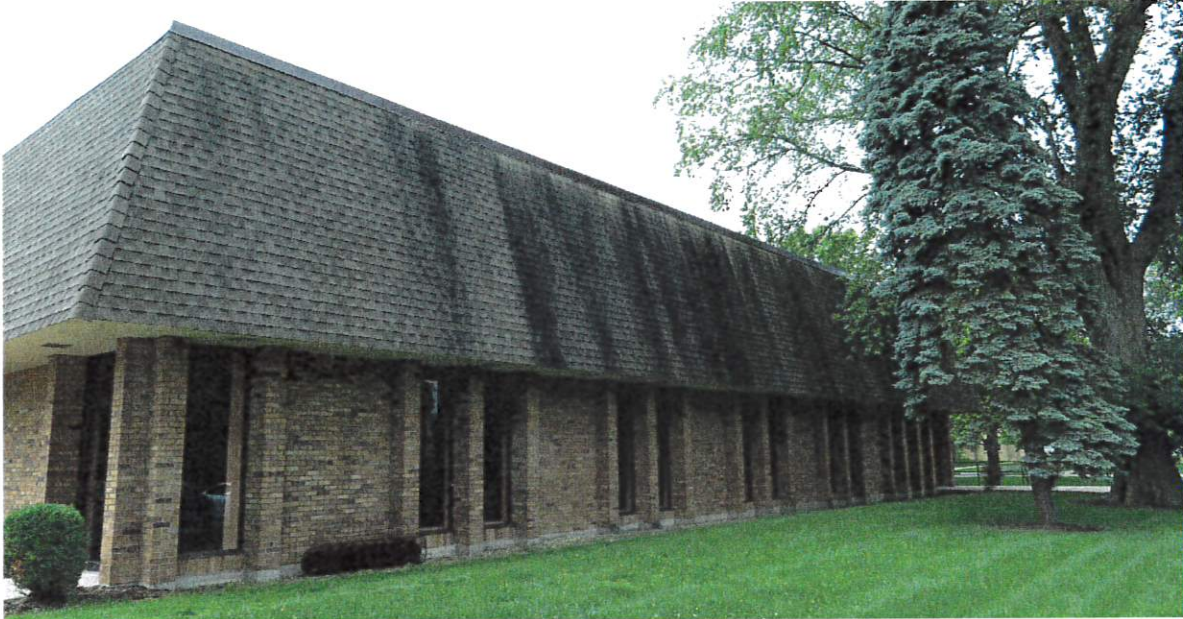
Exterior asphalt shingles on the north and east elevations are stained and deteriorating.

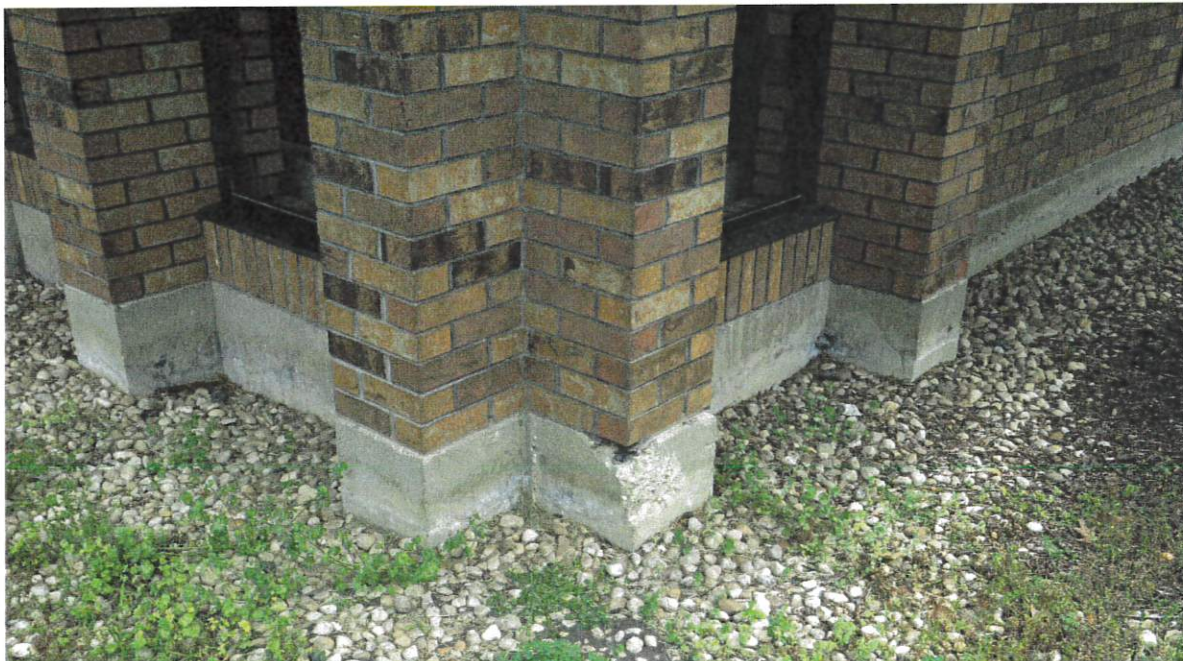
Perimeter concrete foundation is decaying in areas and needs repair.

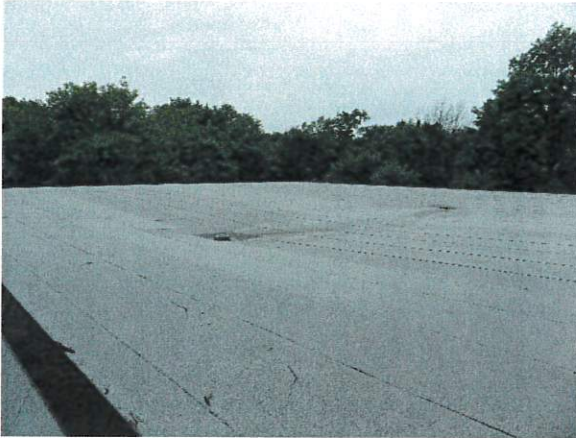
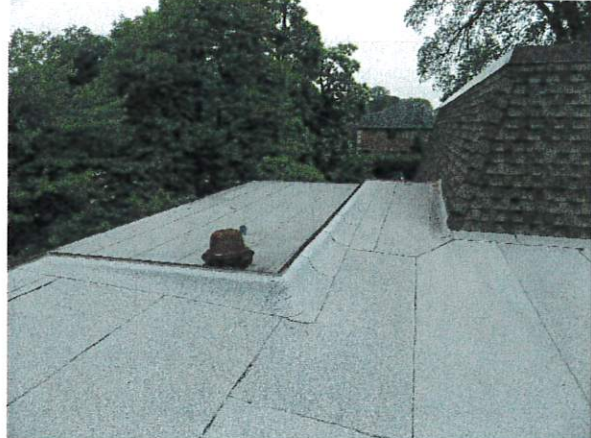
The ten year old roof is in good condition and well maintained. One roof drain cover was missing during the inspection. Roof slopes are adequate to avoid ponding. The higher roof lacked a ladder for access.

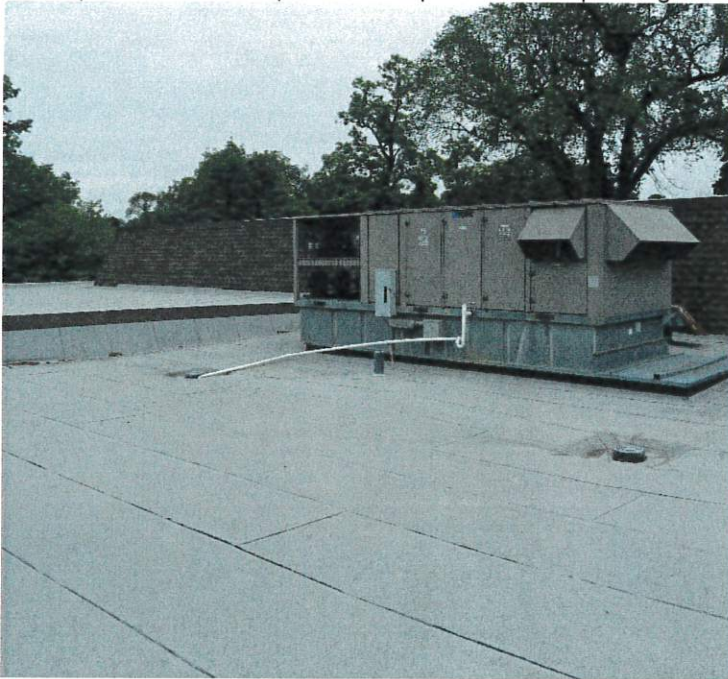
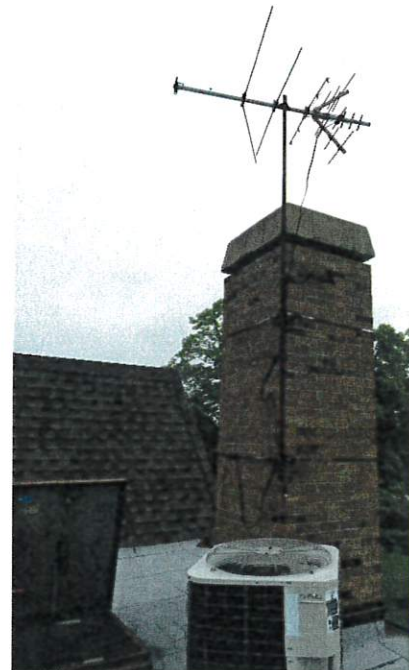
The antenna connected to the chimney is not in use. The roof ladder lacks the proper number of rungs to safely access the roof through the hatch.

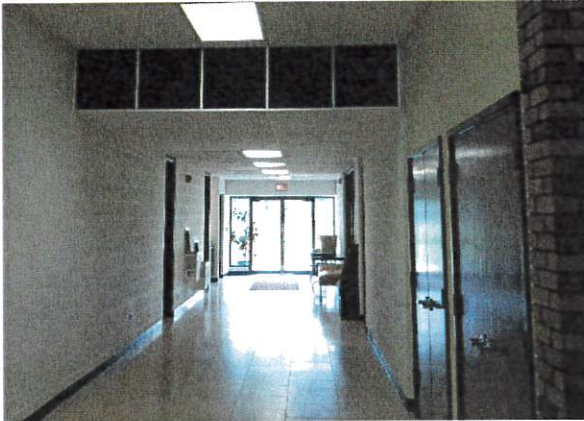
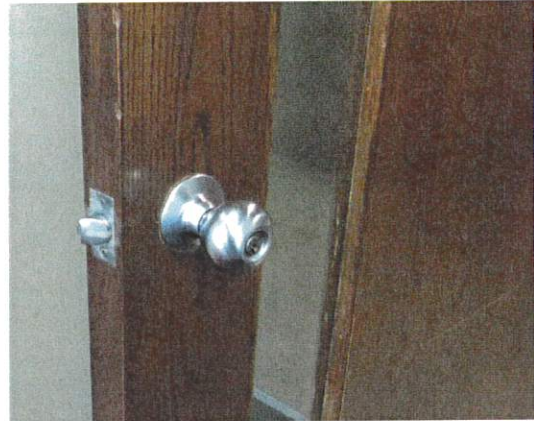
The main entrance lacks a vestibule. Interior lighting and door hardware throughout the building require replacement for ADA and code compliance.

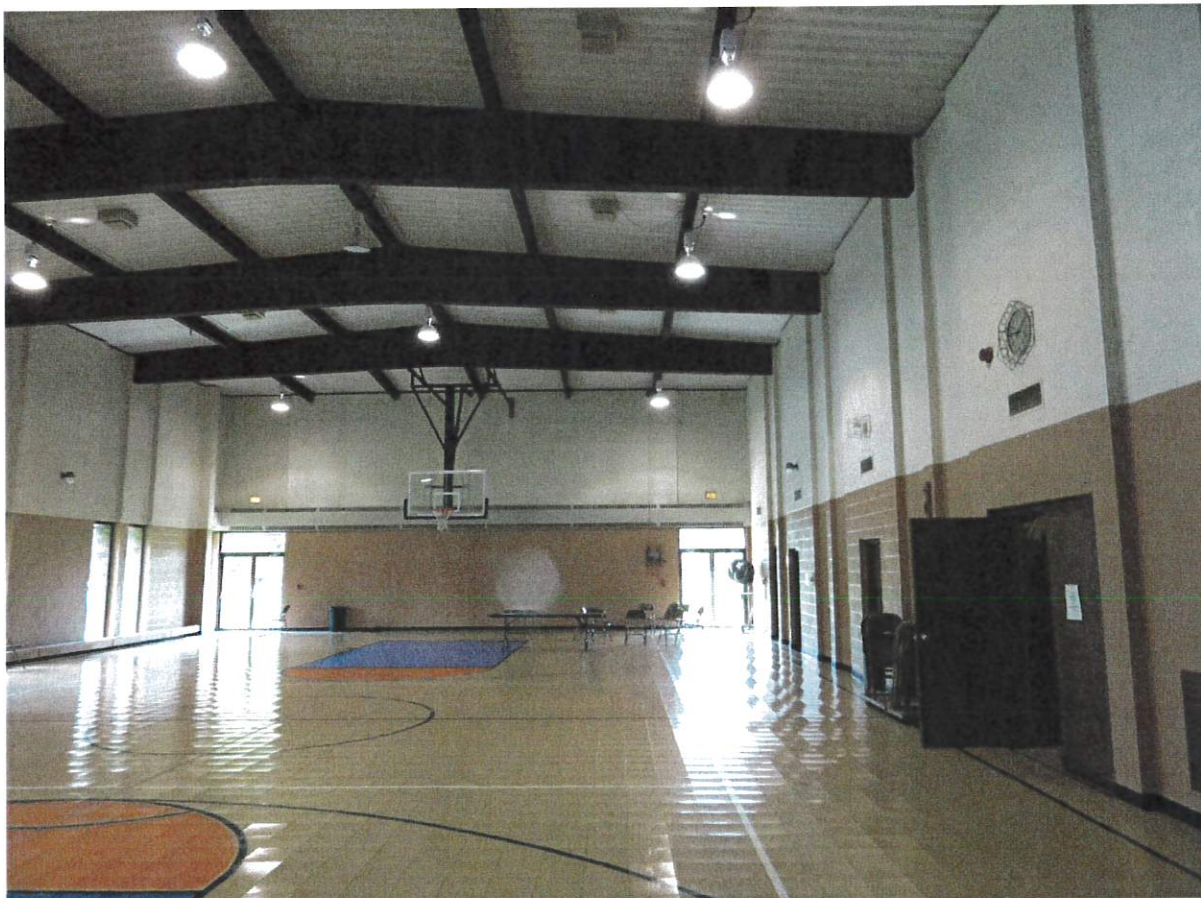
Fellowship Hall / Multipurpose Room floating flooring system needs replacement.

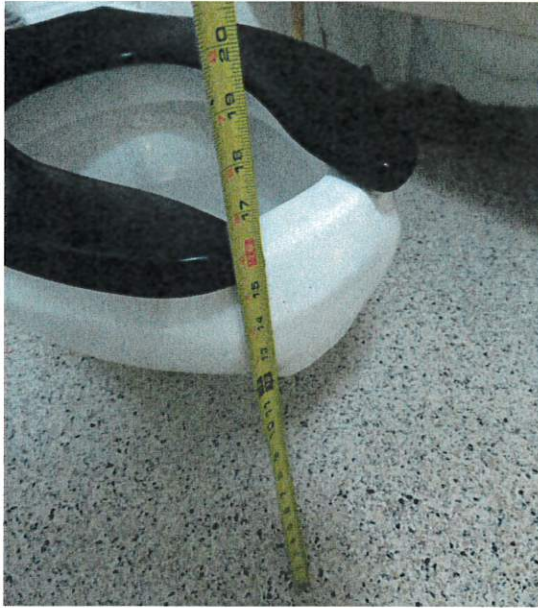
**Public Restrooms** are not ADA compliant and require a room reconfiguration for required clearances and dimensions.

Top of seat required 17" – 19" above floor.

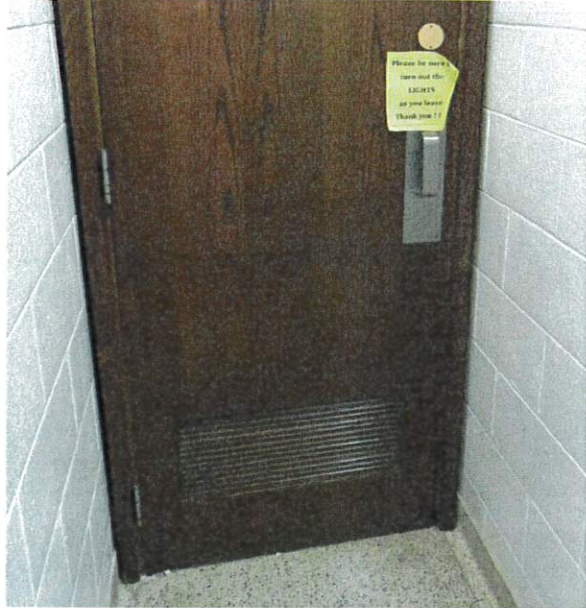
Front approach requires min. 18" at side of door pull.

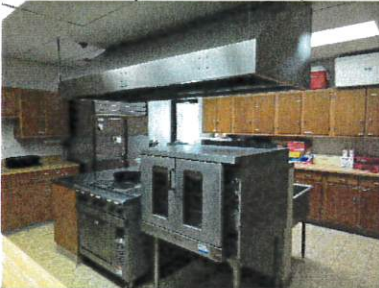
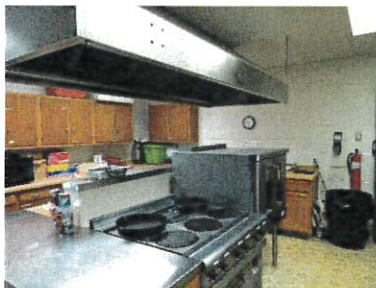
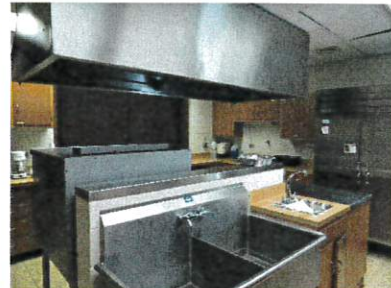
A triple basin sink, seamless floor system, food service rated ceiling panels, and a non-porous, solid surface or stainless steel countertop are required by the health code.

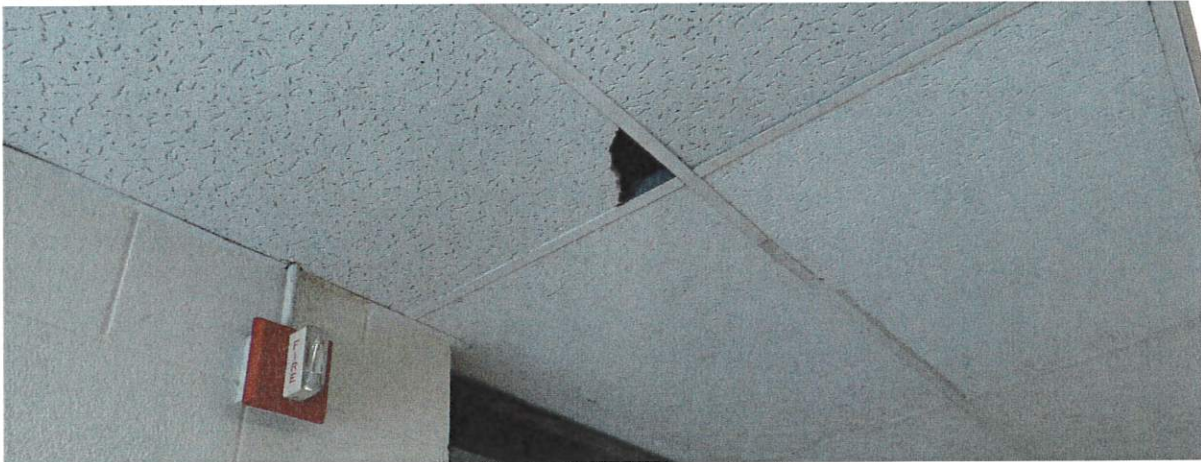
Acoustical lay-in ceiling panels and suspended grid system need replacement.

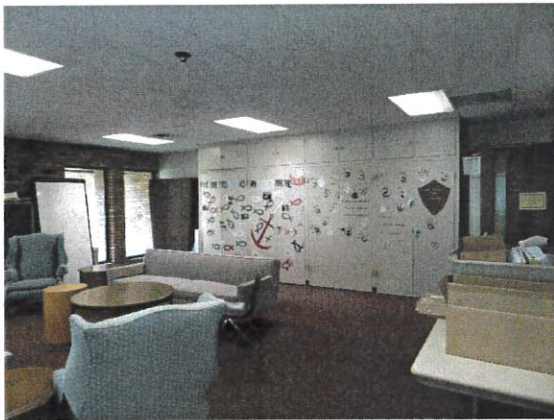
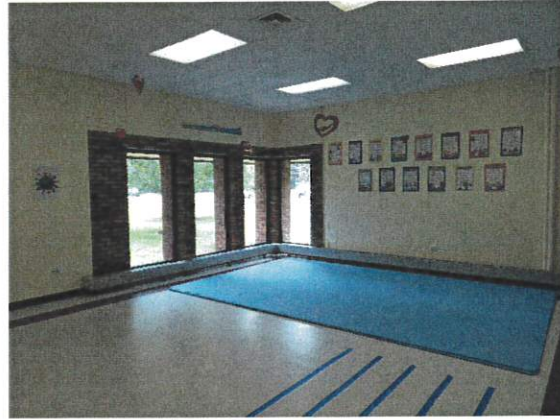
Walls, flooring and window treatment may need attention as per owner's preferences.

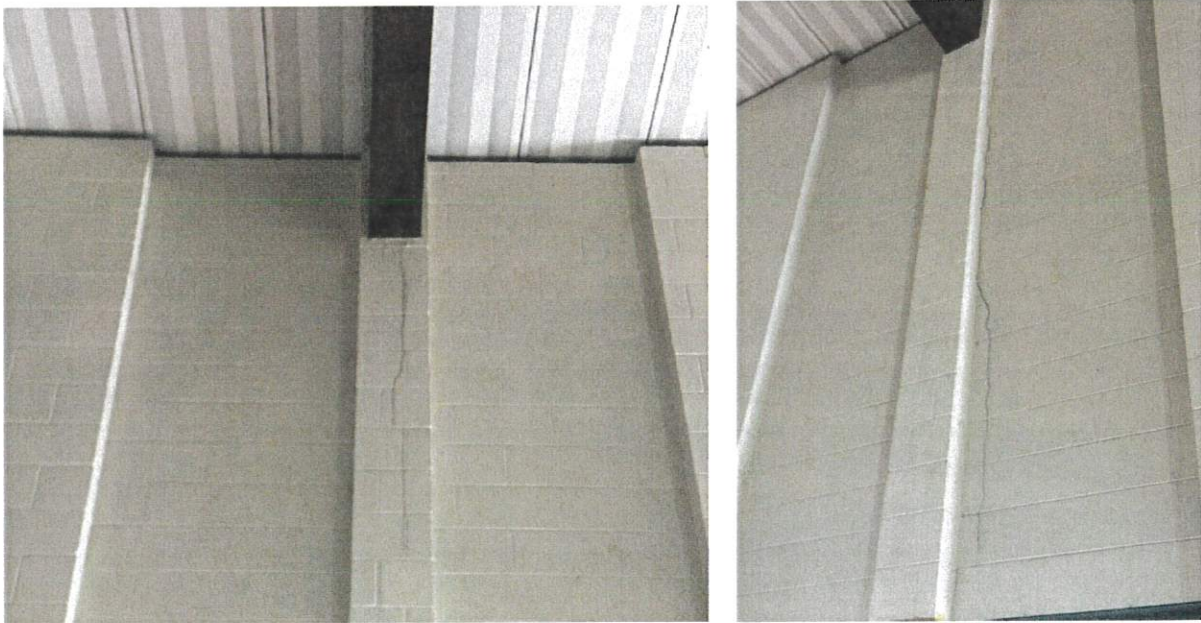
- The interior CMU on the long walls of the gymnasium have some vertical cracking above the windows at several of the CMU piers. The masonry piers encase the steel columns supporting the roof beams. The cracking appears to be cosmetic and as a result of shrinkage of the CMU. There are no control joints in the gymnasium walls, typical practice at the time of construction. The length of the wall exceeds the current recommended spacing to minimize the potential of cracking. The cracks do not affect the structure of the building and could be tuck-pointed to reduce their visibility.

Cracking at interior masonry piers

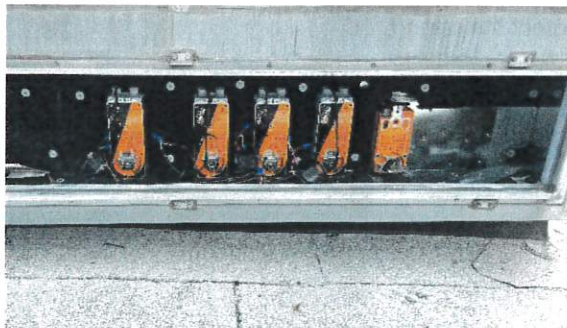
Figure 1: Motorized zone dampers

The original design of the HVAC system consisted of a natural gas heating, direct expansion cooling multi-zone rooftop air handler with five (5) zones of control. In approximately 2003 the existing multi-zone unit was removed and replaced with a cooling only packaged rooftop unit. The new unit is not equipped with a means of providing space heating. Therefore, all heating in the winter months is produced by the boiler system, which heats the facility by means of perimeter radiation (fin tube or cabinet unit heaters). The existing RTU only operates in the summer months, which means that ventilation air is only available when then the rooftop unit is operational. To control the original five (5) zones, the new rooftop unit was retrofitted with motorized dampers on the discharge at each original zone. The supply fan has a variable frequency drive that allows the fan to modulate speed as it reacts to the opening and closing of each zone, essentially acting as a VAV system with no reheat.

- To allow the RTU to operate in the winter months, each zone of control would need to have a hot water duct coil to raise the temperature from mixed air conditions to 90°F discharge.

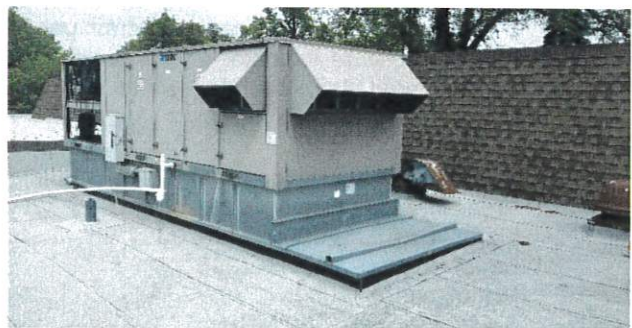
There is (1) one RTU that serves the air conditioning and ventilation needs of the building in the summer months. This unit is not original to the building; the existing unit is cooling only installed in approximately 2003. This makes the existing RTU approximately 16 years old. It is equipped with an adaptor curb to transition from the original RTU curbs to the new roof curbs. Below is a brief description of the existing RTU:

Figure 2: Cooling only RTU on adaptor curb

- Due to the age of the rooftop unit, if consideration is to install a new unit, a gas heat option should be reviewed. Even if a new unit is installed, it is recommended to include VAV boxes with reheat for each zone.

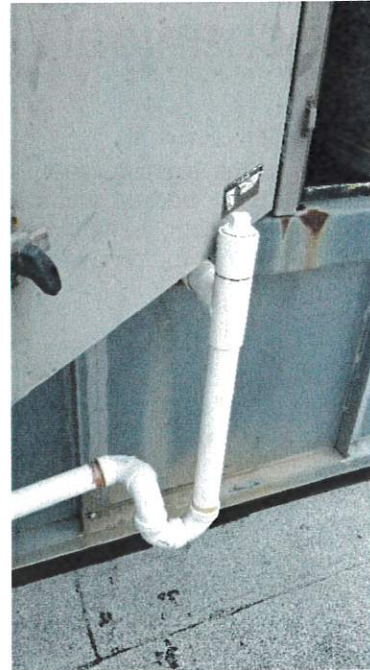
The American Society of Heating, Refrigeration and Air Condition Engineers (ASHRAE) defines mean useful life of equipment as the point at which the probability of failure exceeds 50%. For a packaged rooftop unit, depending on size, the mean useful life is 15 to 20 years of service. The existing unit is approximately 16 years old and should be considered for replacement within the next 5 years. During our observation it was noted that the unit is in fair condition with clean filters. The condensate drain piping, seen in Figure 3, is inhibiting the ability to open the access door to the cooling coil.

Figure 3: Blocked access door

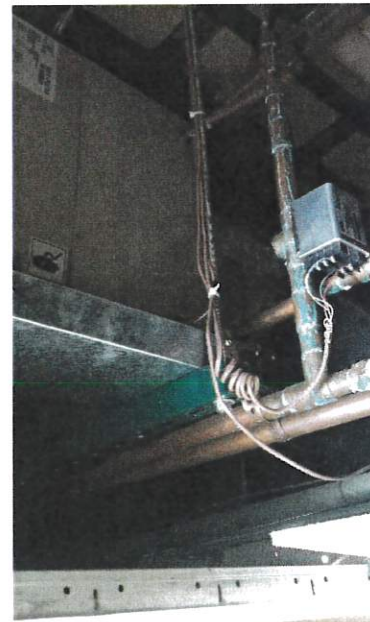
Figure 4: Fan coil unit

The overall the condition of the fan coil system (evaporator and condenser) is poor. Both the evaporator and condenser units have reached the end of their useful life and should be considered for replacement.

- Due to age and condition of the fan coil system, replacement of the existing system is warranted. If the existing rooftop unit is replaced, the installation of a new unit with sufficient capacity to take over the area of the building currently served by the fan coil system should be considered. This would convert the spaces served to VAV with hot water reheat.

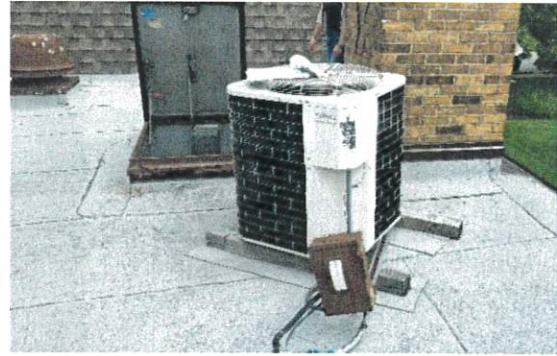
Figure 5: Condensing unit on roof

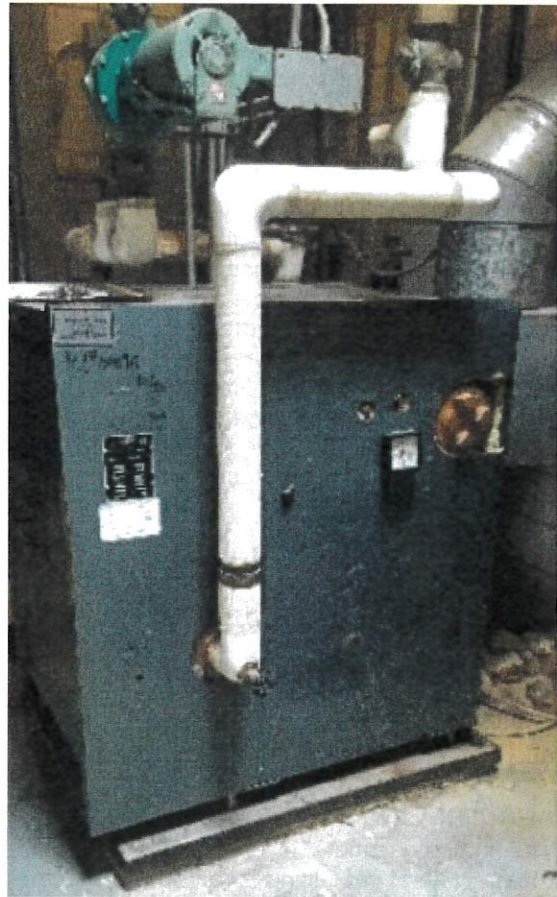
The age of the boiler is unknown although not believed to be original. The boiler was 80% efficient when new. The cast iron design is susceptible to thermal shock (large temperature difference between supply and return) which, if encountered, will crack the cast iron. This type of boiler is inexpensive for the most part and popular for facilities of this size. Boiler technology has made large advancements in the past ten years with the development of condensing boilers that operate at a much higher efficiency (95% +), although there is a cost increase for this efficiency. To truly know the operation of the boiler, a maintenance should be performed by a company that services these types of boilers. They can inspect the interior of the boiler to determine if damage has occurred and the current efficiency of the system, along with performing a general cleaning. This should take place every year as the facility goes into the heating season.

Figure 6: Gas fired boiler

- One of the main concerns is the lack of redundancy in the existing boiler system. If the boiler fails, there is no means of heat for the building. The boiler as it exists may have life remaining, although the poor efficiency of the system along with its lack of redundancy warrants replacement. Condensing boilers, as discussed earlier in this report, offer much higher efficiencies although there is a cost associated with this. Non-condensing boilers provide efficiencies in the high 80% range and are sized to allow two boilers to be installed in the space occupied by the single boiler today.

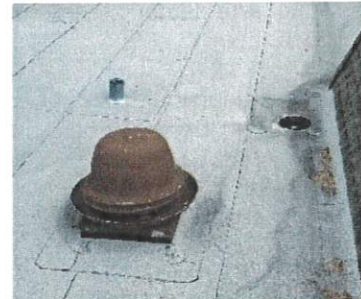
The kitchen hood is served by a single, down-blast exhaust fan controlled by a wall switch with an indicator light in the kitchen. The ductwork between the kitchen hood and the fan should be black iron and wrapped in two layers of fire wrap insulation. In addition, cleanouts should be included in every change of direction. During our site visit we could not determine if these conditions exist. The ductwork should be professionally cleaned to prevent grease fires in the duct every few years depending on how often the hood is used and what food is being prepared. The fan being utilized for the hood exhaust is not suitable for this type of application. The fan should be an up-blast type with a grease trough and hinged base for cleaning.

Figure 9: Kitchen exhaust fan

- The two (2) existing exhaust fans should be replaced. The toilet fan will be like-for-like meeting the capacity required by current code. The kitchen hood fan should be replaced with a fan that is suitable for the application.

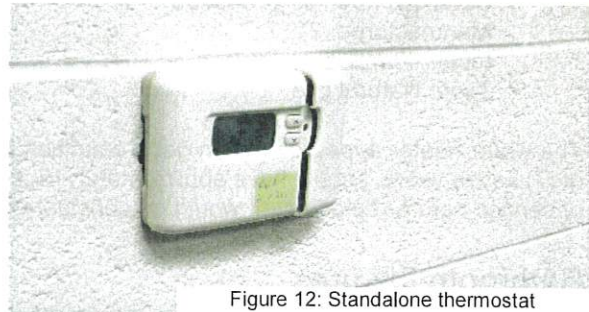
The mechanical system in the building is served primarily by standalone thermostats. The rooftop unit along with the five individual zones are served by space mounted standalone thermostats as well the fan coil system. These thermostats are 7-day programmable type, which are typical to what would be found in a residential home. No building automation system exists.

Figure 12: Standalone thermostat

If energy conservation is a goal of any renovation, consideration should be given to install a building automation system that can control all aspects of the HVAC system in the building. A web based open protocol system will allow the end user to control the building's operation and time and day function from any location.

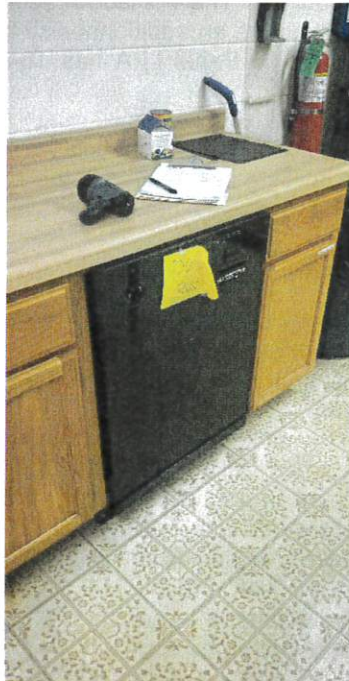
Figure 18: Dishwasher

The kitchen is equipped with a residential under-counter dishwasher, which is also indicated to not run for unknown reasons.

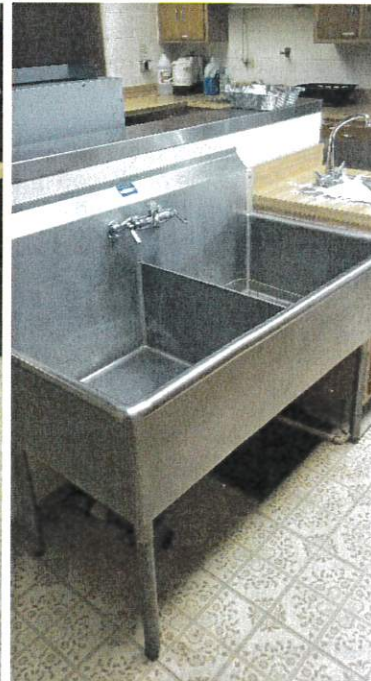
The kitchen has a two-compartment sink which should be a three-compartment sink for dish and utensil cleaning; however, verification by the AHJ is recommended. The discharge from the two-compartment sink is not indirect and is connected to the hand sink discharge and then routed underground to a floor mounted grease trap.

Figure 17: Two-compartment sink

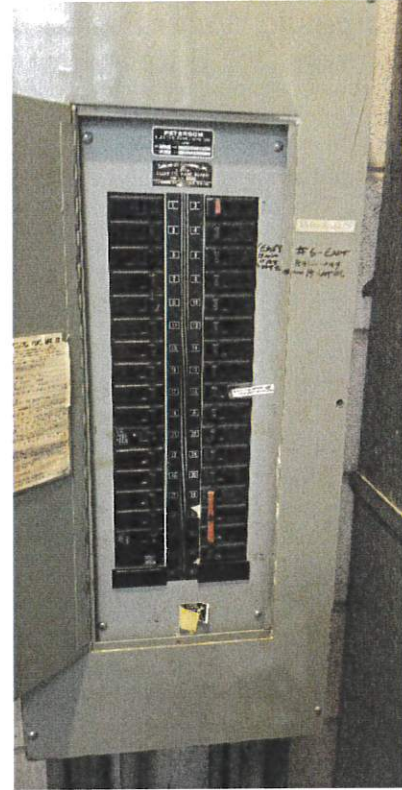
The panels appear to be in good condition. There is lack of additional available circuit spaces, which may require an additional distribution panel if additional circuits are required. Panel LPA has 10 blank spaces for expansion.

Figure 19: Main distribution panel

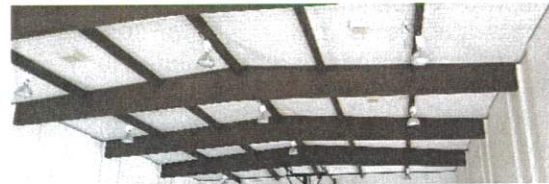
Lighting for the building is mainly a mix of recessed troffers and can lights. The gym has mercury vapor lights and the bathrooms are equipped with LED lighting that was installed recently. The troffers throughout the building are using T12 bulbs. These lamps are no longer manufactured and will / have become difficult to obtain. Consideration should be given to replacing the lay-in troffer fixtures with T-8, T-5, or LED fixtures. There are incentives available through Commonwealth Edison that can greatly offset the cost of lighting replacement. The remainder of the cost is generally offset by the operational savings.

Figure 21: Fellowship Hall lighting

- Future electrical modifications should consider replacement of the existing lighting and conversion to LED, which will allow for a reduction in energy cost, as well as realize potential incentive dollars to assist in funding the project.

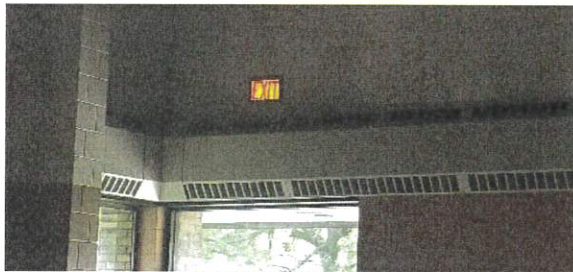
Figure 23: Exist light in Fellowship Hall

The building should upgrade its life safety system to meet the current code standards including supplementing the existing emergency lighting and replacing exit signs with non-incandescent type.

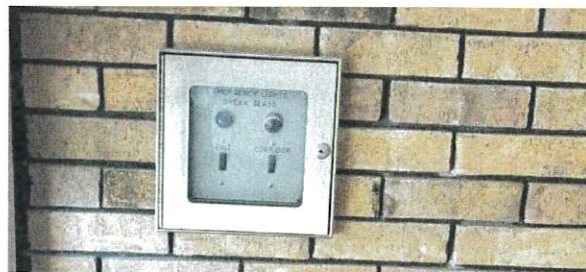
Figure 24: Locked, emergency light switches

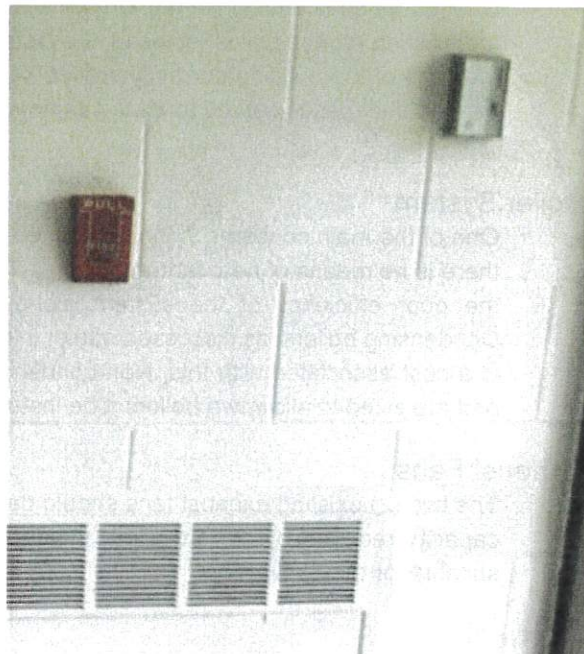
The building has a Tyco Firelite fire alarm panel, model MS-5024UD, located in the boiler room. The system is zone based and not addressable. The devices through the building appear original with the exception of a few locations where strobes were added. The building has smoke detection in most locations. Horns and manual pull stations were also observed.

Figure 25: Fire alarm pull device

Under a renovation to the facility the fire alarm devices should be replaced to bring the facility up to current code standards.
