The Abbey Park

The Abbey Park is senior center that provides programs and services for the seniors in Elmhurst. The main issues at this park are slopes in parking spaces, not properly spaced parking spaces, abrupt transitions, door opening forces too high, brochure racks too high, not properly spaced toilets, lack of sink pipe wrapping, and proper reach ranges. **Please Note:** When a **UD** is indicated, this is a Universal Design (**UD**) recommendation to enhance accessibility. The **UD** recommendation is not required to meet the minimum accessibility standards but it would be encouraged.

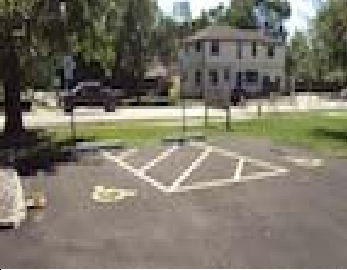
The west parking lot has 23 spaces but none are accessible. The east parking lot has 42 spaces with 4 accessible. The west parking does not provide an entrance to the building so placing all the accessible spaces in the east lot would appear to be appropriate. The two spaces facing the street do not provide the spacing for the access aisle. The two spaces facing the building have the space nearest the door with a cross slope too steep at 3.9% to 4.5%.	IAC 400.310(c)	Provide one accessible parking space with a access aisle a minimum of 96" plus a sign with the International Symbol of Accessibility and a fine sign of \$250 at the head of the parking space. The parking space and access aisle should be no steeper than 2% in all directions. If two spaces are desired here an additional 4' of surface is required to provide the proper dimensions.	1		\$750	2017	Relocated and reconfigured ADA parking spots as part of 2017 Paving project \$4,000

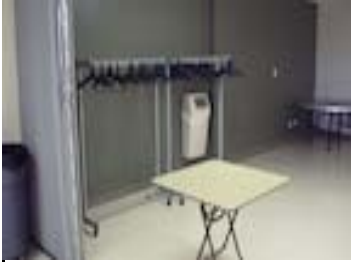
The coat hangers are too high at 53".	ADAAG 222.1 & ADAAG 308	Provide 5% of the coat hangers at a reach range no higher than 48" AFF for a forward reach over an obstruction no deeper than 20" or a side reach of 48" AFF over an object no deeper than 10". Consider adding additional cloths hooks at the lower height.	4		\$200	2019

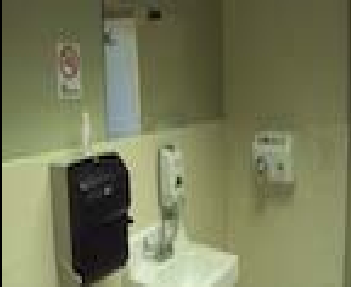
The mirror in the women's restroom is mounted too high at 53 1/2" to reflective surface.	ADAAG 603.3	Lower the mirror above the sink or countertop to be no higher than 40" to the reflective surface. Mirrors not mounted above the sink or a counter top should be mounted no higher than 35" to the reflective surface. UD - A full-length mirror would be a recommended option.	4	Bob Byrne	\$450	2012	Lowered over sink to 39" to reflective surface AFF 8/2012

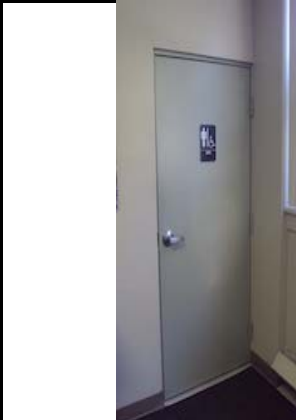
The sign for the men's restroom is mounted on the door.	ADAAG 216.2	The permanent room sign should to be mounted on the wall at the latch side of the door at 48" minimum from the baseline of the lowest tactile character to 60" maximum from the baseline of the highest character with raised lettering and numbers plus Braille.	4	Bob Byrne	\$100	2012	Mounted as directed @ 48 1/4" from baseline of braille AFF 7/2012

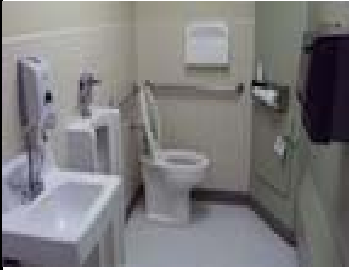
The rear grab bar in the men's restroom is only 2' long.	ADAAG 604.5.2 & ADAAG 609	Provide a rear grab bar a minimum of 36" long mounted 12" from the centerline of the toilet to the corner and 24" from the centerline to the open side of the toilet. The grab bar should be mounted at a centerline of 33" to 36" AFF.	3		\$150	2020

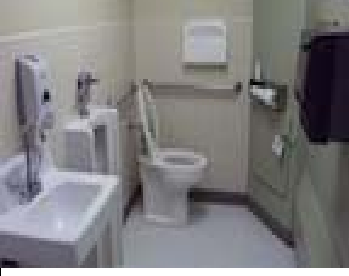
The toilet paper dispenser in the men's restroom is mounted too far in front of the toilet at 18".	ADAAG 604.7	Remount the toilet paper dispenser to be no lower than 15", no higher than 48" AFF and a minimum of 7" to a maximum of 9" in front of the toilet. Do not mount the toilet paper dispenser behind the side grab bar.	3	Bob Byrne	\$100	2012	Located new TP holder @ 7 1/4" in front of toilet @ 20 1/2" AFF 8/2012

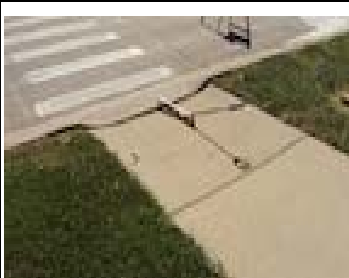
The curb ramp has no truncated domes.	ADAAG 705	Provide truncated domes that go the width of the sidewalk and 24" deep where it meets the road. Provide a color that contrast with the walkway surface. Truncated dome tiles are typically a more durable solution.	1		\$500	See above
