Ben Allison Park

Ben Allison Park is small neighborhood park that provides a sledding hill, ballfield, playground and walkway. The main issues at this park are providing accessible routes, slopes too steep, protruding branches, clear floor space at elements, accessible picnic table and accessible grill. **Please Note:** When a **UD** is indicated, this is a Universal Design (**UD**) recommendation to enhance accessibility. The **UD** recommendation is not required to meet the minimum accessibility standards but it would be encouraged.

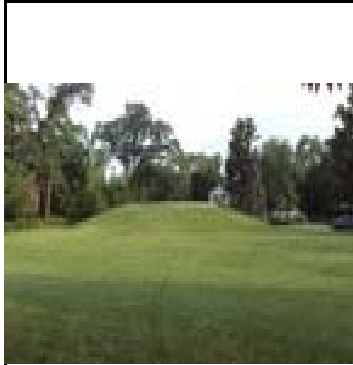
No accessible route is provided to the sledding hill.	ADAAG 403.3	Designate the sledding hill in Eldridge Park as the accessible sledding hill. If changes are made to this sledding hill, then provide a new accessible route with a running slope no steeper than 5% and a cross slope no steeper than 2% and a minimum clear width of 36".		Team Riel	TBD	2016	As part of 2016 Capital Plan renovated hill to provide accessible route Feb. 2016 actual cost \$118,000

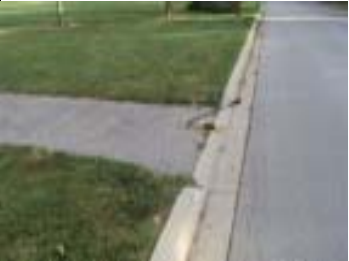
At the curb ramp to the playground, there are no truncated domes.	ADAAG 705	Provide truncated domes that go the width of the sidewalk and 24" deep where it meets the road. Provide a color that contrast with the walkway surface. Truncated dome tiles are typically a more durable solution.			Total playground renovation including accessible routes \$320,000	2021 Capital Plan/ Playground Repair and Replacement Plan

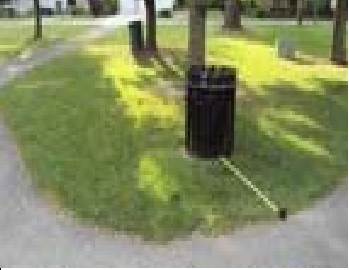
<p>The black trash can is off the accessible route for 4' and the green trash can is off the accessible route for 9'.</p>	<p>Proposed Outdoor Developed Areas Guidelines 1011</p>	<p>Trash Can Recommendation: Locate trash cans on an accessible route as part of your regular policy. For a forward approach provide a trash can within 24" and a minimum clear ground space of 36" by 48" or for a side approach provide a trash can within 24" and a minimum clear ground space of 30" by 60".</p>			<p>To be completed as part of playground replace</p>	<p>2021 Capital Plan/ Playground Repair and Replacement Plan</p>

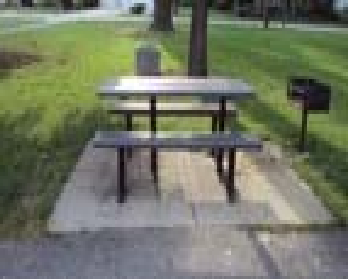
<p>One picnic table is provided that is of an accessible design but does not allow an accessible route to the accessible side.</p>	<p>Proposed Outdoor Developed Areas Guidelines ADAAG 245 & 1011</p>	<p>Picnic Table Recommendation: At least 20% of picnic tables, but no less than two, be of accessible design, connected to an accessible route. Relocate or purchase one more accessible picnic tables (\$750/each) and locate them on an accessible surface (\$900). Also turn or slide the present picnic table over to provide the accessible route to the wheelchair side.</p>			<p>To be completed as part of playground replace</p>	<p>2021 Capital Plan/ Playground Repair and Replacement Plan</p>

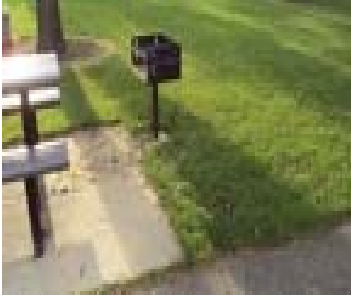
There is no access route and surface is provided around the grill.	Proposed Outdoor Developed Areas Guidelines ADAAG 1011.5	Grill Recommendation: Follow Outdoor Developed Area Report that states 20% of grills, but at least two, be of accessible design, and connected to an accessible route. The accessible grill should provide a cooking surface a minimum of 15" to 34" maximum AFF above the ground surface, a clear floor space and controls that are within a maximum reach range of 48" AFF. And a 48" by 48" space centered on the usable sides of the grill is required. The height and reach range on this grill meets standards.			To be completed as part of playground replace	2021 Capital Plan/ Playground Repair and Replacement Plan

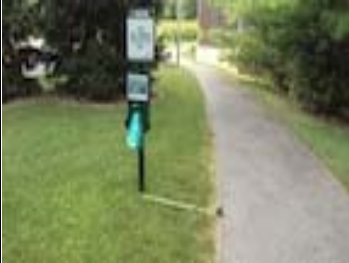
The dog waste bag dispenser is off the accessible route for 36".	ADAAG 403.3	Relocate the dog waste bag dispenser closer to the walkway or provide a new accessible route with a running slope no steeper than 5% and a cross slope no steeper than 2% and a minimum clear width of 36".		Staff	\$50	2012	Removed dispenser 11/13
