# Berens Park

Berens Park is very large neighborhood park that provides miniature golf, splash pad, playgrounds, soccer fields, football fields, batting cages, restrooms, and an extensive walkway system. The main issues at this park are not having proper parking spaces, slope issues, counters too high, not proper drinking fountains, door opening force being too high, protruding branches, lack of pipe protection, and signage not of the proper type or location. **Please Note:** When a **UD** is indicated, this is a Universal Design (**UD**) recommendation to enhance accessibility. The **UD** recommendation is not required to meet the minimum accessibility standards but it would be encouraged.

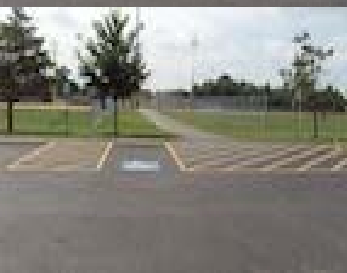
The east parking lot has a middle parking space facing south toward ballfields #1 to #4 that does not provide a parking sign with the International Symbol of Accessibility and a fine sign.	IAC 400.310(c)(7)	Provide a sign with the International Symbol of Accessibility and a fine sign of a between \$250 and \$350 depending on local codes. Mount the sign at the head of the parking space.			\$250,000 entire project	2019 Capital

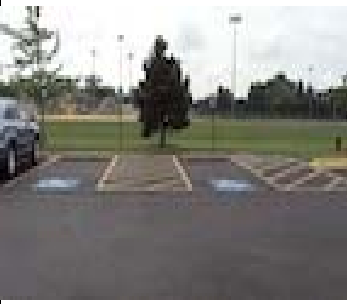
The east parking lot furthest west parking space that is nearest the Hub Building has a cross slope too steep at 3.1% to 3.2% and a running slope too steep at the end of the access aisle at 3.7%.	ADAAG 502.4	With this parking space being so close to the Hub and other park elements, regrade the parking space to be no steeper than 2% in all directions and provide a smooth transition.			" " "	2019 Capital

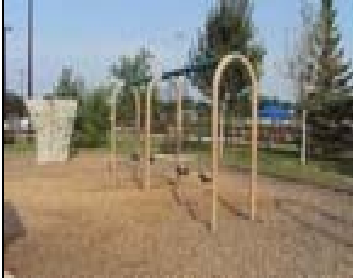
The adult/older child swings have a slope too steep at 7.1% to 26.8%	ADAAG 1008.4.4	Provide a regular maintenance to the play surface to provide a seat less than 24" off the ground and a slope under the swings no greater than 2%. Consider a mat under the swing to prevent kick-out of surface material. An accessible swing with a seat would be recommended at some point.			\$300,000 to upgrade playground and accessible routes	2023 Capital

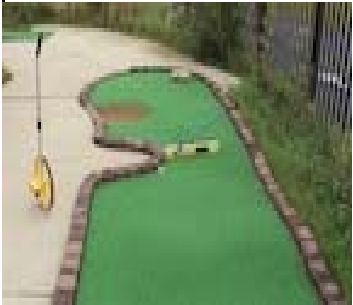
All the holes have an issue with the cross slope being too steep and sections of the green being too narrow. The holes also are wider than the 36" reach from an adjacent accessible route.	ADAAG 239.2 & ADAAG 1007	At least 50% of the holes must be accessible in a sequence with an option of one break in the sequence. The accessible route should begin at the first hole but end at the last hole. Provide an accessible route that complies with ADAAG 403.3 and hole that are within a 36" reach range.			\$150,000 to replace mini golf	2023 Capital

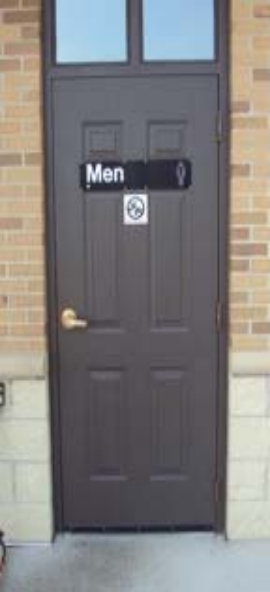
The men's restroom door has an opening force too high at 14 lbs. and closes too quickly at 4 seconds.	IAC 400.310(j)(10)(B)(i)	Adjust the closer so the door opening force is no heavier than 8.5 lbs. to open and takes a minimum of 5 seconds to close or provide an automatic door opener at one of the doors		Bob Byrne	\$100	2014	Door force adjusted 3/14/14
	The men's room sign is mounted on the door and does not have raised lettering.	ADAAG 216.2	The permanent room sign should be mounted on the wall at the latch side of the door at 48" minimum from the baseline of the lowest tactile character to 60" maximum from the baseline of the highest character with raised lettering and numbers plus Braille.		Bob Byrne	\$100	2014	New sign mounted per specs

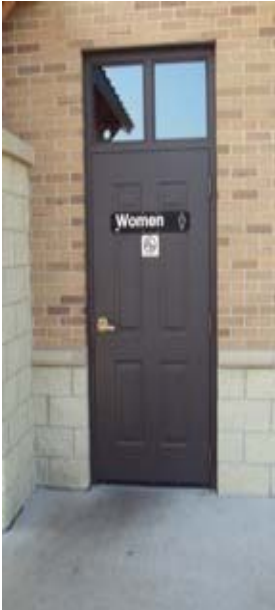
The women's restroom sign is mounted on the door and does not have raised lettering.	ADAAG 216.2	The permanent room sign should to be mounted on the wall at the latch side of the door at 48" minimum from the baseline of the lowest tactile character to 60" maximum from the baseline of the highest character with raised lettering and numbers plus Braille.		Bob Byrne	\$150	2014	New sign mounted per specs 3/14/14

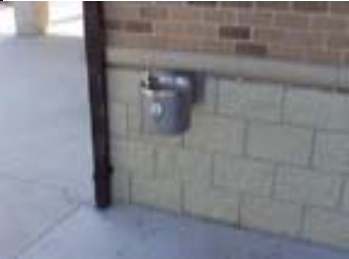
The drinking fountain mounted on the wall meets the requirements for a wheelchair drinking fountain but it does not provide a standing height.	ADAAG 211 & ADAAG 602	Provide another standing height drinking fountain or a single hi-lo drinking fountain that provides a wheelchair accessible fountain with a spout at 36" maximum and a standing drinking fountain with a height between 38" minimum and 43" maximum. The toe clearance should be a minimum of 9".			\$2,125	2019

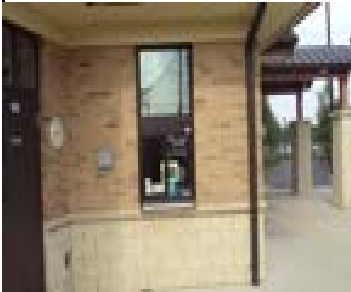
The counter at the window for miniature golf, spray ground and batting cages is too high at 38" AFF.	IAC 400.320(h)(1)(A)	Provide a section of counter that is no higher than 34" and is at least 36" long. In alterations where it is technically infeasible to provide an accessible counter, an auxiliary counter meeting those requirements maybe provided.			\$600	2019

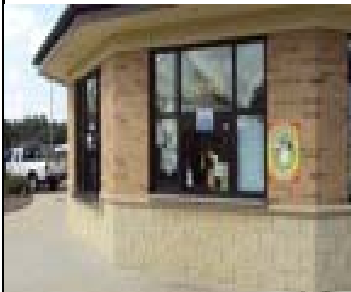
The counter labeled for placing orders is too high at 38" AFF.	IAC 400.320(h)(1)(A)	Provide a section of counter that is no higher than 34" and is at least 36" long. In alterations where it is technically infeasible to provide an accessible counter, an auxiliary counter meeting those requirements maybe provided.			\$600	2019

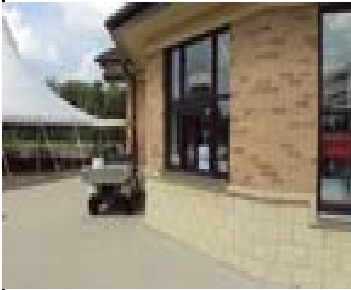
The window labeled "next window please" is too high at 38 1/2".	IAC 400.320(h)(1)(A)	If this counter is used, provide a section of counter that is no higher than 34" and is at least 36" long. In alterations where it is technically infeasible to provide an accessible counter, an auxiliary counter meeting those requirements maybe provided.			\$600	Counter not used

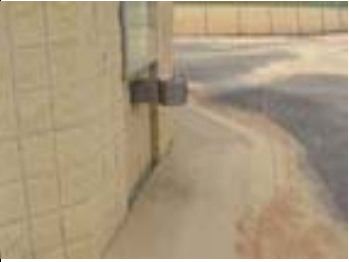
The drinking fountain mounted on the wall is of a wheelchair design but does not provide a standing height.	ADAAG 211 & ADAAG 602	Provide two individual drinking fountain or a single hi-lo drinking fountain that provides a wheelchair accessible fountain with a spout at 36" maximum and a standing drinking fountain with a height between 38" minimum and 43" maximum. The toe clearance should be a minimum of 9".			\$2,215	2020

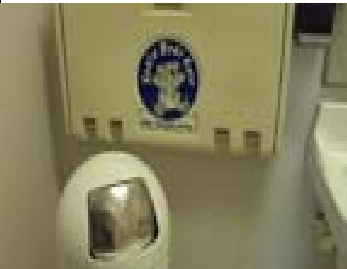
The baby changing tables clear floor space is partially blocked by trash can.	ADAAG 305	Relocate the trash can to provide a clear floor space of at least 30" wide by 48" deep that is connected by an accessible route. Train janitorial staff from placing trash cans in the clear floor spaces of restroom elements.		Bob Byrne	\$50	2014	Trash can moved 3/18/14

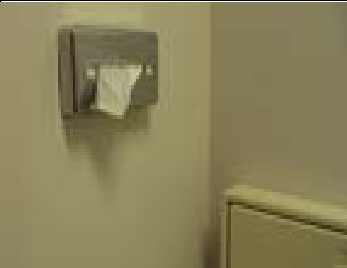
The tissue holder in the restroom is mounted too high at 62".	ADAAG 308	Remount the tissue holder to provide a reach range no higher than 48" AFF for a forward reach over an obstruction no deeper than 20" or a side reach of 48" AFF over an object no deeper than 10".		Bob Byrne	\$100	2014	Tissue holder removed 3/18/14

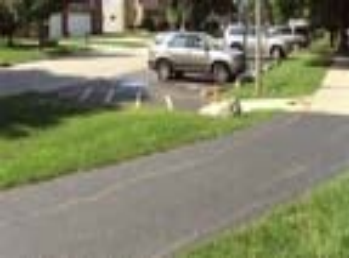
The walkway from the access aisle to the west walkway has a running slope too steep at 8.4% to 13.3 for 10'.	ADAAG 403.3	Remove and regrade section to provide a running slope no greater than 5% and a cross slope no greater than 2%. Because of the slope in this present location regrading to 5% may not be possible. Follow ADAAG 405 for ramps if necessary or create a new accessible route to the south.		All Star Asphalt	\$325	2018 Capital	As part of the 2018 Capital project all west parking lot issues will be resolved. \$195,000

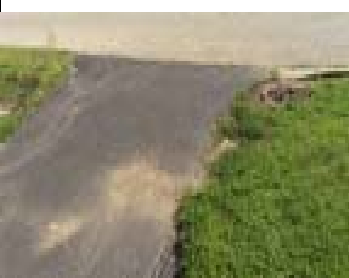
The southwest curb ramp does not provide truncated domes.	ADAAG 705	Provide truncated domes that go the width of the sidewalk and 24" deep where it meets the road. Provide a color that contrast with the walkway surface. Truncated dome tiles are typically a more durable solution.		City of Elmhurst	\$500	2016	Truncated domes added as part of City paving

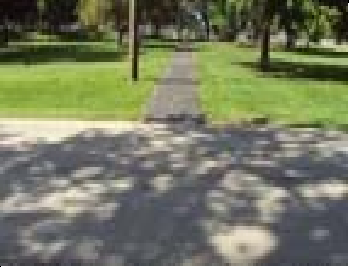
The south curb ramp at the walkway to the tennis courts, playground and restrooms does not provide truncated domes.	ADAAG 705	Provide truncated domes that go the width of the sidewalk and 24" deep where it meets the road. Provide a color that contrast with the walkway surface. Truncated dome tiles are typically a more durable solution.			\$500	2020-2023

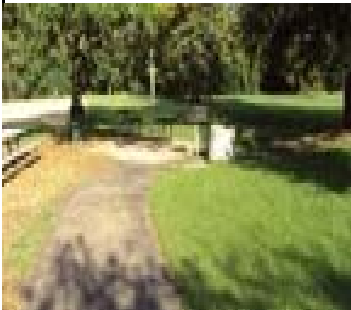
There is one grill provided at the picnic area but it is mounted too high at 40" AFF.	<u>Proposed</u> Outdoor Developed Areas Guidelines ADAAG 1011.5	<b>Grill Recommendation:</b> Follow Outdoor Developed Area Report that states 20% of grills, but at least two, be of accessible design, and connected to an accessible route. The accessible grill should provide a cooking surface a minimum of 15" to 34" maximum AFF above the ground surface, a clear floor space and controls that are within a maximum reach range of 48" AFF. And a 48" by 48" space centered on the usable sides of the grill is required.			\$400	2019

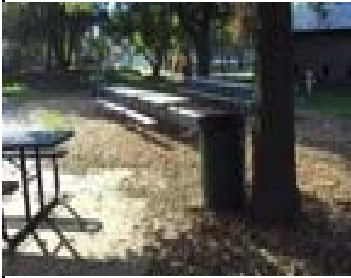
Three trash cans are provided but none are on the accessible route.	<b>Proposed</b> Outdoor Developed Areas Guidelines 1011	<b>Trash Can Recommendation:</b> Locate trash cans on an accessible route as part of your regular policy. For a forward approach provide a trash can within 24" and a minimum clear ground space of 36" by 48" or for a side approach provide a trash can within 24" and a minimum clear ground space of 30" by 60".			\$100	2018

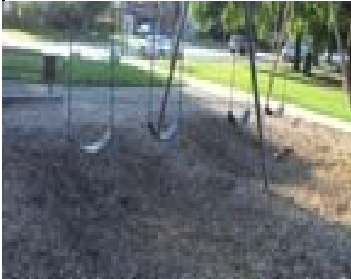
The adult/older child swings have a slope too steep at 20.9% to 23.6%.	ADAAG 1008.4.4	Provide a regular maintenance to the play surface to provide a seat less than 24" off the ground and a slope under the swings no greater than 2%. Consider a mat under the swing to prevent kick-out of surface material. An accessible swing with a seat would be recommended at some point.			" " " "	2012 Capital Plan	Replaced Playground equip., and surfacing \$177,00 for entire project

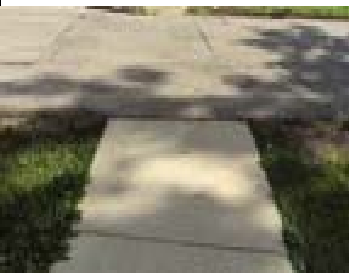
The curb ramp for the southeast concrete walkway does not provide truncated domes.	ADAAG 705	Provide truncated domes that go the width of the sidewalk and 24" deep where it meets the road. Provide a color that contrast with the walkway surface. Truncated dome tiles are typically a more durable solution.			\$500		Work with City's sidewalk schedule

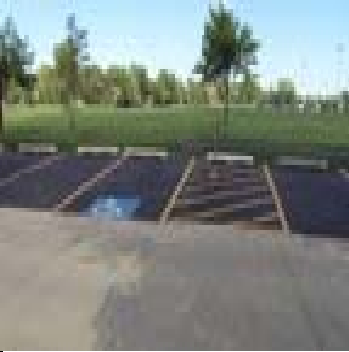
The north parking lot accessible parking is missing a sign.	IAC 400.310(c)(7)	Provide a sign with the International Symbol of Accessibility and a fine sign of a between \$250 and \$350 depending on local codes. Mount the sign at the head of the parking space.			\$900	2018 Capital Project	As part of the 2018 Capital project all west parking lot issues will be resolved. \$195,000
	The north accessible parking space has a running slope too steep at 2.8% to 4.4%.	ADAAG 502.4	Regrade the parking spaces on the shortest accessible route to be no steeper than 2% in all directions.			\$750	2018 Capital Project	As part of the 2018 Capital project all west parking lot issues will be resolved. \$195,000

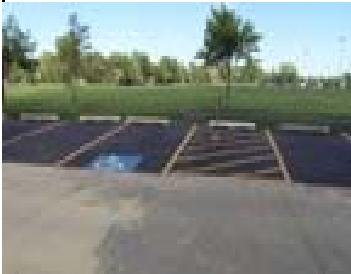
The north parking lot has 32 parking spaces but only one designated accessible parking space.	IAC 400.310(c)	Provide one accessible parking space with a access aisle a minimum of 96" plus a sign with the International Symbol of Accessibility and a fine sign of \$250 at the head of the parking space. The parking space and access aisle should be no steeper than 2% in all directions. Locate the accessible parking space on the shortest accessible route.			\$1,000	2018 Capital Project	As part of the 2018 Capital project all west parking lot issues will be resolved. \$195,000

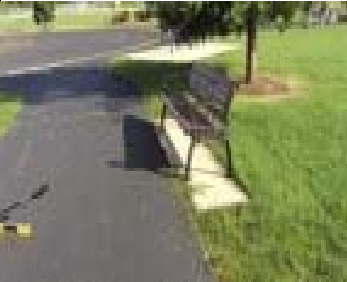
The bench near the east parking lot has no companion seating but does have the spacing if moved over.	<b>Proposed</b> Outdoor Areas Standards ADAAG 1011	<b>Bench Recommendation:</b> Provide at least 20% but no less than two benches to provide a clear ground space of at least 30" by 48" positioned near the bench with one side adjoining the walkway and a slope no steeper than 2% in all directions. The clear ground space should not overlap the accessible route or another clear ground space. For the existing bench slide it over on the concrete to provide the companion seating.		Scott Dohnal	\$250	2014	Moved bench on existing pad to provide companion seating 9/5/2014
