Butterfield Park

Butterfield Park is a very large neighborhood park that provides a playground, picnic areas, ballfields and a building for preschool program. The main issues at this park are not having proper accessible parking spaces, slopes, abrupt transitions, no the correct number of accessible picnic tables or on the correct surface, not having companion seating at benches and bleachers, protruding branches, restroom grab bars not properly mounted and various restroom elements out of reach ranges. . **Please Note:** When a **UD** is indicated, this is a Universal Design (**UD**) recommendation to enhance accessibility. The **UD** recommendation is not required to meet the minimum accessibility standards but it would be encouraged.

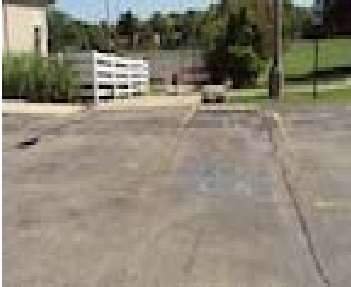
| Photo | Barrier | ADAAG/IAC | Solution | Priority | By Whom | Projected Cost | Projected Date | Action Taken |
|---|---|---|---|---|---|---|---|--|
| | <p>The main parking lot has one accessible parking space marked with a sign but the sign is mounted at the front of the access aisle and not the parking space.</p> | IAC 400.310(c) | <p>Leave the post where it is but restripe the accessible parking space's access aisle to parking space just to it north with the light symbol of accessibility and black out the present access aisles light stripes to make it the accessible parking space.</p> | | Elanar Construction | \$50 | 2016 | <p>Parking lot repaved and signs in appropriate location. 11/2016. \$135,000 for entire lot.</p> |

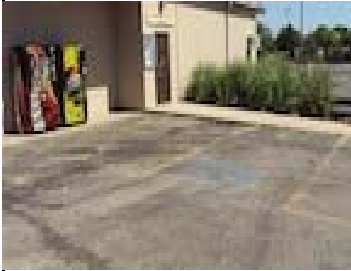
| Photo | Barrier | ADAAG/IAC | Solution | Priority | By Whom | Projected Cost | Projected Date | Action Taken |
|---|---|---|---|---|---|---|---|--|
| | <p>The main parking lot has 71 parking spaces and requires a total of 3 accessible parking spaces. The spaces near the preschool building have cross slopes too steep at 2.8% to 3.4% and do not provide signage.</p> | IAC 400.310(c) | <p>Provide two accessible parking spaces with a access aisle a minimum of 96" plus a sign with the International Symbol of Accessibility and a fine sign of \$250 at the head of the parking space. The parking space and access aisle should be no steeper than 2% in all directions. Locate an accessible parking space at the playground entrance and one at the walkway entrance to the picnic and ballfield.</p> | | Elanar Construction | \$1,500 | 2016 | <p>Parking lot repaved and signs in appropriate location. 11/2016. \$135,000 for entire lot.</p> |

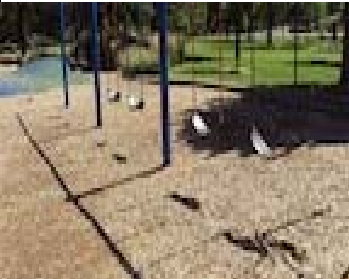
| Photo | Barrier | ADAAG/IAC | Solution | Priority | By Whom | Projected Cost | Projected Date | Action Taken |
|---|--|---|---|---|---|---|---|---|
| | The adult/older child swings have a slope too steep at 8.6% to 13.1% | ADAAG 1008.4.4 | Provide a regular maintenance to the play surface to provide a seat less than 24" off the ground and a slope under the swings no greater than 2%. Consider a mat under the swing to prevent kick-out of surface material. An accessible swing with a seat would be recommended at some point. | | Hacienda Landscaping | \$100 | 2016 | Playground and pavement surfaces renovated to meet ADA guidelines, 11/2016 \$600,000 |

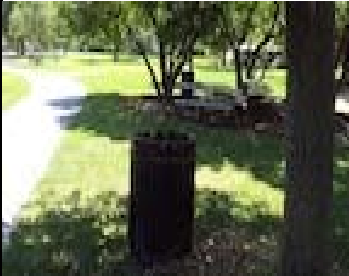
| Photo | Barrier | ADAAG/IAC | Solution | Priority | By Whom | Projected Cost | Projected Date | Action Taken |
|---|---|--|---|---|---|---|---|--|
| | The black trash can is 4' off the accessible route. | <u>Proposed</u> Outdoor Developed Areas Guidelines 1011 | Trash Can Recommendation: Locate trash cans on an accessible route as part of your regular policy. For a forward approach provide a trash can within 24" and a minimum clear ground space of 36" by 48" or for a side approach provide a trash can within 24" and a minimum clear ground space of 30" by 60". | | | \$50 | 2016 | Replaced and moved trash can as part of Park renovation |

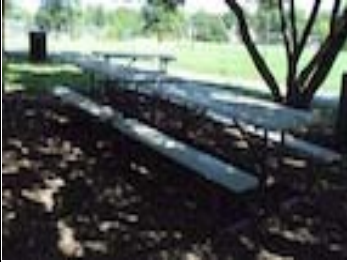
| Photo | Barrier | ADAAG/IAC | Solution | Priority | By Whom | Projected Cost | Projected Date | Action Taken |
|---|---|---|---|---|---|---|---|---|
| | <p>Three picnic tables are provided at the playground with one being of an accessible design but provides only a 26" knee clearance and none are on an accessible route or surface for 32'.</p> | <p><u>Proposed</u> Outdoor Developed Areas Guidelines ADAAG 245 & 1011</p> | <p>Picnic Table Recommendation: At least 20% of picnic tables, but no less than two, be of accessible design, connected to an accessible route and on an accessible surface. Relocate or purchase two accessible picnic tables and locate them on an accessible surface.</p> | | Hacienda Landscaping | \$750 | 2016 | <p>Playground and pavement surfaces renovated to meet ADA guidelines, 11/2016</p> |

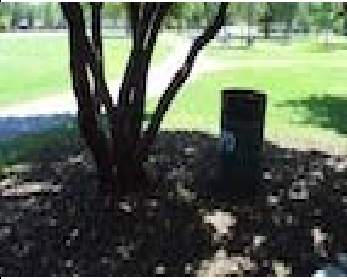
| Photo | Barrier | ADAAG/IAC | Solution | Priority | By Whom | Projected Cost | Projected Date | Action Taken |
|---|---|---|---|---|---|---|---|---|
| | <p>The green trash can is off the accessible route for 15'.</p> | <p><u>Proposed</u> Outdoor Developed Areas Guidelines 1011</p> | <p>Trash Can Recommendation: Locate trash cans on an accessible route as part of your regular policy. For a forward approach provide a trash can within 24" and a minimum clear ground space of 36" by 48" or for a side approach provide a trash can within 24" and a minimum clear ground space of 30" by 60".</p> | | | \$50 | 2016 | <p>Replaced and moved trash can as part of Park renovation</p> |

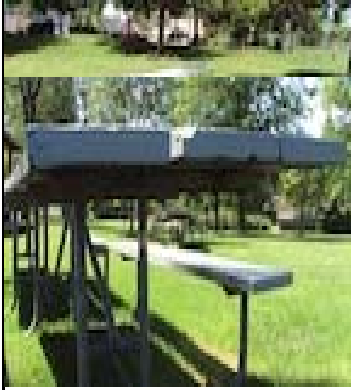
| Photo | Barrier | ADAAG/IAC | Solution | Priority | By Whom | Projected Cost | Projected Date | Action Taken |
|--|---|--|--|---|---|---|---|---|
| | Twenty two tables are provided at the shelter with two designed to be accessible except the support bar underneath cuts the clear knee space down to 26". They are also located in the grass. | <u>Proposed</u> Outdoor Developed Areas Guidelines ADAAG 245 & 1011 | Picnic Table Recommendation: At least 20% of picnic tables, but in this case no less than three, be of accessible design, connected to an accessible route. Relocate or purchase three accessible picnic tables and locate them on an accessible surface. | | | \$3,750 | 2019 | |

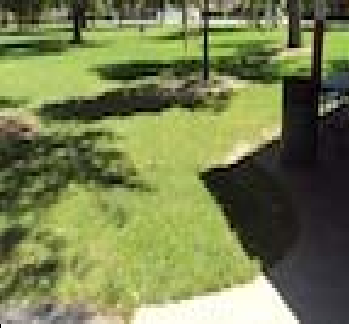
| Photo | Barrier | ADAAG/IAC | Solution | Priority | By Whom | Projected Cost | Projected Date | Action Taken |
|--|--|--|---|---|---|---|---|--|
| | The grill provided but it is not on an accessible route for 84'. | Proposed Outdoor Developed Areas Guidelines ADAAG 1011.5 | Grill Recommendation: Follow Outdoor Developed Area Report that states 20% of grills, but at least two, be of accessible design, and connected to an accessible route. The accessible grill should provide a cooking surface a minimum of 15" to 34" maximum AFF above the ground surface, a clear floor space and controls that are within a maximum reach range of 48" AFF. And a 48" by 48" space centered on the usable sides of the grill is required. | | | \$2,775 | 2019 | |

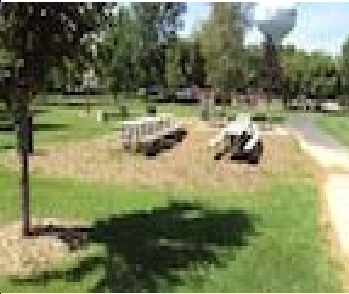
| Photo | Barrier | ADAAG/IAC | Solution | Priority | By Whom | Projected Cost | Projected Date | Action Taken |
|--|--|--|---|---|---|---|---|--|
| | Picnic area #8 has 11 tables with 2 that are accessible. | Proposed Outdoor Developed Areas Guidelines ADAAG 245 & 1011 | Picnic Table Recommendation: At least one more picnic table that is of an accessible design, connected to an accessible route. Relocate or purchase one accessible picnic tables and locate it on an accessible surface. | | District staff | \$1,650 | 2016 | Removed picnic area as part of Park renovation 11/2016 |

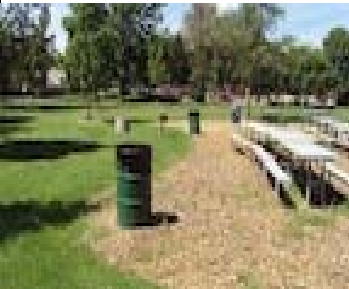
| Photo | Barrier | ADAAG/IAC | Solution | Priority | By Whom | Projected Cost | Projected Date | Action Taken |
|---|---|--|---|---|---|---|---|---|
| | <p>There are 3 trash cans not on an accessible route. The grill and hot coal bin is not on an accessible route for 24'.</p> | <p><u>Proposed</u> Outdoor Developed Areas Guidelines 1011</p> | <p>Trash Can Recommendation: Locate trash cans on an accessible route as part of your regular policy. For a forward approach provide a trash can within 24" and a minimum clear ground space of 36" by 48" or for a side approach provide a trash can within 24" and a minimum clear ground space of 30" by 60". Use these same standards with the coal bin.</p> | | <p>District staff</p> | <p>\$50</p> | <p>2016</p> | <p>Removed picnic area as part of Park renovation 11/2016</p> |

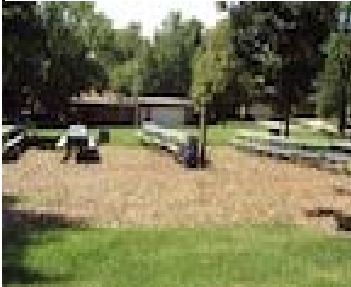
| Photo | Barrier | ADAAG/IAC | Solution | Priority | By Whom | Projected Cost | Projected Date | Action Taken |
|---|---|---|--|---|---|---|---|---|
| | <p>There are 20 picnic tables provided that are 60' off the accessible route. No tables provide an accessible design.</p> | <p><u>Proposed</u> Outdoor Developed Areas Guidelines ADAAG 245 & 1011</p> | <p>Picnic Table Recommendation: At least 20% of picnic tables, but no less than two, be of accessible design, connected to an accessible route. Relocate or purchase four accessible picnic tables and locate them on an accessible surface.</p> | | District staff | \$6,600 | 2016 | Removed picnic area |

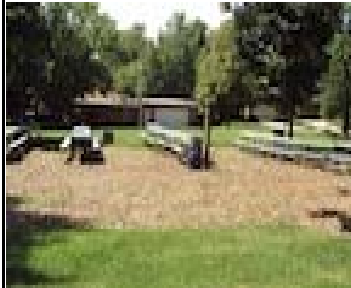
| Photo | Barrier | ADAAG/IAC | Solution | Priority | By Whom | Projected Cost | Projected Date | Action Taken |
|---|---|---|--|---|---|---|---|---|
| | <p>There are 4 trash cans located between 71' to 114" off an accessible route and a coal bin located 61' off an accessible route.</p> | <p><u>Proposed</u> Outdoor Developed Areas Guidelines 1011</p> | <p>Trash Can Recommendation: Locate trash cans on an accessible route as part of your regular policy. For a forward approach provide a trash can within 24" and a minimum clear ground space of 36" by 48" or for a side approach provide a trash can within 24" and a minimum clear ground space of 30" by 60". Do the same with the coal bin using this standard.</p> | | District staff | \$100 | 2016 | Removed picnic area |

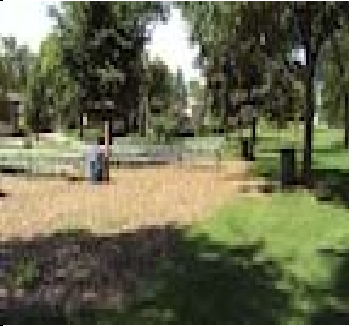
| Photo | Barrier | ADAAG/IAC | Solution | Priority | By Whom | Projected Cost | Projected Date | Action Taken |
|--|---|---|---|---|---|---|---|--|
| | A grill is provided but is located 80' from an accessible route. | Proposed Outdoor Developed Areas Guidelines ADAAG 1011.5 | Grill Recommendation: Follow Outdoor Developed Area Report that states 20% of grills, but at least two, be of accessible design, and connected to an accessible route. The accessible grill should provide a cooking surface a minimum of 15" to 34" maximum AFF above the ground surface, a clear floor space and controls that are within a maximum reach range of 48" AFF. And a 48" by 48" space centered on the usable sides of the grill is required. | | District staff | \$400 | 2016 | Removed picnic area |

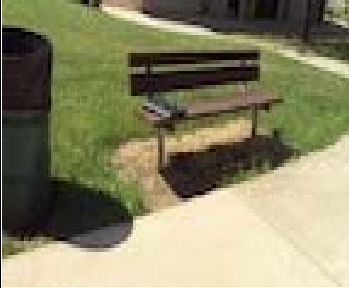
| Photo | Barrier | ADAAG/IAC | Solution | Priority | By Whom | Projected Cost | Projected Date | Action Taken |
|--|--|--|--|---|---|---|---|---|
| | The bench at the tennis courts does not provide companion seating. | <u>Proposed</u> Outdoor Areas Standards ADAAG 1011 | Bench Recommendation: Provide at least 20% but no less than two benches to provide a clear ground space of at least 30" by 48" positioned near the bench with one side adjoining the walkway. The clear ground space should not overlap the accessible route or another clear ground space. UD - Provide benches with armrests and no gaps between the seat and backrest. | | Elanar Construction | \$250 | 2016 | Park renovated including paths to meet ADA requirements 11/2016 (part of park renovation total spent \$1,000,000) |

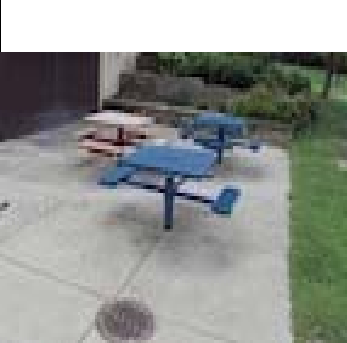
| Photo | Barrier | ADAAG/IAC | Solution | Priority | By Whom | Projected Cost | Projected Date | Action Taken |
|--|--|--|--|---|---|---|---|--|
| | Three picnic tables are provided but only one is of an accessible design. | Proposed Outdoor Developed Areas Guidelines ADAAG 245 & 1011 | Picnic Table Recommendation: At least 20% of picnic tables, and in this case at least one more be of accessible design, connected to an accessible route. Relocate, purchase or modify one picnic table to be accessible. | | Elanar Construction | \$750 | 2016 | Picnic area removed as part of Park renovations, 11/2015 |

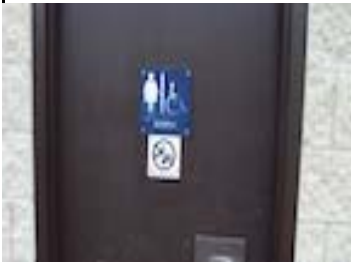
| Photo | Barrier | ADAAG/IAC | Solution | Priority | By Whom | Projected Cost | Projected Date | Action Taken |
|---|--|---|---|---|---|---|---|--|
| | The sign for the women's restroom door is mounted on the door. | ADAAG 216.2 | The permanent room sign should to be mounted on the wall at the latch side of the door at 48" minimum from the baseline of the lowest tactile character to 60" maximum from the baseline of the highest character with raised lettering and numbers plus Braille. | | Bob Byrne | \$100 | 6/20/2012 | Sign changed moved to recommend ed location |

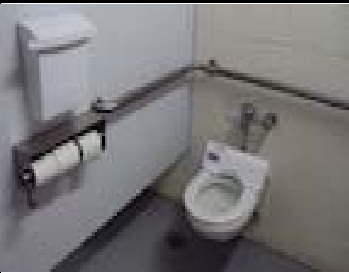
| Photo | Barrier | ADAAG/IAC | Solution | Priority | By Whom | Projected Cost | Projected Date | Action Taken |
|--|---|---|--|---|---|---|---|---|
| | The women's toilet paper is mounted too far in front of the toilet at 16". | ADAAG 604.7 | Remount the toilet paper dispenser to be no lower than 15", no higher than 48" AFF and a minimum of 7" to a maximum of 9" in front of the toilet. Do not mount the toilet paper dispenser behind the side grab bar. | | Bob Byrne | \$100 | 2013 | Relocated dispenser to 8" center of dispenser in front of toilet 1/16/2013 |

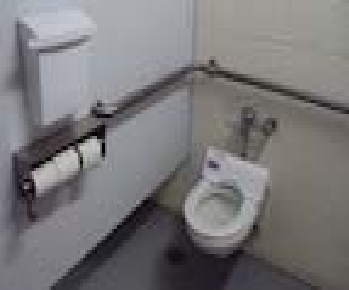
| Photo | Barrier | ADAAG/IAC | Solution | Priority | By Whom | Projected Cost | Projected Date | Action Taken |
|--|---|---|--|---|---|---|---|--|
| | The grab bars in the men's restroom are reversed with the longer section in the back and the shorter section on the side. | ADAAG 604.5 | Remount the grab bar to provide a rear grab bar a minimum of 36" long mounted 12" from the centerline of the toilet to the corner and 24" from the centerline to the open side of the toilet. Also, provide a side grab bar a minimum of 42" long and a maximum of 12" from the corner. Both grab bars should be mounted at 33" to 36" to the top of the grab bar. | | Bob Byrne | \$200 | 2013 | Reversed grab bars to comply 6/20/2013 |

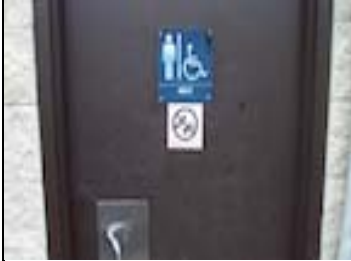
| Photo | Barrier | ADAAG/IAC | Solution | Priority | By Whom | Projected Cost | Projected Date | Action Taken |
|---|--|---|--|---|---|---|---|--|
| | The sign for the men's restroom door is mounted on the door. | ADAAG 216.2 | The permanent room sign should to be mounted on the wall at the latch side of the door at 48" minimum from the baseline of the lowest tactile character to 60" maximum from the baseline of the highest character with raised lettering and numbers plus Braille. | | Bob Byrne | \$100 | 2012 | Sign changed moved to recommended location 6/20/2012 |

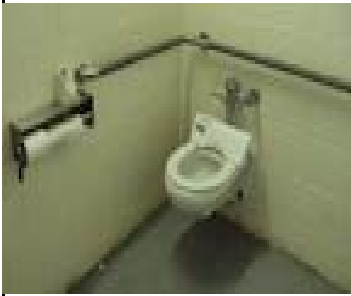
| Photo | Barrier | ADAAG/IAC | Solution | Priority | By Whom | Projected Cost | Projected Date | Action Taken |
|---|--|---|--|---|---|---|---|--|
| | The grab bars in the men's restroom are reversed with the longer section in the back and the shorter section on the side. Women's toilet | ADAAG 604.5 | Remount the grab bar to provide a rear grab bar a minimum of 36" long mounted 12" from the centerline of the toilet to the corner and 24" from the centerline to the open side of the toilet. Also, provide a side grab bar a minimum of 42" long and a maximum of 12" from the corner. Both grab bars should be mounted at 33" to 36" to the top of the grab bar. | | Bob Byrne | \$200 | 2013 | Reversed grab bars to comply 1/16/2013 |

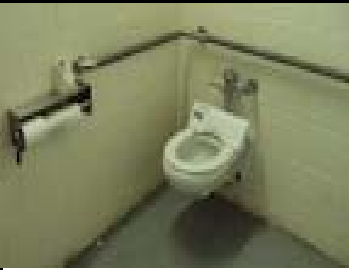
| Photo | Barrier | ADAAG/IAC | Solution | Priority | By Whom | Projected Cost | Projected Date | Action Taken |
|--|--|---|---|---|---|---|---|---|
| | The toilet paper holder in the men's restroom is mounted too far from the toilet at 17". | ADAAG 604.7 | Remount the toilet paper dispenser to be no lower than 15", no higher than 48" AFF and a minimum of 7" to a maximum of 9" in front of the toilet. Do not mount the toilet paper dispenser behind the side grab bar. | | Bob Byrne | \$100 | 2013 | Reversed grab bars to comply 1/16/2013 |

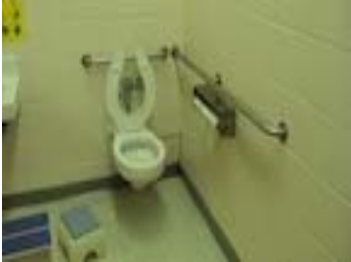
| Photo | Barrier | ADAAG/IAC | Solution | Priority | By Whom | Projected Cost | Projected Date | Action Taken |
|---|--|---|--|---|---|---|---|---|
| | <p>The toilet in the boy's restroom is 19 1/2" AFF and 18 1/2" to the centerline.</p> | <p>ADAAG 604.9</p> | <p>Depending on the age of the children the toilet should have a centerline of 12" and height of 11" to 12" for children ages 3 to 4, 12" to 15" and height of 12" to 15" for children ages 5 to 8 and a centerline of 15" to 18" and height of 15" to 17" for children ages 9 to 12.</p> | | | <p>\$750</p> | <p>2019</p> | |

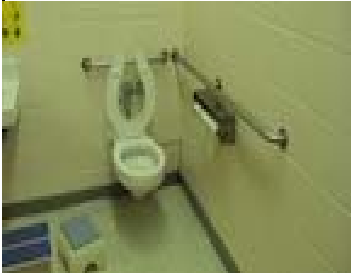
| Photo | Barrier | ADAAG/IAC | Solution | Priority | By Whom | Projected Cost | Projected Date | Action Taken |
|---|--|---|--|---|---|---|---|---|
| | <p>The rear grab bar in the boys restroom is a too short at 2' and is mounted 34 1/2" AFF.</p> | <p>ADAAG 604.5</p> | <p>The children's grab bar at the accessible toilet should be mounted at 18" AFF to 20" AFF for children ages 3 to 4, 20" AFF to 25" AFF for children ages 5 to 8 and 25" to 27" for children ages 9 to 12. The rear grab bar should be a minimum of 36" long and 4" to 6" from the corner and the side grab bar a minimum of 42" long and a maximum of 12" from the corner.</p> | | | <p>\$500</p> | <p>2019</p> | |

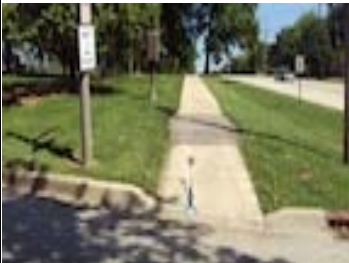
| Photo | Barrier | ADAAG/IAC | Solution | Priority | By Whom | Projected Cost | Projected Date | Action Taken |
|--|--|---|--|---|---|---|---|---|
| | The sidewalk to the corner has a running slope too steep at 5.6% to 20.7% for 64'. | ADAAG 403.3 | Remove and regrade section to provide an accessible route with a running slope no greater than 5% and an cross slope no greater than 2%. Because of the terrain in this area, the slope may need to be lessened to the greatest extent possible. | | | \$6,000 | 2020 | Coordinate with City sidewalk replacement program |

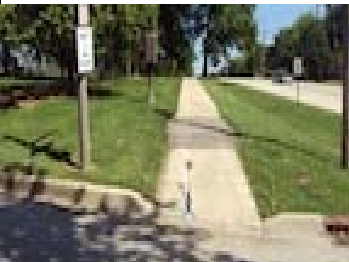
| Photo | Barrier | ADAAG/IAC | Solution | Priority | By Whom | Projected Cost | Projected Date | Action Taken |
|--|--|---|--|---|---|---|---|---|
| | There are no truncated domes at the corner curb ramp. | ADAAG 705 | Provide truncated domes that go the width of the sidewalk and 24" deep where it meets the road. Provide a color that contrast with the walkway surface. Truncated dome tiles are typically a more durable solution. | | | \$500 | 2020 | Coordinate with City sidewalk replacement program |
