Conrad Fisher Park

Conrad Fisher Park is a large neighborhood park that provides ballfields, tennis, playgrounds, picnic areas and walkways. The main issues at this park are accessible routes to at least one ballfield, abrupt transitions, slopes too high, and accessible features at the playground. **Please Note:** When a **UD** is indicated, this is a Universal Design (**UD**) recommendation to enhance accessibility. The **UD** recommendation is not required to meet the minimum accessibility standards but it would be encouraged.

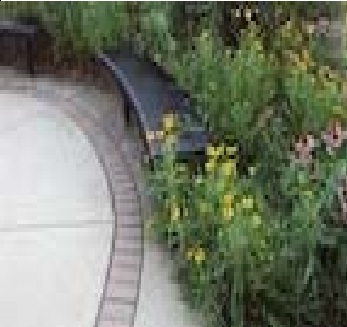
| Photo | Barrier | ADAAG/IAC | Solution | Priority | By Whom | Projected Cost | Projected Date | Action Taken |
|--|---|--|---|---|---|---|---|---|
| | <p>The plants at the bench protrude into the clear floor space of the companion seating area next to the bench.</p> | <p><u>Proposed</u> Outdoor Areas Standards ADAAG 1011</p> | <p>Bench Recommendation: Provide a clear ground space of at least 30" by 48" positioned near the bench with one side adjoining the walkway. Trim the plants on one of the sides of the bench. The clear ground space should not overlap the accessible route or another clear ground space. UD - Provide benches with armrests and no gaps between the seat and backrest.</p> | | | \$100 | 2018 | Staff trimmed plants 6/2018 |

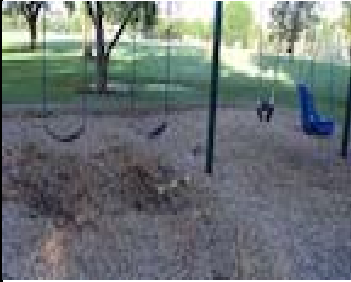
| Photo | Barrier | ADAAG/IAC | Solution | Priority | By Whom | Projected Cost | Projected Date | Action Taken |
|--|--|---|---|---|---|---|---|--|
| | The adult/older child swings have a slope too steep at 20.9% to 21.3%. | ADAAG 1008.4.4 | Provide a regular maintenance to the play surface to provide a seat less than 24" off the ground and a slope under the swings no greater than 2%. Consider a mat under the swing to prevent kick-out of surface material. An accessible swing with a seat would be recommended at some point. | | Hacienda | \$100 | 2018 Capital | Playground replaced as part of 2018 Conrad Fisher redevelopment 6/2018 \$404,000 |

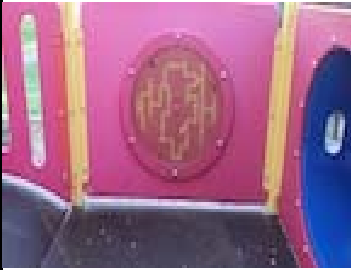
| Photo | Barrier | ADAAG/IAC | Solution | Priority | By Whom | Projected Cost | Projected Date | Action Taken |
|--|--|---|---|---|---|---|---|--|
| | The marble panel only provided finger holes to operate the panel. | ADAAG 309 | Provide controls that require 5 lbs. or less of pressure to operate, do not require tight grasping, pinching or twisting of the wrist provide a clear floor space and with a side or forward reach range no higher than 48" AFF. | | Hacienda | \$100 | 2018 Capital | Playground replaced as part of 2018 Conrad Fisher redevelopment 6/2018 \$404,000 |

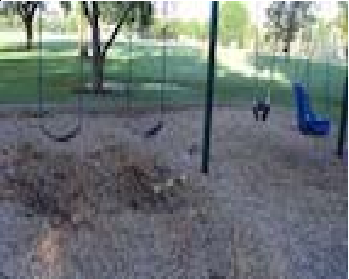
| Photo | Barrier | ADAAG/IAC | Solution | Priority | By Whom | Projected Cost | Projected Date | Action Taken |
|--|---|---|---|---|---|---|---|--|
| | The swings have slopes too steep at 11.4% to 21.3% and the older child/adult plus the accessible swings are too high at 25" to 27". | ADAAG 1008.4.4 | Provide a regular maintenance to the play surface to provide a seat less than 24" off the ground and a slope under the swings no greater than 2%. Consider a mat under the swing to prevent kick-out of surface material. An accessible swing with a seat would be recommended at some point. | | Hacienda | \$1,000 | 2018 Capital | Playground replaced as part of 2018 Conrad Fisher redevelopment 6/2018 \$404,000 |

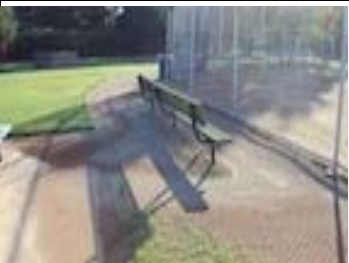
| Photo | Barrier | ADAAG/IAC | Solution | Priority | By Whom | Projected Cost | Projected Date | Action Taken |
|--|--|---|--|---|---|---|---|---|
| | The north players bench has loose fill for the accessible route and companion seating for 18'. Determine which field will be the accessible field at this park. Note: when improvements are made to a ball field then access to the field is required. | ADAAG 221.2.1.4 & 802.1 | Provide at least one wheelchair space on an accessible route that has a 36" by 48" clear floor space from the front or rear or provide a 36" by 60" clear floor space for a side approach. | | | \$250 | 2012 | Benches adjusted to meet requirements \$2,000 |

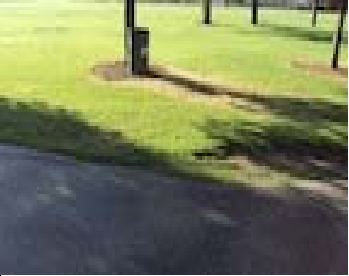
| Photo | Barrier | ADAAG/IAC | Solution | Priority | By Whom | Projected Cost | Projected Date | Action Taken |
|--|---|--|---|---|---|---|---|--|
| | There is a trash can located in the grass for 18'. | <u>Proposed</u> Outdoor Developed Areas Guidelines 1011 | Trash Can Recommendation: Locate trash cans on an accessible route as part of your regular policy. For a forward approach provide a trash can within 24" and a minimum clear ground space of 36" by 48" or for a side approach provide a trash can within 24" and a minimum clear ground space of 30" by 60". | | | \$50 | 2018 | Can moved to accessible location 6/2018 |

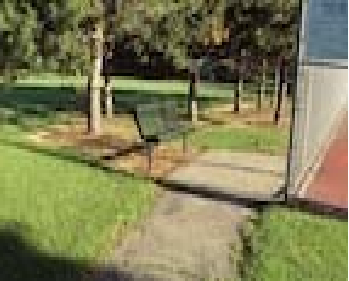
| Photo | Barrier | ADAAG/IAC | Solution | Priority | By Whom | Projected Cost | Projected Date | Action Taken |
|--|---|--|---|---|---|---|---|---|
| | The bench at the tennis courts does not provide companion seating. | <u>Proposed</u> Outdoor Areas Standards ADAAG 1011 | Bench Recommendation: Provide at least 20% but no less than two benches to provide a clear ground space of at least 30" by 48" positioned near the bench with one side adjoining the walkway and a slope no steeper than 2% in all directions. The clear ground space should not overlap the accessible route or another clear ground space. UD - Provide benches with armrests and no gaps between the seat and backrest. | | | \$250 | 2018 | Companion seat added as part of CF redevelopment 6/2018 |

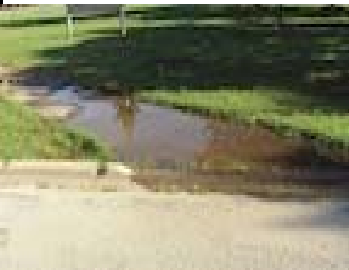
| Photo | Barrier | ADAAG/IAC | Solution | Priority | By Whom | Projected Cost | Projected Date | Action Taken |
|---|--|---|---|---|---|---|---|---|
| | The curb ramp at the south park sign does not have truncated domes. | ADAAG 705 | Provide truncated domes that go the width of the sidewalk and 24" deep where it meets the road. Provide a color that contrast with the walkway surface. Truncated dome tiles are typically a more durable solution. | | | \$500 | 2020 | |

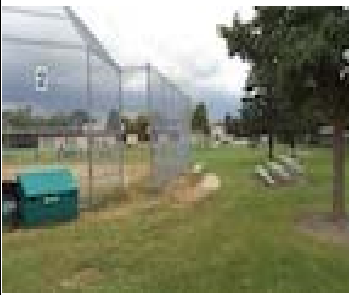
| Photo | Barrier | ADAAG/IAC | Solution | Priority | By Whom | Projected Cost | Projected Date | Action Taken |
|--|---|---|--|---|---|---|---|---|
| | Field #2 does not provide an accessible route for 240'. | ADAAG 403.3 | Relocate ball games and practices to accessible fields as required. If an accessible route is decided for this field, then provide a new accessible route with a running slope no steeper than 5% and a cross slope no steeper than 2% and a minimum clear width of 36". | NA | | NA | Complete | Reasonable accommodation made as needed |
