Courts Plus

Courts Plus is the main fitness building for the park district. The main issues at this park are accessible parking being too sloped, slopes too steep, door opening forces too high, item out of reach ranges, no high low drinking fountains and exercise machines not having proper spacing next to them. **Please Note:** When a **UD** is indicated, this is a Universal Design (**UD**) recommendation to enhance accessibility. The **UD** recommendation is not required to meet the minimum accessibility standards but it would be encouraged.

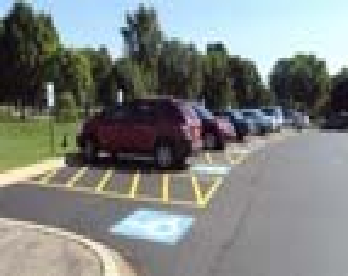
<p>The 6 accessible parking spaces across from the entrance have 5 accessible parking spaces with cross slopes too steep at 2.9% to 6.2% for the two accessible spaces furthest to the west, and running slopes too steep at 2.7% to 3.4% for the third space from the west and the two furthest east accessible parking spaces. This parking lot has 125 spaces and requires 5 accessible parking spaces.</p>	<p>ADAAG 502.4</p>	<p>The fourth accessible parking space from the west is acceptable. This parking space would require for more accessible parking spaces with slopes not steeper than 2% in all directions. Consider a mix of parking across from the entrance and selecting some to the west of the entrance. Provide spaces that are on the shortest accessible route. The previous accessible parking spaces should paint over the International Symbol of Accessible and the access aisle striping.</p>	<p>1</p>		<p>\$ 1,900.00</p>	<p>2020</p>

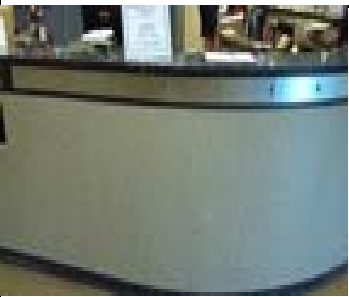
The front counter is too high at 44" AFF.	IAC 400.320(h)(1)(A)	Provide a section of counter that is no higher than 34" and is at least 36" long. In alterations where it is technically infeasible to provide an accessible counter, an auxiliary counter meeting those requirements maybe provided.	2		\$ 600.00	\$2,012	Registration desk is accessible and near the service desk

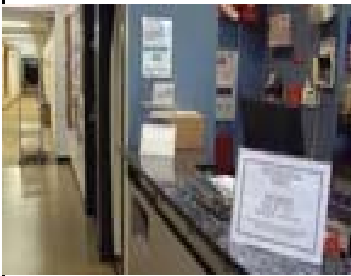
The nomination box is mounted to high at 58".	ADAAG 308	Remount the nomination box to provide a reach range no higher than 48" AFF for a forward reach over an obstruction no deeper than 20" or a side reach of 48" AFF over an object no deeper than 10".	2		\$ 100.00	\$2,012	Removed nomination box from wall and placed on counter

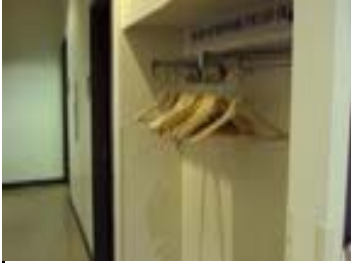
Coat hangers are provided but are mounted too high at 54".	ADAAG 222.1 & ADAAG 308	Provide 5% of the cloths hangers at a reach range no higher than 48" AFF for a forward reach over an obstruction no deeper than 20" or a side reach of 48" AFF over an object no deeper than 10". Consider adding additional cloths hooks at the lower height.	4		\$ 200.00	2012	remounted one rack to proper height

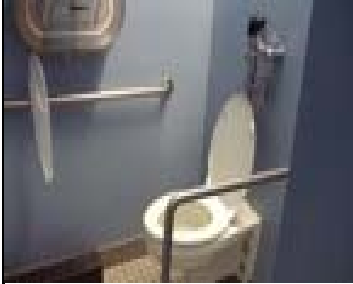
The men's room toilet does not provide a rear grab bar and the side grab bar interferes with a transfer onto the toilet.	ADAAG 604.5.2 & ADAAG 609	Remove the side grab bar nears the open space of the room and provide a rear grab bar a minimum of 36" long mounted 12" from the centerline of the toilet to the corner and 24" from the centerline to the open side of the toilet. The grab bar should be mounted at a centerline of 33" to 36" AFF.	3		\$ 150.00	2012	Re-installed grab bars in correct locations \$175

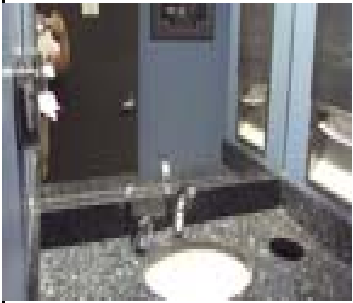
The men's tissue dispenser is mounted too high at 52".	ADAAG 308	Remount the tissue dispenser to provide a reach range no higher than 48" AFF for a forward reach over an obstruction no deeper than 20" or a side reach of 48" AFF over an object no deeper than 10".	2		\$ 25.00	2012	Re-installed at correct height \$25

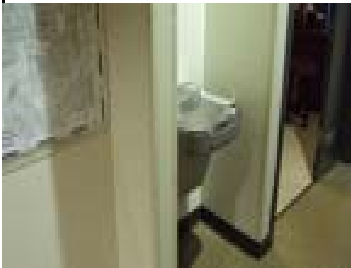
The drinking fountain between the two restrooms has a 28" knee and 35" spout	ADAAG 211 & ADAAG 602	This drinking fountain provides the proper height for a wheelchair accessible drinking fountain but it does not provide the heights for a standing or high drinking fountain. Provide a standing individual drinking fountain or a single hi-lo drinking fountain that provides a wheelchair accessible fountain with a spout at 36" maximum and a standing drinking fountain with a height between 38" minimum and 43" maximum. The toe clearance should be a minimum of 9".	4		\$ 2,125.00	2021

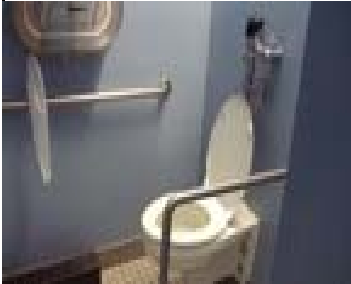
The women's room toilet does not provide rear grab bars.	ADAAG 604.5.2 & ADAAG 609	Remove the side grab bar nears the open space of the room and provide a rear grab bar a minimum of 36" long mounted 12" from the centerline of the toilet to the corner and 24" from the centerline to the open side of the toilet. The grab bar should be mounted at a centerline of 33" to 36" AFF.	3		\$ 150.00	2012	Replaced and installed at required dimensions \$175

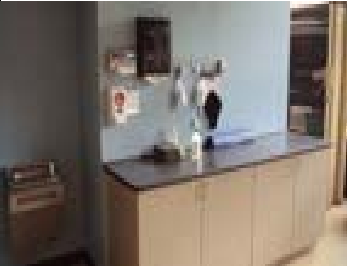
Two dispensers are mounted too high: tissues at 62" and paper towels at 58".	ADAAG 308	Remount the tissue and paper towel dispensers to provide a reach range no higher than 48" AFF for a forward reach over an obstruction no deeper than 20" or a side reach of 48" AFF over an object no deeper than 10".	2		\$ 100.00	2012	relocated at proper height

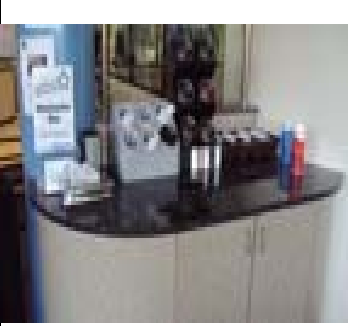
Condiment dispenser is mounted too high at 55" AFF.	ADAAG 308	Remount the condiments to provide a reach range no higher than 48" AFF for a forward reach over an obstruction no deeper than 20" or a side reach of 48" AFF over an object no deeper than 10".	4		\$ 250.00	2012	Removed from counter

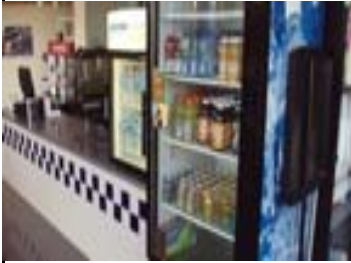
The drinks in the refrigerator are mounted too high at 56" AFF.	ADAAG 308	Redistribute the drinks at different levels that are within the proper reach ranges. Or provide a refrigerator with a reach range no higher than 48" AFF for a forward reach over an obstruction no deeper than 20" or a side reach of 48" AFF over an object no deeper than 10".	4		NA	2012	Removed from facility

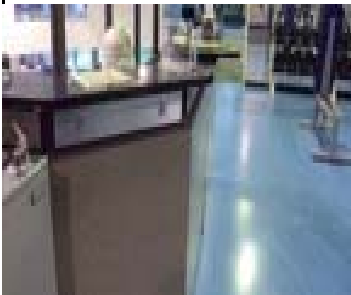
The counter at the weights is too high at 44" AFF.	IAC 400.320(h)(1)(A)	Provide a section of counter that is no higher than 34" and is at least 36" long. In alterations where it is technically infeasible to provide an accessible counter, an auxiliary counter meeting those requirements maybe provided.	2		\$ 600.00	2020

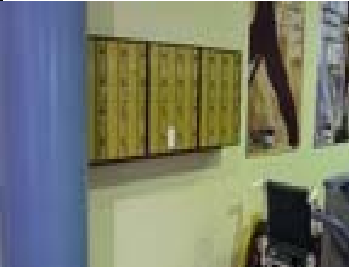
Key box near the stairs is mounted too high at 50" AFF to the lower lockers.	ADAAG 308	Remount the key box to provide a reach range no higher than 48" AFF for a forward reach over an obstruction no deeper than 20" or a side reach of 48" AFF over an object no deeper than 10" for the lower part of the boxes.	4		\$ 150.00	2020

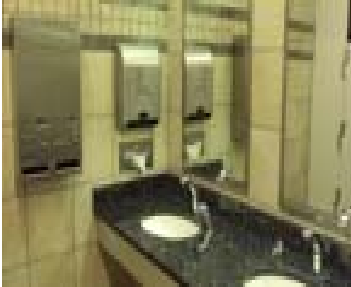
The mirror in the women's locker-room is mounted too high at 41" AFF.	ADAAG 603.3	Lower the mirror above the sink or countertop to be no higher than 40" to the reflective surface. Mirrors not mounted above the sink or a counter top should be mounted no higher than 35" to the reflective surface. UD - A full-length mirror would be a recommended option.	4		\$ 450.00	2021

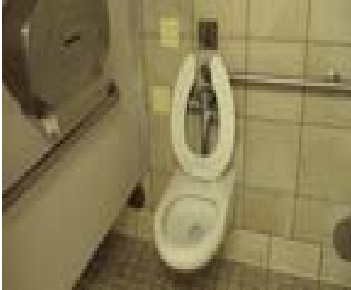
The women's restroom toilet rear grab bar does not go into the corner.	ADAAG 604.5.2 & ADAAG 609	Remount the rear grab bar to be a minimum of 36" long mounted 12" from the centerline of the toilet to the corner and 24" from the centerline to the open side of the toilet. The grab bar should be mounted at a centerline of 33" to 36" AFF.	3		\$ 150.00	2019

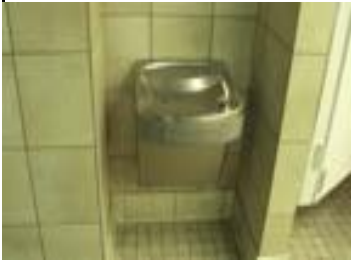
The women's locker-room drinking fountain is only a wheelchair design and height.	ADAAG 211 & ADAAG 602	Provide two individual drinking fountain or a single hi-lo drinking fountain that provides a wheelchair accessible fountain with a spout at 36" maximum and a standing drinking fountain with a height between 38" minimum and 43" maximum. The toe clearance should be a minimum of 9".	4		\$ 2,125.00	2020

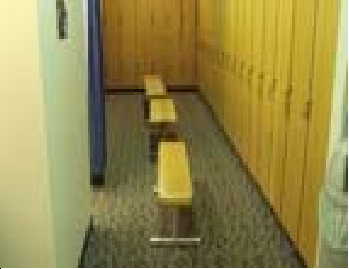
No permanent benches are provided in the women's locker-room.	ADAAG 222 & 903	Provide a bench that is a minimum 42" long, and a minimum of 20" to a maximum of 24" deep. The bench should be affixed to a wall or have a back support that extends at least 42" the length of the bench at a point a maximum of 2" above the seat. The accessible bench should be adjacent to the accessible lockers and have a seat between 17" to 19" AFF. Locate this near an accessible locker.	2		\$ 700.00	2019

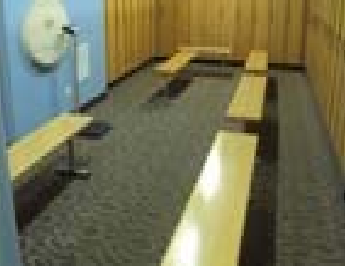
No permanent benches are provided in the men's locker-room.	ADAAG 222 & 903	Provide a bench that is a minimum 42" long, and a minimum of 20" to a maximum of 24" deep. The bench should be affixed to a wall or have a back support that extends at least 42" the length of the bench at a point a maximum of 2" above the seat. The accessible bench should be adjacent to the accessible lockers and have a seat between 17" to 19" AFF. Locate this near an accessible locker.	2		\$ 700.00	2021

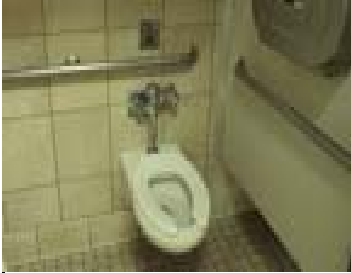
The grab bars in the men's accessible stall in the locker-room are mounted too high at 37 1/2" to the top surface.	ADAAG 604.5	Using the same grab bars, provide a rear grab bar a minimum of 36" long mounted 12" from the centerline of the toilet to the corner and 24" from the centerline to the open side of the toilet. Also, provide a side grab bar a minimum of 42" long and a maximum of 12" from the corner. Both grab bars should be mounted at 33" to 36" to the top of the grab bar.	3		\$ 150.00	2019

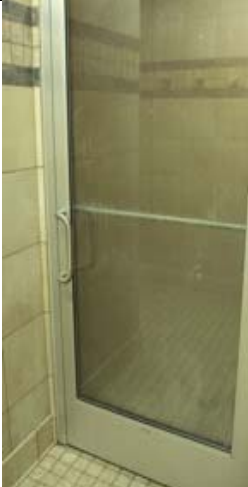
The door to the men's locker-room steam room has a opening force too high at 12 lbs. and closes too quickly at 2 seconds.	ADAAG 404.2.8 & ADAAG 404.2.9	Adjust the closer so the door opening force is no heavier than 5 lbs. to open and takes a minimum of 5 seconds to close or provide an automatic door opener at one of the doors.	2		\$ 100.00	2019

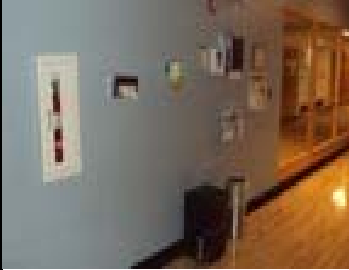
Several dispensers are mounted too high including: tissues at 54 1/2, paper towel at 58", hand sanitizer at 58" and ear plugs at 54".	ADAAG 308	Remount these items to provide a reach range no higher than 48" AFF for a forward reach over an obstruction no deeper than 20" or a side reach of 48" AFF over an object no deeper than 10".	2		\$ 100.00	2012	remounted at proper height

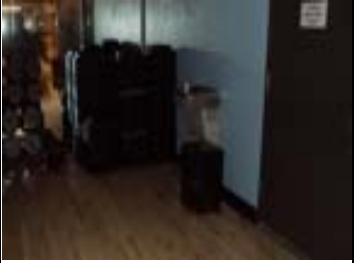
A drinking fountain that is of a wheelchair design is the only one provided.	ADAAG 211 & ADAAG 602	Provide another individual drinking fountain or a single hi-lo drinking fountain that provides a wheelchair accessible fountain with a spout at 36" maximum and a standing drinking fountain with a height between 38" minimum and 43" maximum. The toe clearance should be a minimum of 9".	4		\$ 2,125.00	2022

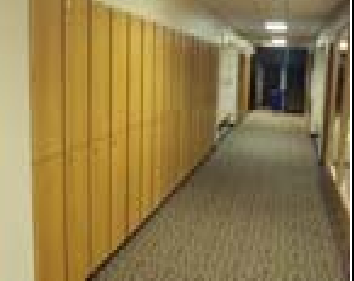
Twenty two small lockers are provided in the hall but none provided the proper accessible heights.	ADAAG 225.1 & 811	Provide at least 5%, or in this case at least three of the lockers with a clear floor space, with the coat hook and shelf no higher than 48" for a side approach or front approach. The base should be no lower than 15" and provide accessible door hardware. A 30" by 48" clear floor space should be provided at the accessible lockers with accessible locker door hardware. Provide these at or near the accessible bench.	2		\$ 250.00	2022

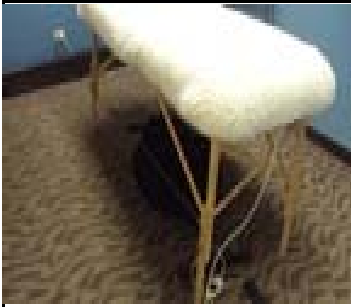
The message therapy room table is too high at 33".	ADAAG 604.4	For at least one of the message therapy rooms, consider an adjustable table that can adjust down to 18" to allow for a transfer from a wheelchair. Use the toilet seat height requirement for guidance.	2		\$ 750.00	2022

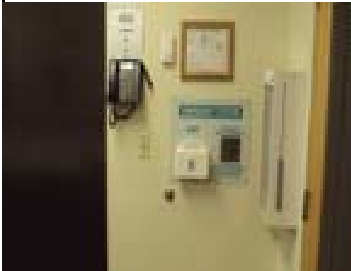
The phone in the conference room is mounted too high at 57 1/2".	ADAAG 308	Remount the phone to provide a reach range no higher than 48" AFF for a forward reach over an obstruction no deeper than 20" or a side reach of 48" AFF over an object no deeper than 10".	2		\$ 150.00	2019

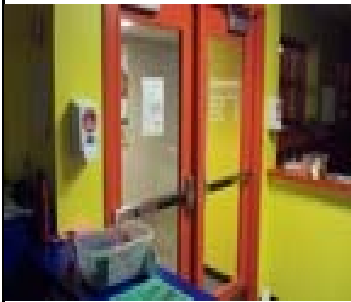
The two hand sanitizer dispenser are mounted too high at 53" AFF.	ADAAG 308	Remount the hand sanitizers to provide a reach range no higher than 48" AFF for a forward reach over an obstruction no deeper than 20" or a side reach of 48" AFF over an object no deeper than 10".	2		\$ 100.00	2012	Removed \$10

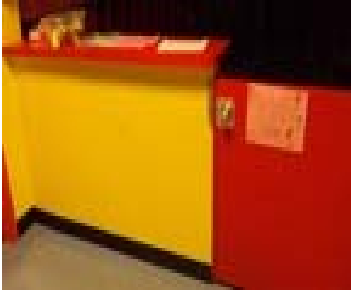
Red counter is mounted too high at 41 1/4" AFF.	IAC 400.320(h)(1)(A)	Provide a section of counter that is no higher than 34" and is at least 36" long. In alterations where it is technically infeasible to provide an accessible counter, an auxiliary counter meeting those requirements maybe provided.	2		\$ 600.00	2012	Removed \$250

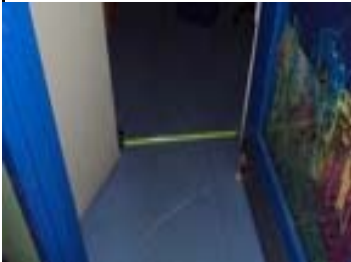
The doorway into the supervisors office is too narrow at 24" because of a file cabinet.	ADAAG 403.5.1	If meetings with parents or staff are in this office, then relocate the file cabinet to provide a clear accessible route that is 36" wide but can narrow down to 32" but for no more that 24". Or provide another location that provides an accessible route into the space.	2		\$ 50.00	2012	Removed \$20

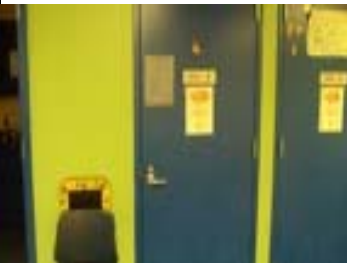
The sign for the boy's restroom is mounted on the door and does not provide Braille or raised characters.	ADAAG 216.2	The permanent room sign should to be mounted on the wall at the latch side of the door at 48" minimum from the baseline of the lowest tactile character to 60" maximum from the baseline of the highest character with raised lettering and numbers plus Braille.	4		\$ 150.00	2012	No longer in use

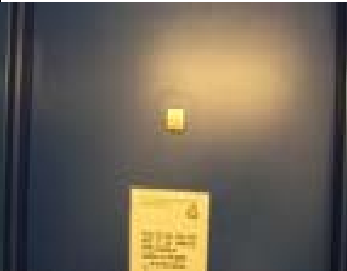
The coat hook in the boy's restroom is mounted too high at 67 1/4".	ADAAG 308.1	Depending on the age of the student, provide the remount the coat hook or provide a second hook at a height between 20" to 36" for ages 3 to 4, 18" to 40" for ages 5 to 8 and 16" to 44" for ages 9 to 12.	2		\$ 50.00	2012	No longer in use

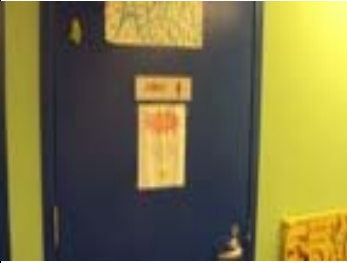
The sign for the girl's restroom is mounted on the door and does not provide Braille or raised characters.	ADAAG 216.2	The permanent room sign should to be mounted on the wall at the latch side of the door at 48" minimum from the baseline of the lowest tactile character to 60" maximum from the baseline of the highest character with raised lettering and numbers plus Braille.	4		\$ 150.00	2012	No longer in use

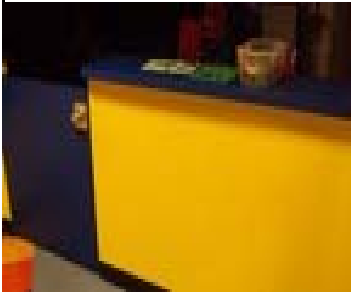
Blue counter is mounted too high at 41 1/2" AFF.	IAC 400.320(h)(1)(A)	Provide a section of counter that is no higher than 34" and is at least 36" long. In alterations where it is technically infeasible to provide an accessible counter, an auxiliary counter meeting those requirements maybe provided.	2		\$ 600.00	2012	No longer in use

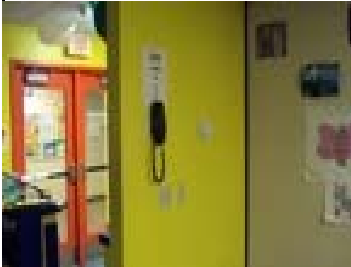
The phone is mounted too high at 59".	ADAAG 308	If used by the public, remount the phone to provide a reach range no higher than 48" AFF for a forward reach over an obstruction no deeper than 20" or a side reach of 48" AFF over an object no deeper than 10".	2		\$ 150.00	2012	No longer in use

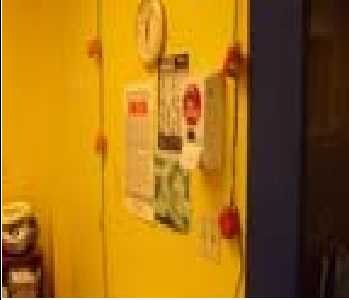
The hand sanitizer dispenser is mounted too high at 55 1/4".	ADAAG 308	Remount the hand sanitizer to provide a reach range no higher than 48" AFF for a forward reach over an obstruction no deeper than 20" or a side reach of 48" AFF over an object no deeper than 10".	2		\$ 100.00	2012	No longer in use

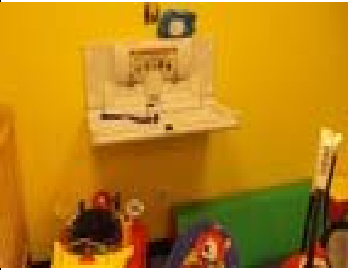
The diaper changing table is mounted too high at 36" and has stuff underneath it.	IAC 400.320(w)	Remount the baby changing table to be no higher than 34" AFF and provide a minimum knee clearance of 27". Also mount it so the handle is no higher than 48" AFF. Relocate the items underneath to provide a clear floor space.	3		\$ 250.00	2012	No longer in use

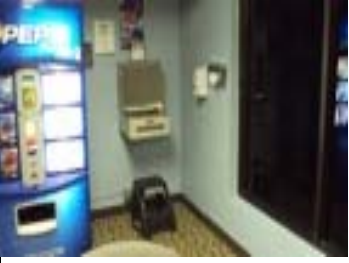
The drinking fountain is mount at 41 1/2" to the spout and 32 1/2" knee.	ADAAG 211 & ADAAG 602	Provide one individual drinking fountain at a wheelchair height or a single hi-lo drinking fountain that provides a wheelchair accessible fountain with a spout at 36" maximum and a standing drinking fountain with a height between 38" minimum and 43" maximum. The toe clearance should be a minimum of 9".	4		\$ 2,125.00	2012	Mounted to proper height

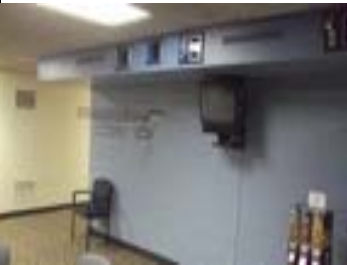
The coat hangers are mounted too high at 56" AFF.	ADAAG 222.1 & ADAAG 308	Provide 5% of the coat hangers at a reach range no higher than 48" AFF for a forward reach over an obstruction no deeper than 20" or a side reach of 48" AFF over an object no deeper than 10". Consider adding additional cloths hooks at the lower height.	4		\$ 200.00	2019

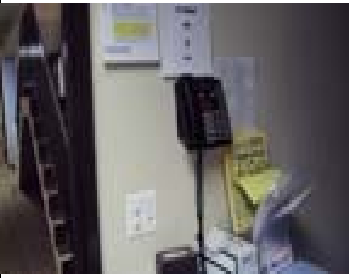
The phone is mounted too high at 56".	ADAAG 308	Remount the phone to provide a reach range no higher than 48" AFF for a forward reach over an obstruction no deeper than 20" or a side reach of 48" AFF over an object no deeper than 10".	2		\$ 150.00	2019

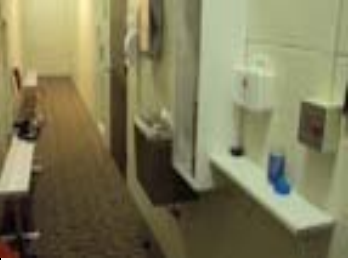
The drinking fountain at the courts is mounted at 40 1/2" to the spout.	ADAAG 211 & ADAAG 602	Provide one more individual drinking fountain at a wheelchair height or a single hi-lo drinking fountain that provides a wheelchair accessible fountain with a spout at 36" maximum and a standing drinking fountain with a height between 38" minimum and 43" maximum. The toe clearance should be a minimum of 9".	4		\$ 2,125.00	2024

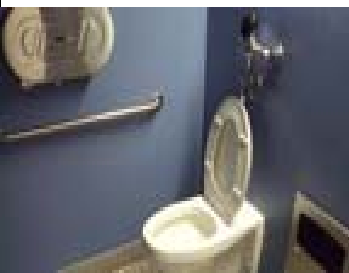
The toilet in the second single users restroom does not provide rear grab bars.	ADAAG 604.5.2 & ADAAG 609	Provide a rear grab bar a minimum of 36" long mounted 12" from the centerline of the toilet to the corner and 24" from the centerline to the open side of the toilet. The grab bar should be mounted at a centerline of 33" to 36" AFF.	3		\$ 150.00	2012	Installed correct grab bar
