Crescent Park

Crescent Park is small neighborhood park that provides mostly green space, a picnic table and a bench. The main issues at this park are there is only one picnic table of an accessible design, the bench is located in the grass and not on an accessible route, the dog bags are too far off the accessible route and the gutter slope for the walkway is too steep. **Please Note:** When a **UD** is indicated, this is a Universal Design (**UD**) recommendation to enhance accessibility. The **UD** recommendation is not required to meet the minimum accessibility standards but it would be encouraged.

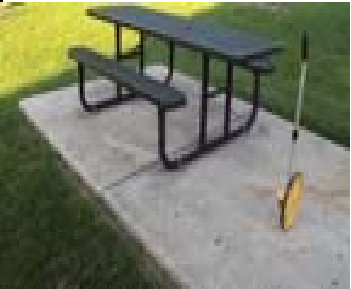
There is one picnic table.	Proposed Outdoor Developed Areas Guidelines ADAAG 245 & 1011	Picnic Table Recommendation: At least 20% of picnic tables, but no less than two, be of accessible design, connected to an accessible route. Relocate or purchase two accessible picnic tables and locate them on an accessible surface.			\$1,650	TBD

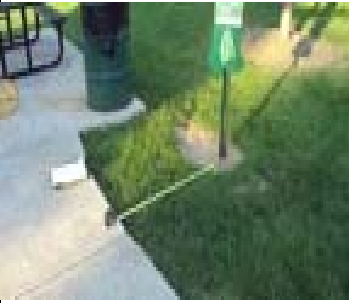
The stand for the dog disposal bags is off the accessible route for 48".	ADAAG 308	Relocate the stand closer to the walkway to provide a reach range no higher than 48" AFF for a forward reach over an obstruction no deeper than 20" or a side reach of 48" AFF over an object no deeper than 10".			\$100	2015	Moved dog waste dispenser

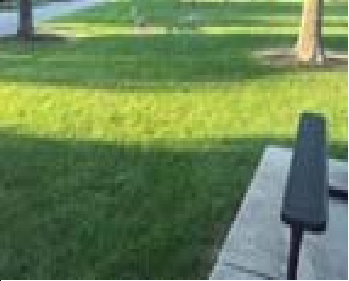
There is a bench provided but there is no companion seating and no accessible route to the bench for 48'.	<u>Proposed</u> Outdoor Areas Standards ADAAG 1011	Bench Recommendation: Provide at least 20% but no less than two benches to provide a clear ground space of at least 30" by 48" positioned near the bench with one side adjoining the walkway and a slope no steeper than 2% in all directions. The clear ground space should not overlap the accessible route or another clear ground space. UD - Provide benches with armrests and no gaps between the seat and backrest.			\$2,300	TBD
