Crestview Park

Crestview Park is a large neighborhood park that provides a preschool building, parking lot, playground, sledding hill, tennis court, basketball court and ballfields. The main issues at this park are not having proper accessible parking spaces, slopes too steep, protruding branches, trash cans too far off the accessible route, gates have too narrow of clear openings, and low accessible routes that fill with water and mud. The rock program in the basement of the Recreation Building is not accessible and would require a major expense such as a lift of elevator to make it accessible. Consider relocating the program to an accessible site. **Please Note:** When a **UD** is indicated, this is a Universal Design (**UD**) recommendation to enhance accessibility. The **UD** recommendation is not required to meet the minimum accessibility standards but it would be encouraged. When engineered wood fiber is provided at playgrounds provide a regular maintenance of the surface to maintain an accessible surface.

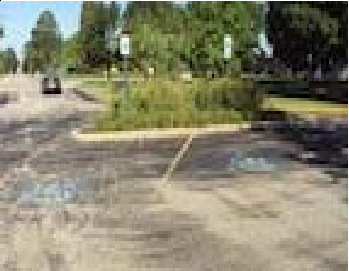
The south parking space does not provide a fine sign at the accessible parking space sign.	IAC 400.310(c)(7)	Provide a fine sign with a minimum \$250 fine.			\$150	2012	Resurfaced and restriped lot 5/2012 \$20,000

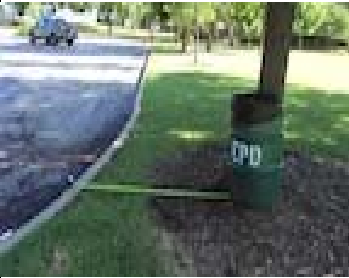
The trash can is not on an accessible route for 6'.	<u>Proposed</u> Outdoor Developed Areas Guidelines 1011	Trash Can Recommendation: Locate trash cans on an accessible route as part of your regular policy. For a forward approach provide a trash can within 24" and a minimum clear ground space of 36" by 48" or for a side approach provide a trash can within 24" and a minimum clear ground space of 30" by 60".			\$50	2012	Moved can 2012

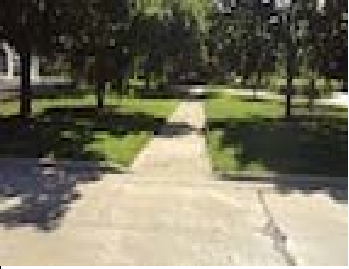
The curb ramp at the walkway from west street does not provide truncated domes	ADAAG 705	Provide truncated domes that go the width of the sidewalk and 24" deep where it meets the road. Provide a color that contrast with the walkway surface. Truncated dome tiles are typically a more durable solution.			\$500	2012	Added Curb ramp 5/2012

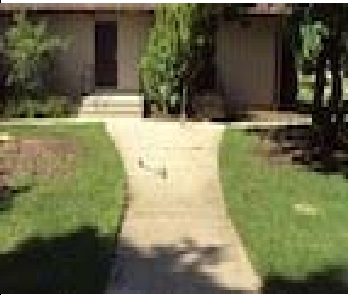
The north entrance walkway has a running slope too steep at 5.6% to 15.6% for 14'.	ADAAG 403.3	Remove and regrade section to provide a running slope no greater than 5% and a cross slope no greater than 2%. Because of the slope in this area regrading to 5% may not be possible. Follow ADAAG 405 for ramps if necessary.			\$1,875	2021

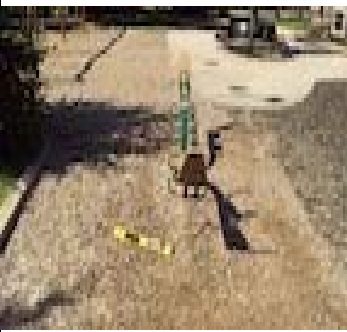
The four person spring rider has a slope up to the seats at 15.2%.	ADAAG 1008.4.4	Provide a regular maintenance to the play surface to provide a seat less than 24" off the ground and a slope under the swings no greater than 2%. Consider a mat under the spring rider to prevent kick-out of surface material.			\$100	2024	Playground and surfacing scheduled to be replaced in 2024 Capital Plan \$400,000

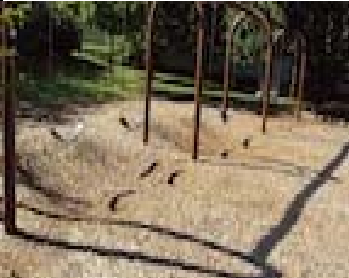
<p>The adult/older child swings have a slope too steep at 24.3% to 29.7%. Also two seats are at 25 1/2" AFF and 26" AFF.</p>	<p>ADAAG 1008.4.4</p>	<p>Provide a regular maintenance to the play surface to provide a seat less than 24" off the ground and a slope under the swings no greater than 2%. Consider a mat under the swing to prevent kick-out of surface material. An accessible swing with a seat would be recommended at some point.</p>			<p>\$100</p>	<p>2024</p>	<p>Playground and surfacing scheduled to be replaced in 2024 Capital Plan \$400,000</p>

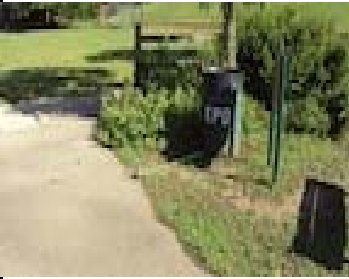
<p>The trash can is located in the grass for 40".</p>	<p><u>Proposed</u> Outdoor Developed Areas Guidelines 1011</p>	<p>Trash Can Recommendation: Locate trash cans on an accessible route as part of your regular policy. For a forward approach provide a trash can within 24" and a minimum clear ground space of 36" by 48" or for a side approach provide a trash can within 24" and a minimum clear ground space of 30" by 60".</p>			<p>\$50</p>	<p>2013</p>	<p>Trash can moved 4/2013</p>

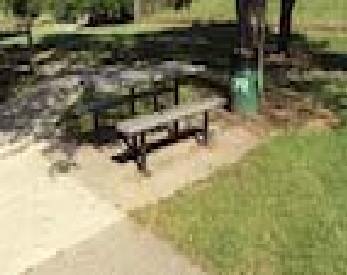
The trash can provided at the picnic table is not in an accessible location.	<u>Proposed</u> Outdoor Developed Areas Guidelines 1011	Trash Can Recommendation: Locate trash cans on an accessible route as part of your regular policy. For a forward approach provide a trash can within 24" and a minimum clear ground space of 36" by 48" or for a side approach provide a trash can within 24" and a minimum clear ground space of 30" by 60".			\$50	2013	Trash Can moved 4/2013

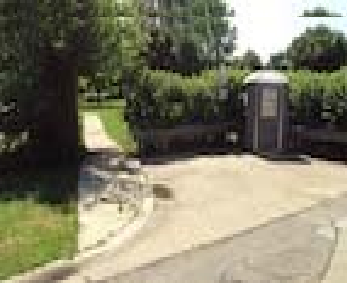
The curb ramp at the portable toilets has no truncated domes.	ADAAG 705	Provide truncated domes that go the width of the sidewalk and 24" deep where it meets the road. Provide a color that contrast with the walkway surface. Truncated dome tiles are typically a more durable solution.			\$500	2024

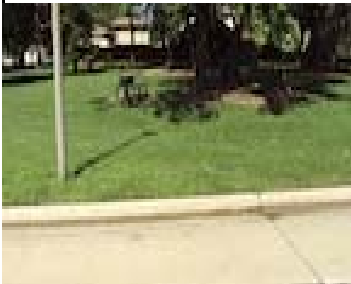
There is no accessible route to the picnic table for 41'.	<p><u>Proposed</u> Outdoor Developed Areas Guidelines ADAAG 245 & 1011</p>	<p>Picnic Table Recommendation: At least 20% of picnic tables, but no less than two, be of accessible design, connected to an accessible route. Relocate or purchase two accessible picnic tables (\$750/each) and locate them on an accessible surface (\$900).</p>			\$525	2024

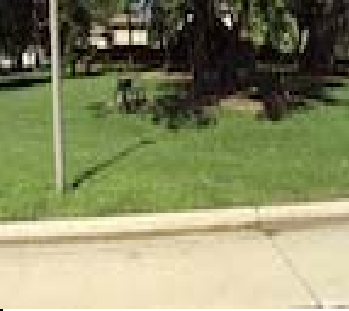
There is no accessible route to the grill for 16'.	<p style="text-align: center;"><u>Proposed</u> Outdoor Developed Areas Guidelines ADAAG 1011.5</p>	<p>Grill Recommendation: Follow Outdoor Developed Area Report that states 20% of grills, but at least two, be of accessible design, and connected to an accessible route. The accessible grill should provide a cooking surface a minimum of 15" to 34" maximum AFF above the ground surface, a clear floor space and controls that are within a maximum reach range of 48" AFF. And a 48" by 48" space centered on the usable sides of the grill is required.</p>			\$50	2024

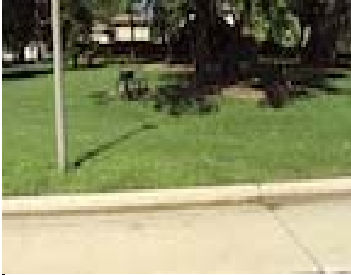
There is no accessible route to the trash can for 15'.	<u>Proposed</u> Outdoor Developed Areas Guidelines 1011	Trash Can Recommendation: Locate trash cans on an accessible route as part of your regular policy. For a forward approach provide a trash can within 24" and a minimum clear ground space of 36" by 48" or for a side approach provide a trash can within 24" and a minimum clear ground space of 30" by 60".			\$50	2024

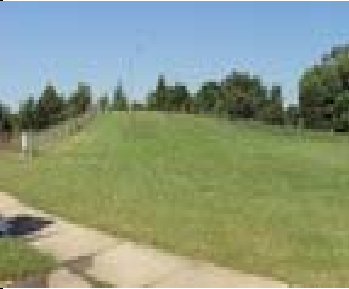
No accessible route is provided to the sledding hill.	ADAAG 403.3	Designate the sledding hill in Eldridge Park as the accessible sledding hill. If changes are made to this sledding hill, then provide a new accessible route with a running slope no steeper than 5% and a cross slope no steeper than 2% and a minimum clear width of 36".			NA	NA

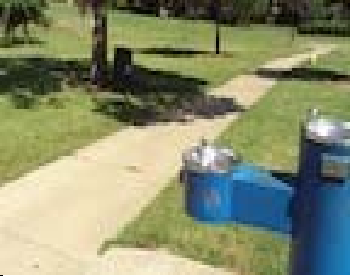
The trash can near the drinking fountain is off the accessible route for 8'.	<u>Proposed</u> Outdoor Developed Areas Guidelines 1011	Trash Can Recommendation: Locate trash cans on an accessible route as part of your regular policy. For a forward approach provide a trash can within 24" and a minimum clear ground space of 36" by 48" or for a side approach provide a trash can within 24" and a minimum clear ground space of 30" by 60".			\$50	2024

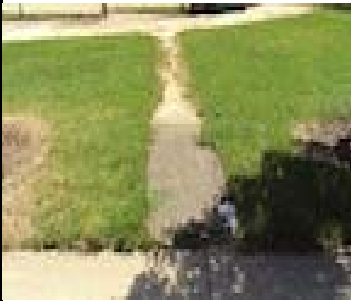
The walkway to ballfield #1 is not wide enough at 36" for 28'.	ADAAG 403.3	Provide a new accessible route with a running slope no steeper than 5% and a cross slope no steeper than 2% and a minimum clear width of 36". Until that time relocate to an accessible field as needed.			\$925	2024

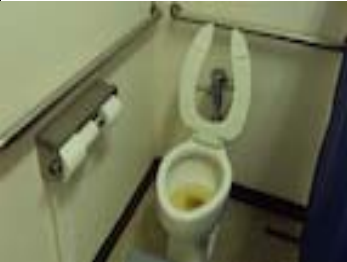
The toilet in the girls restroom has a centerline of 16 3/4" and is 19" AFF to the top of the toilet seat.	ADAAG 604.9	Depending on the age of the children the toilet should have a centerline of 12" and height of 11" to 12" for children ages 3 to 4, 12" to 15" and height of 12" to 15" for children ages 5 to 8 and a centerline of 15" to 18" and height of 15" to 17" for children ages 9 to 12.			\$750	2019

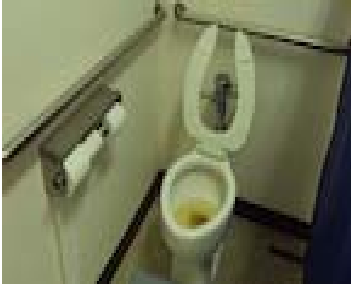
The grab bars in the girls toilet are mounted too high at 35 1/2".	ADAAG 604.5	Depending on the age of children, the children's grab bar at the accessible toilet should be mounted at 18" AFF to 20" AFF for children ages 3 to 4, 20" AFF to 25" AFF for children ages 5 to 8 and 25" to 27" for children ages 9 to 12. The rear grab bar should be a minimum of 36" long and 4" to 6" from the corner and the side grab bar a minimum of 42" long and a maximum of 12" from the corner.			\$150	2019

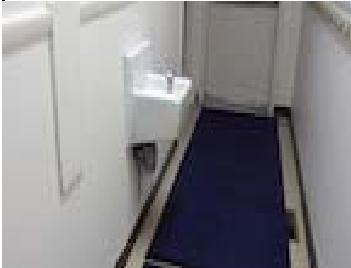
The drinking fountain has a spout height of 34 1/2" and a knee clearance of only 24" knee.	ADAAG 211 & ADAAG 602	Consideration could be made to leave this drinking fountain for the children and add the other two required drinking fountains. Provide two individual drinking fountain or a single hi-lo drinking fountain that provides a wheelchair accessible fountain with a spout at 36" maximum and a standing drinking fountain with a height between 38" minimum and 43" maximum. The toe clearance should be a minimum of 9".			\$2,125	2019

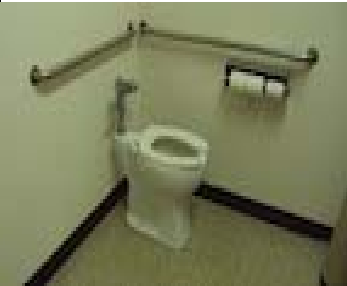
The grab bars in the boys toilet are mounted too high at 36".	ADAAG 604.5	Depending on the age of children, the children's grab bar at the accessible toilet should be mounted at 18" AFF to 20" AFF for children ages 3 to 4, 20" AFF to 25" AFF for children ages 5 to 8 and 25" to 27" for children ages 9 to 12. The rear grab bar should be a minimum of 36" long and 4" to 6" from the corner and the side grab bar a minimum of 42" long and a maximum of 12" from the corner.			\$150	2019

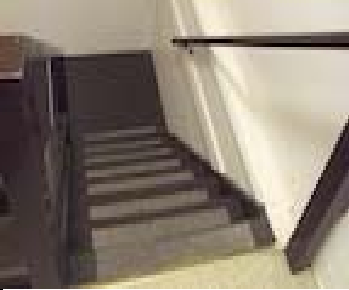
The stairs to the basement has a handrail on only one side for the top half of the steps.	ADAAG 504.6	Provide handrails on both sides of the stairs that are, continuous on the inside, between 34" to 38" to the top of the railing above the stair nosing, have handrails extensions, provide clear space of 1 1/2" and comply with ADAAG 505.			\$1,200	2019

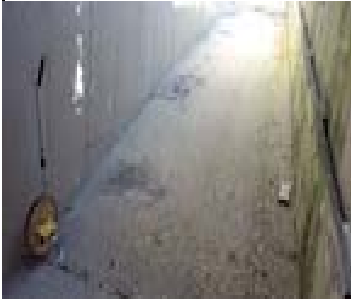
The ramp at the downstairs exit door has a running slope too steep at 9.8% to 15.2% for 36' and abrupt transitions between 3/4" to 1 1/2".	ADAAG 405.8	Provide handrails with extensions on both sides of the ramp for a total of 72'. Mount the handrails to 34" to 38" to the top of the gripping surface. The ramp may not be able to be adjusted to meet code because of its steepness and short length. Consider relocating this program to another accessible site.			\$5,400	TBD	Alternate location available for reasonable accommodation
