The Depot

The Depot is small historic train station building presently used for a preschool program. The main issues at this building are door opening force too high, items not within reach ranges, the drinking fountain not of a proper design and not providing protective pipe wrapping and the walkway around the building having gaps too wide and not a proper sloped entrance into the building. **Please Note:** When a **UD** is indicated, this is a Universal Design (**UD**) recommendation to enhance accessibility. The **UD** recommendation is not required to meet the minimum accessibility standards but it would be encouraged.

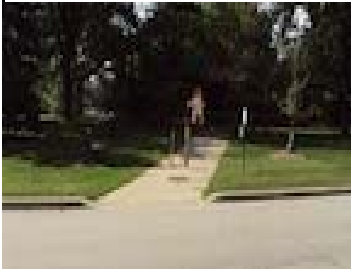
| Photo | Barrier | ADAAG/IAC | Solution | Priority | By Whom | Projected Cost | Projected Date | Action Taken |
|---|--|---|---|---|---|---|---|---|
| | The curb ramp to The Depot does not provide Truncated domes. | ADAAG 705 | Provide truncated domes that go the width of the sidewalk and 24" deep where it meets the road. Provide a color that contrast with the walkway surface. Truncated dome tiles are typically a more durable solution. | | | \$250 | 2017 | Added truncated domes as part of 2017 Capital project 5/2017 \$34,000 |

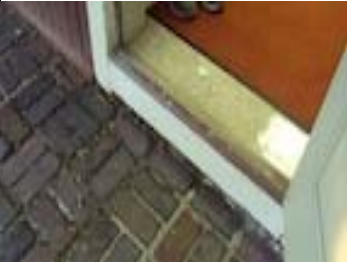
| Photo | Barrier | ADAAG/IAC | Solution | Priority | By Whom | Projected Cost | Projected Date | Action Taken |
|--|---|---|--|---|---|---|---|--|
| | The north door has a 8" step. | ADAAG 216.3 & ADAAG 703.5 | Provide a sign with a directional arrow that provides a contrast of color, at least 2" lettering and is mounted between 70" AFF to 120" AFF to the visual characters. Place this sign at the north door to direct people to the south accessible door. | | | \$100 | 2019 | |

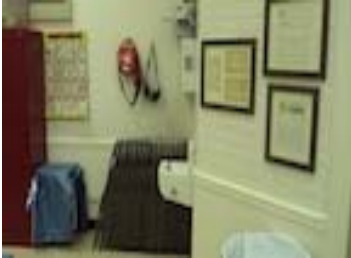
| Photo | Barrier | ADAAG/IAC | Solution | Priority | By Whom | Projected Cost | Projected Date | Action Taken |
|--|---|---|--|---|---|---|---|--|
| | The spout for the drinking fountain is at 33" and the knee space is too low at 26". | ADAAG 211 & ADAAG 602 | Provide two individual drinking fountain or a single hi-lo drinking fountain that provides a wheelchair accessible fountain with a spout at 36" maximum and a standing drinking fountain with a height between 38" minimum and 43" maximum. The toe clearance should be a minimum of 9". | | | \$4,250 | 2020 | |

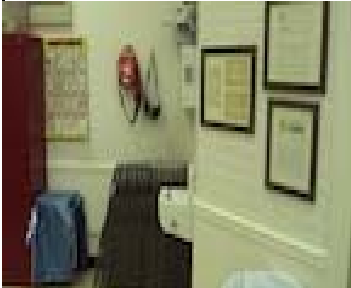
| Photo | Barrier | ADAAG/IAC | Solution | Priority | By Whom | Projected Cost | Projected Date | Action Taken |
|--|---|---|--|---|---|---|---|--|
| | The first aid kit is mounted too high at 67" AFF. | ADAAG 308 | Remount the first aid kit to provide a reach range no higher than 48" AFF for a forward reach over an obstruction no deeper than 20" or a side reach of 48" AFF over an object no deeper than 10". | | Bob Byrne | \$50 | 2012 | Relocated fanny pack to 47 3/4 AFF; relocated Zee box to 47 3/4 AFF 7/2012 |

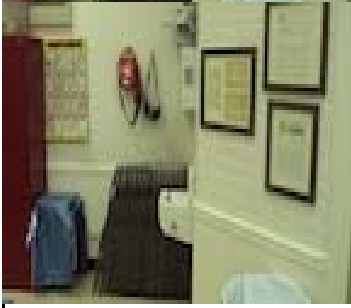
| Photo | Barrier | ADAAG/IAC | Solution | Priority | By Whom | Projected Cost | Projected Date | Action Taken |
|--|---|---|--|---|---|---|---|--|
| | The defibrillator is mounted too high at 68" AFF. | ADAAG 308 | Remount the defibrillator to provide a reach range no higher than 48" AFF for a forward reach over an obstruction no deeper than 20" or a side reach of 48" AFF over an object no deeper than 10". | | Bob Byrne | \$50 | 2012 | Relocated to 47 1/2 AFF 7/2012 |
