East End Park and Pool

East End Park and Pool is large neighborhood park that provides a pool, playground, three ballfields, soccer field and picnic area. The main issues at this park are not properly designed parking spaces, slopes too steep, elements within reach ranges, door opening forces too high, need for proper benches in locker-room and in the park, routes to bleachers, player benches and entrance to fields, and providing the proper number of accessible picnic tables. It would be recommended to make Ballfields #2 and #3 accessible just with their close location to parking. **Please Note:** When a **UD** is indicated, this is a Universal Design (**UD**) recommendation to enhance accessibility. The **UD** recommendation is not required to meet the minimum accessibility standards but it would be encouraged.

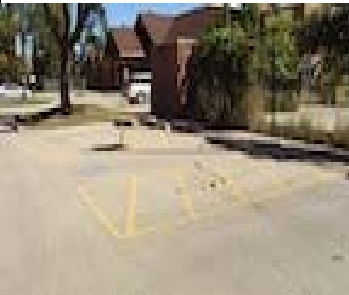
<p>The north accessible parking space has a running slope too steep at 3.3% to 4.4%.</p>	<p>IAC 400.310(c)</p>	<p>The parking lot has 63 total spaces which requires only 3 accessible parking spaces. With one directly in front of the entrance good and modifications to the previously mentioned accessible parking spaces, the north parking space could be converted into regular parking. Mark out the stripping and remove the signage.</p>			<p>\$900</p>	<p>2023 as part of District Paving Plan</p>

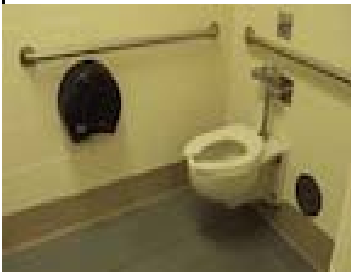
The toilet paper dispenser in the 1st Family changing room is mounted too far from the toilet seat at 16".	ADAAG 604.7	Remount the toilet paper dispenser to be no lower than 15", no higher than 48" AFF and a minimum of 7" to a maximum of 9" in front of the toilet. Do not mount the toilet paper dispenser behind the side grab bar.		Bob Byrne	\$50	2012	Remounted toilet paper dispenser to proper height 5/21/12

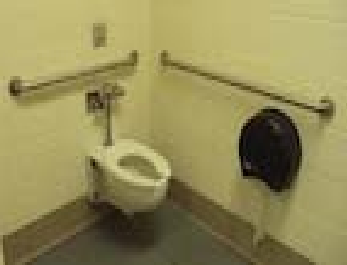
The toilet paper dispenser in the 2nd Family changing room is mounted too far from the toilet at 19".	ADAAG 604.7	Remount the toilet paper dispenser to be no lower than 15", no higher than 48" AFF and a minimum of 7" to a maximum of 9" in front of the toilet. Do not mount the toilet paper dispenser behind the side grab bar.		Bob Byrne	\$100	2012	Remounted dispensers 5/2012

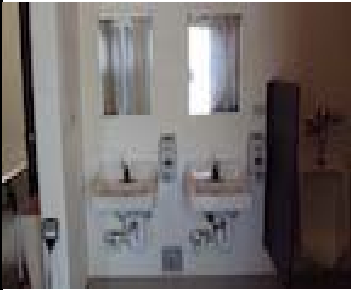
The mirrors in the men's locker-room are mounted too high at 48 3/4" to the reflective surface.	ADAAG 603.3	Lower the mirror above the sink or countertop to be no higher than 40" to the reflective surface. Mirrors not mounted above the sink or a counter top should be mounted no higher than 35" to the reflective surface. UD - A full-length mirror would be a recommended option.		Bob Byrne	\$100	2012	Lowered both mirrors to 40" 5/2012

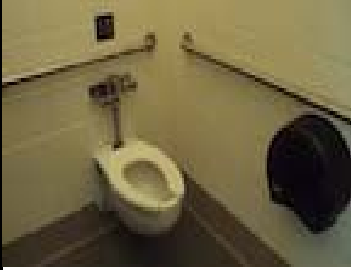
The toilet paper dispenser in the men's locker-room is mounted too far from the toilet seat at 17".	ADAAG 604.7	Remount the toilet paper dispenser to be no lower than 15", no higher than 48" AFF and a minimum of 7" to a maximum of 9" in front of the toilet. Do not mount the toilet paper dispenser behind the side grab bar.		Bob Byrne	\$100	2012	Remounted dispensers 5/2012

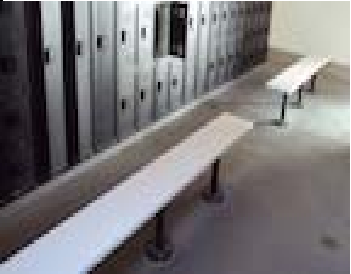
The benches in the men's locker-room provided in front of the lockers are not located against a wall or have backs.	ADAAG 222 & 903	Provide a bench that is a minimum 42" long, and a minimum of 20" to a maximum of 24" deep. The bench should be affixed to a wall or have a back support that extends at least 42" the length of the bench at a point a maximum of 2" above the seat. The accessible bench should be adjacent to the accessible lockers and have a seat between 17" to 19" AFF.			\$700	2021

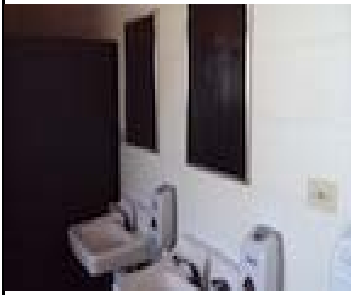
The mirrors in the women's locker room are mounted too high at 48 3/4" to the reflective surface.	ADAAG 603.3	Lower the mirror above the sink or countertop to be no higher than 40" to the reflective surface. Mirrors not mounted above the sink or a counter top should be mounted no higher than 35" to the reflective surface. UD - A full-length mirror would be a recommended option.		Bob Byrne	\$100	2012	Lowered both mirrors to 40" 5/2012

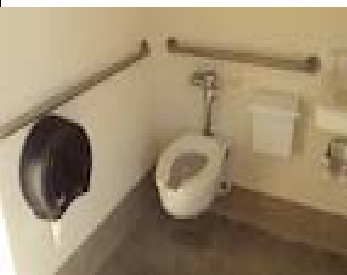
The toilet paper dispenser in the women's deck restroom is mounted too far from the toilet seat at 20".	ADAAG 604.7	Remount the toilet paper dispenser to be no lower than 15", no higher than 48" AFF and a minimum of 7" to a maximum of 9" in front of the toilet. Do not mount the toilet paper dispenser behind the side grab bar.		Bob Byrne	\$100	2012	Remounted dispensers 5/2012

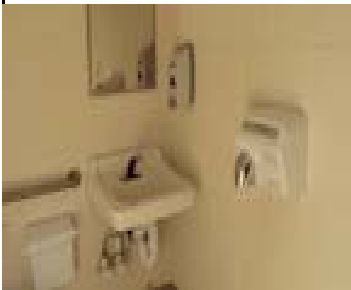
The mirror in the women's deck restroom is mounted too high at 48 3/4" to the reflective surface.	ADAAG 603.3	Lower the mirror above the sink or countertop to be no higher than 40" to the reflective surface. Mirrors not mounted above the sink or a counter top should be mounted no higher than 35" to the reflective surface. UD - A full-length mirror would be a recommended option.		Bob Byrne	\$100	2012	Remounted mirrors 5/2012

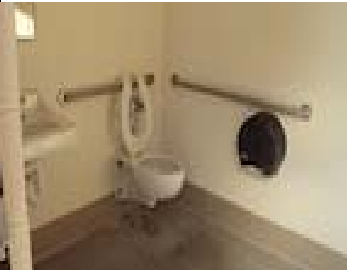
The toilet paper dispenser in the men's deck restroom is mounted too far from the toilet seat at 18".	ADAAG 604.7	Remount the toilet paper dispenser to be no lower than 15", no higher than 48" AFF and a minimum of 7" to a maximum of 9" in front of the toilet. Do not mount the toilet paper dispenser behind the side grab bar.		Bob Byrne	\$100	2012	Remounted dispensers 5/2012

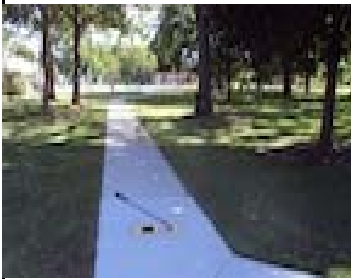
Along this walkway there is a trash can located in the grass.	<u>Proposed</u> Outdoor Developed Areas Guidelines 1011	Trash Can Recommendation: Locate trash cans on an accessible route as part of your regular policy. For a forward approach provide a trash can within 24" and a minimum clear ground space of 36" by 48" or for a side approach provide a trash can within 24" and a minimum clear ground space of 30" by 60".			\$50	2012	Trash can moved 4/2012

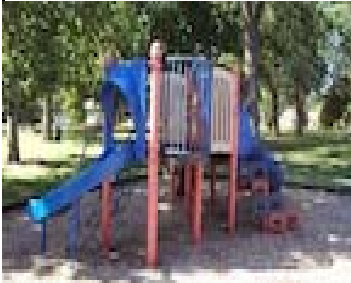
The 2 to 5 year old playground does not provide a transfer platform or ramp to the elevated play components.	ADAAG 1008.3.1.2	Provide a surface at the transfer platform that is between 11" and 18" above the ground. Because of the age and design of this playground, a new transfer platform or ramp may not be able to added. If so, consideration should be made to replace this playground.			\$1,900	2016	Playground removed in 10/2016 \$10,000

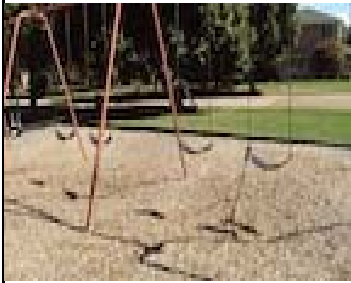
The adult/older child swings have a slope too steep at 12.7% to 16.1%	ADAAG 1008.4.4	Provide a regular maintenance to the play surface to provide a seat less than 24" off the ground and a slope under the swings no greater than 2%. Consider a mat under the swing to prevent kick-out of surface material. An accessible swing with a seat would be recommended at some point.			\$100	2016	Playground removed in 10/2016 \$10,000

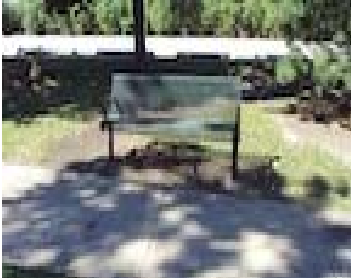
The bench along the walkway to the courts does not provide companion seating.	Proposed Outdoor Areas Standards ADAAG 1011	Bench Recommendation: Provide at least 20% but no less than two benches to provide a clear ground space of at least 30" by 48" positioned near the bench with one side adjoining the walkway and a slope no steeper than 2% in all directions. The clear ground space should not overlap the accessible route or another clear ground space. UD - Provide benches with armrests and no gaps between the seat and backrest.		J and R first in asphalt	\$250	2015	Path renovated with tennis court resurfacing \$20,000 for total project 5/2015

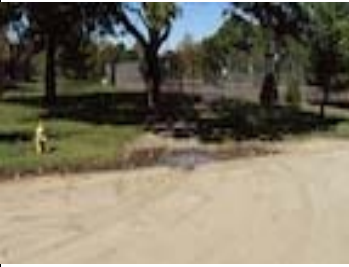
There is not curb ramp provided to the east entrance to the tennis court area.	ADAAG 406	When up grading this area provide a curb ramp with a running slope no steeper than 8.3% and a cross slope no steeper than 2% and a smooth transition to the sidewalk and street gutter. Also provide truncated domes.			\$1,200	2020

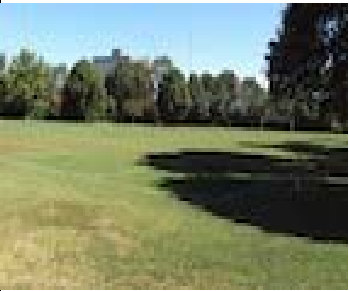
There is no access route to the soccer field.	ADAAG 403.3	If there are viewing area for games and practices then provide a new accessible route with a running slope no steeper than 5% and a cross slope no steeper than 2% and a minimum clear width of 36". Otherwise relocate to an accessible field when necessary.			\$1,250	2020

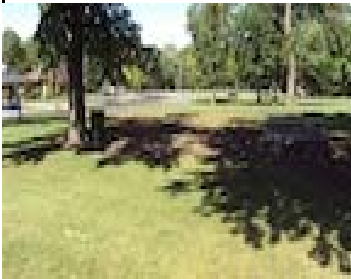
<p>A picnic table and trash can are off the parking lot and accessible route for 35'.</p>	<p>Proposed Outdoor Developed Areas Guidelines ADAAG 245 & 1011</p>	<p>Picnic Table Recommendation: At least 20% of picnic tables, but no less than two, be of accessible design, connected to an accessible route. Relocate or purchase two accessible picnic tables (\$750/each) and locate them on an accessible surface (\$900).</p>			\$3,300	2015	<p>Picnic table removed 5/2015</p>
		<p>ADAAG 403.3</p>	<p>Provide a new accessible route with a running slope no steeper than 5% and a cross slope no steeper than 2% and a minimum clear width of 36".</p>			\$1,150	2015	<p>Picnic table removed 5/2015</p>

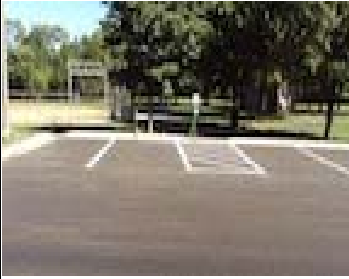
<p>No accessible parking is provided to ball field #1 and #2. There is a 7' striped area at the walkway that could be widened to 8' and become an access aisle.</p>	<p>IAC 400.310(c)</p>	<p>Provide one accessible parking space with a access aisle a minimum of 96" plus a sign with the International Symbol of Accessibility and a fine sign of \$250 at the head of the parking space. The parking space and access aisle should be no steeper than 2% in all directions. Locate the accessible parking space on the shortest accessible route.</p>			<p>\$700</p>	<p>2020</p>

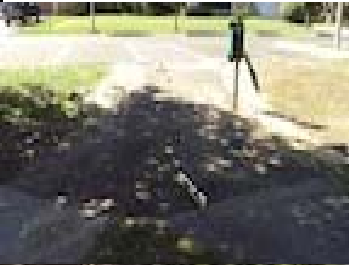
The walkway toward field #2 and restrooms has a running slope too steep at 5.6% to 10.3%.	ADAAG 403.3	Remove and regrade section to provide a running slope no greater than 5% and a cross slope no greater than 2%. Because of the slope in this area regrading to 5% may not be possible. Follow ADAAG 405 for ramps if necessary.			\$925	2020

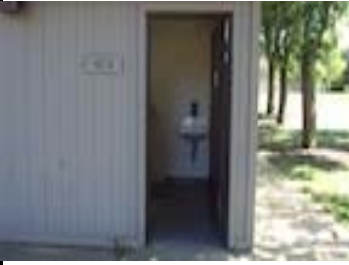
The sign for the men's restroom is not of an accessible design.	ADAAG 216.2	The permanent room sign should to be mounted on the wall at the latch side of the door at 48" minimum from the baseline of the lowest tactile character to 60" maximum from the baseline of the highest character with raised lettering and numbers plus Braille.		Bob Byrne	\$150	2012	Installed new restroom sign w/raised lettering, numbers & Braille at appropriate height 5/2012

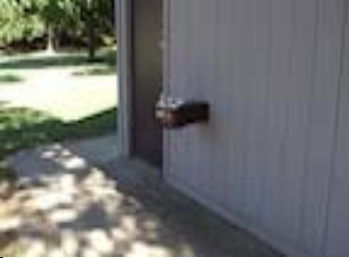
The drinking fountain at the fields restrooms only provides wheelchair height.	ADAAG 211 & ADAAG 602	Provide standing individual drinking fountain or a single hi-lo drinking fountain that provides a wheelchair accessible fountain with a spout at 36" maximum and a standing drinking fountain with a height between 38" minimum and 43" maximum. The toe clearance should be a minimum of 9".			\$2,125	2020

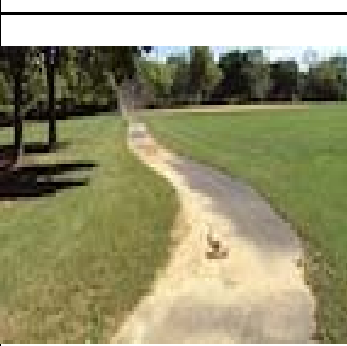
Route to field #1 uneven, cracks and has cross slopes between 2.6% to 4.2%. This would include routes to the bleachers, player benches and opening to the field entrances.	ADAAG 403.3	When resurfacing or updating this walkway, remove and regrade section to provide a cross slope no greater than 2%. Relocate to an accessible field as needed.				2020

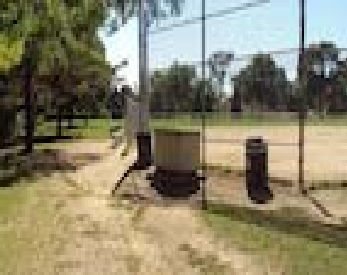
There is a trash can along the route to field #1 that is located in the grass.	Proposed Outdoor Developed Areas Guidelines 1011	Trash Can Recommendation: Locate trash cans on an accessible route as part of your regular policy. For a forward approach provide a trash can within 24" and a minimum clear ground space of 36" by 48" or for a side approach provide a trash can within 24" and a minimum clear ground space of 30" by 60".			\$50	2012	Moved trash can 5/2012

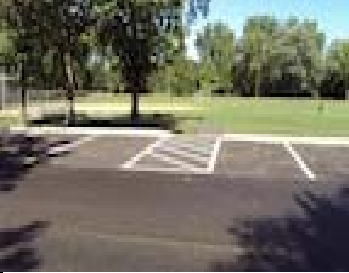
No accessible parking is provided to ball field #3. There is a 7' 2" striped area at the walkway that could be widened to 8' and become an access aisle.	IAC 400.310(c)	Provide one accessible parking space with a access aisle a minimum of 96" plus a sign with the International Symbol of Accessibility and a fine sign of \$250 at the head of the parking space. The parking space and access aisle should be no steeper than 2% in all directions. Locate the accessible parking space on the shortest accessible route.			\$750	2020

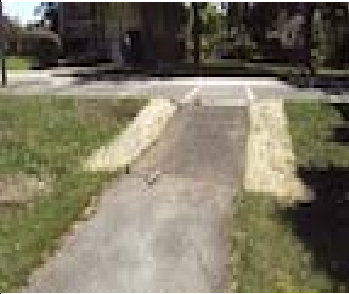
Running slope too steep at 5.6% - 13.2% for 16'.	ADAAG 403.3	Remove and regrade section to provide a running slope no greater than 5% and a cross slope no greater than 2%. Because of the slope in this area regrading to 5% may not be possible. Follow ADAAG 405 for ramps if necessary.			\$950	2020

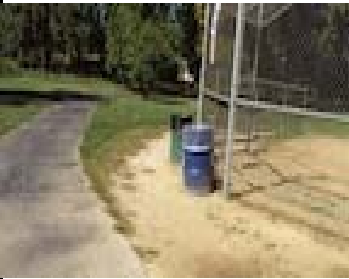
Field #3 there is no accessible route to the trash can for 17'.	<u>Proposed</u> Outdoor Developed Areas Guidelines 1011	Trash Can Recommendation: Locate trash cans on an accessible route as part of your regular policy. For a forward approach provide a trash can within 24" and a minimum clear ground space of 36" by 48" or for a side approach provide a trash can within 24" and a minimum clear ground space of 30" by 60".			\$50	2012	Moved garbage can 5/2012

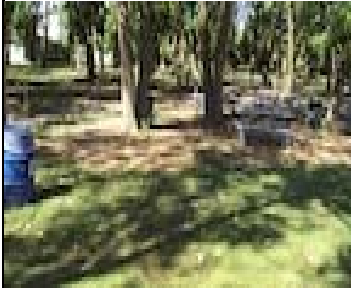
A total of 28 picnic tables are provided with two being accessible.	<u>Proposed</u> Outdoor Developed Areas Guidelines ADAAG 245 & 1011	Picnic Table Recommendation: At least 20% of picnic tables, be of accessible design, connected to an accessible route. Relocate or purchase four more accessible picnic tables (\$750/each) and locate them on an accessible surface (\$900).			\$6,600	2014	Picnic area removed due to flooding

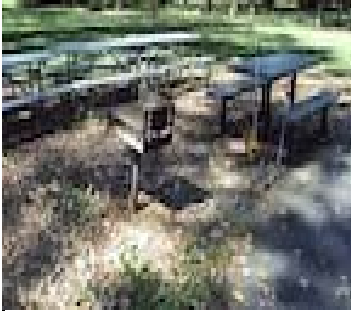
<p>The grills provided at the north and south of the picnic area do not provide the proper space around them.</p>	<p>Proposed Outdoor Developed Areas Guidelines ADAAG 1011.5</p>	<p>Grill Recommendation: Follow Outdoor Developed Area Report that states 20% of grills, but at least two, be of accessible design, and connected to an accessible route. The accessible grill should provide a cooking surface a minimum of 15" to 34" maximum AFF above the ground surface, a clear floor space and controls that are within a maximum reach range of 48" AFF. And a 48" by 48" space centered on the usable sides of the grill is required.</p>			\$250	2019

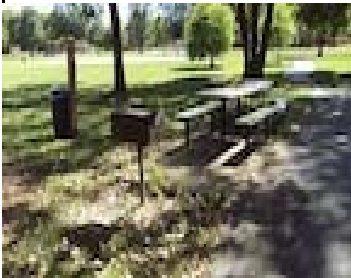
A trash cans are provided but are located in the grass.	Proposed Outdoor Developed Areas Guidelines 1011	Trash Can Recommendation: Locate trash cans on an accessible route as part of your regular policy. For a forward approach provide a trash can within 24" and a minimum clear ground space of 36" by 48" or for a side approach provide a trash can within 24" and a minimum clear ground space of 30" by 60".			\$50	2012	Moved trash can 5/2012
