Eldridge Park

Eldridge Park is very large neighborhood park that provides walkways, playgrounds, picnic areas, tennis courts, a grill, sledding hill, soccer fields, ballfield and preschool building. The main issues at this park are accessible routes, slopes, not properly marked accessible parking spaces, protruding branches. The preschool building has been upgraded for accessibility and could with some upgrades be a designated accessible preschool site. **Please Note:** When a **UD** is indicated, this is a Universal Design (**UD**) recommendation to enhance accessibility. The **UD** recommendation is not required to meet the minimum accessibility standards but it would be encouraged.

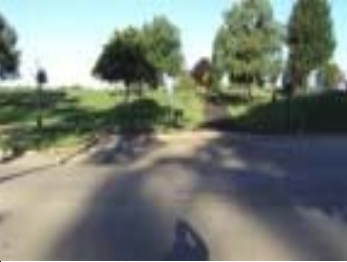
The present Universal Designed parking space has light painting and needs to be repainted.	IAC 400.310(c)	You can repaint the present parking space with a 5' access aisle and a 11' parking space. Or restripe the accessible parking space's access aisle to provide an access aisle that is a minimum of 96" and a parking space that is a minimum of 96".			\$50	2012 Seal coating and striping project	seal coated and restriped new hc spots 5/2012

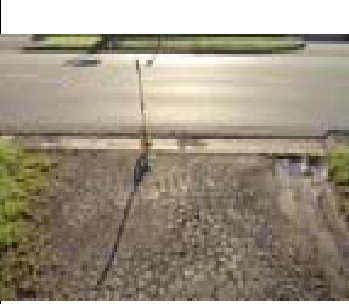
The curb ramp near the southeast stairs does not have truncated domes.	ADAAG 705	Provide truncated domes that go the width of the sidewalk and 24" deep where it meets the road. Provide a color that contrast with the walkway surface. Truncated dome tiles are typically a more durable solution.			\$500	2017	Remove curb and replace with mountable curb, not a pedestrian crossing, should not have TDs. 4/2017

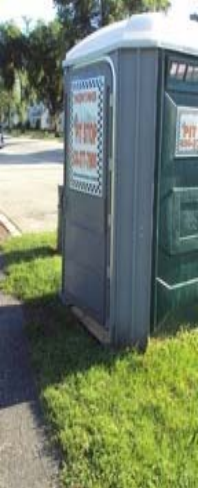
<p>The portable toilet is located in the grass and not on an accessible route. The toilet paper holder is mounted too high at 56" and the soap dispenser is too high at 53".</p>	<p>ADAAG 213.2</p>	<p>When ordering portable toilets if only one is provided it should be accessible and located on an accessible route. Also check with the companies to make sure the features in the accessible toilets are actually to code. The toilet paper and soap dispenser should be mounted no higher than 48" AFF.</p>			<p>NA</p>	<p>2017</p>	<p>Provide asphalt pavement for portable toilet as part of Eld ADA project April 2017</p>

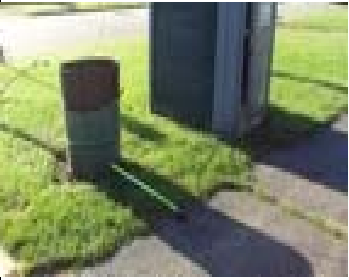
<p>The trash can next to the portable toilet is located off the accessible route by 36".</p>	<p>Proposed Outdoor Developed Areas Guidelines 1011</p>	<p>Trash Can Recommendation: Locate trash cans on an accessible route as part of your regular policy. For a forward approach provide a trash can within 24" and a minimum clear ground space of 36" by 48" or for a side approach provide a trash can within 24" and a minimum clear ground space of 30" by 60".</p>			<p>\$50</p>	<p>2012</p>	<p>Moved garbage can to accessible location 4/2012</p>

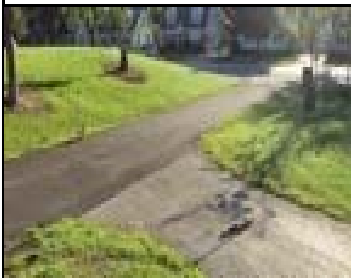
The walkway near the accessible parking that is the accessible route up to the upper walkway area has a cross slope too steep at the intersection of 2.6% to 5.8% for 19'.	ADAAG 403.3	Regrade section to provide a cross slope no greater than 2%.			\$625	2014	Path improvement to meet standards 6/2014 \$15,000

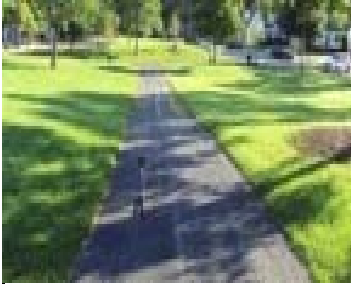
The walkway that could be the accessible route up to the upper walkway has a running slope too steep at 2.6% to 7.9% for 50'.	ADAAG 403.3	Remove and regrade section to provide an accessible route with a running slope no greater than 5% and an cross slope no greater than 2%. Option: The slopes in this area are within ramp slopes and could just require the instillation of handrails that comply with ADAAG 405.8.			\$2,225	2023

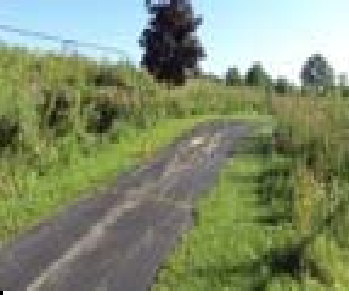
The south walkway at the small hill behind the soccer post near the bench has a running slope too steep at 5.6% to 11.8% for 28'.	ADAAG 403.3	Remove and regrade section to provide a running slope no greater than 5% and a cross slope no greater than 2%. Because of the slope in this area regrading to 5% may not be possible. Follow ADAAG 405 for ramps if necessary.			\$1,700	2023

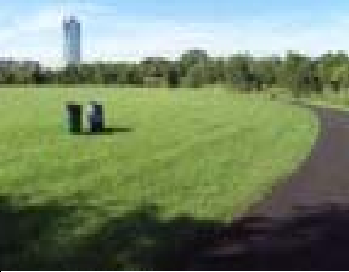
A trash can and recycle can are provided at the soccer field but they are not on an accessible route.	<u>Proposed</u> Outdoor Developed Areas Guidelines 1011	Trash Can Recommendation: Locate trash cans on an accessible route as part of your regular policy. For a forward approach provide a trash can within 24" and a minimum clear ground space of 36" by 48" or for a side approach provide a trash can within 24" and a minimum clear ground space of 30" by 60".			\$50	2012	Moved trash can to accessible location 4/2012

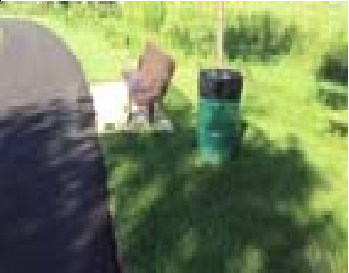
The trash can at the bench is placed too far from the bench or walkway at 40".	<u>Proposed</u> Outdoor Developed Areas Guidelines 1011	Trash Can Recommendation: Locate trash cans on an accessible route as part of your regular policy. For a forward approach provide a trash can within 24" and a minimum clear ground space of 36" by 48" or for a side approach provide a trash can within 24" and a minimum clear ground space of 30" by 60".			\$50	2012	Moved trash can to accessible location 4/2012

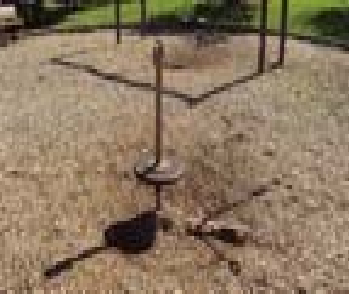
<p>The spinner in the playground has a slope too steep at 19.2%.</p>	<p>ADAAG 1008.4.4</p>	<p>Provide a regular maintenance to the play surface to provide a seat less than 24" off the ground and a slope under the spinner no greater than 2%. Consider a mat under the spinner to prevent kick-out of surface material.</p>			<p>\$100</p>	<p>2020 as part of Playground replacement</p>

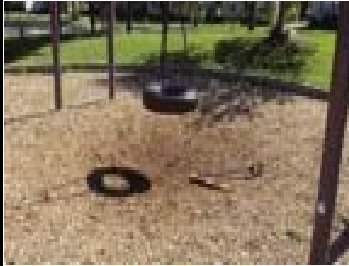
<p>The tire swing in the playground has a slope too steep at 16.1% and a tire seat height too high at 32".</p>	<p>ADAAG 1008.4.4</p>	<p>Provide a regular maintenance to the play surface to provide a tire height less than 24" off the ground and a slope under the swings no greater than 2%. Consider a mat under the tire to prevent kick-out of surface material.</p>			<p>\$100</p>	<p>2020 as part of Playground replacement</p>

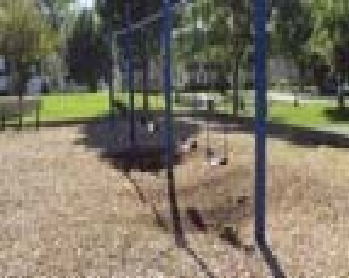
The adult/older child swings have a slope too steep at 23.9% to 25.5%	ADAAG 1008.4.4	Provide a regular maintenance to the play surface to provide a seat less than 24" off the ground and a slope under the swings no greater than 2%. Consider a mat under the swing to prevent kick-out of surface material. An accessible swing with a seat would be recommended at some point.			\$100	2020 as part of Playground replacement

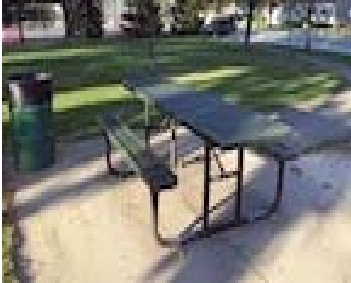
Two picnic tables are provided but only one is of an accessible design.	Proposed Outdoor Developed Areas Guidelines ADAAG 245 & 1011	Picnic Table Recommendation: At least 20% of picnic tables, but no less than two, be of accessible design, connected to an accessible route. Relocate or purchase two accessible picnic tables (\$750/each) and locate them on an accessible surface (\$900).			\$1,000	2020 as part of Playground replacement

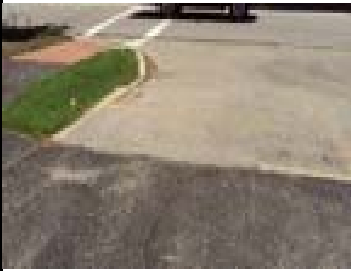
A built-up curb ramp in the parking area does not provide truncated domes.	ADAAG 705	Provide truncated domes that go the width of the sidewalk and 24" deep where it meets the road. Provide a color that contrast with the walkway surface. Truncated dome tiles are typically a more durable solution.			\$500	2017	Provide asphalt pavement for portable toilet as part of Eld ADA project April 2017

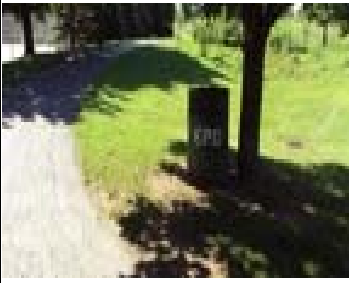
The trash can at the northeast corner of the tennis courts is off the accessible route for 50".	Proposed Outdoor Developed Areas Guidelines 1011	Trash Can Recommendation: Locate trash cans on an accessible route as part of your regular policy. For a forward approach provide a trash can within 24" and a minimum clear ground space of 36" by 48" or for a side approach provide a trash can within 24" and a minimum clear ground space of 30" by 60".			\$50	2012	Moved trash can to accessible route 4/2012

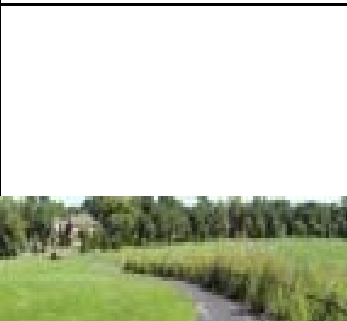
The east walkway up to the top of the sledding hill has a slope of 5.6% to 8.9% for 109'.	ADAAG 405.6 and ADAAG 405.7	Because of the length of this ramp have three landings every 30' that are 60" minimum in length and the width of the walkway to provide a resting area. Consider this side the accessible side.			\$825	2023

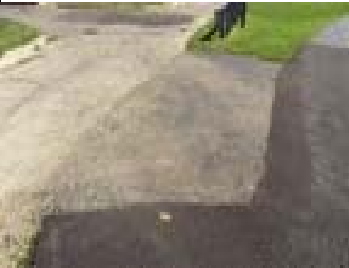
The northwest entrance does not provide truncated domes.	ADAAG 705	Provide truncated domes that go the width of the sidewalk and 24" deep where it meets the road. Provide a color that contrast with the walkway surface. Truncated dome tiles are typically a more durable solution.			\$500	2023

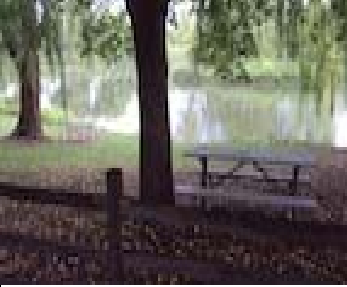
The two picnic tables are provided at the water and one at the playground. The one at the playground is accessible and on an accessible surface.	Proposed Outdoor Developed Areas Guidelines ADAAG 245 & 1011	Picnic Table Recommendation: At least 20% of picnic tables, but no less than two, be of accessible design, connected to an accessible route. Relocate or purchase one more accessible picnic table and locate it on an accessible surface.			\$1,650	2021

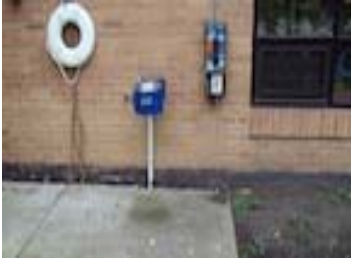
The drinking fountain on the outside of the building has a 29 3/4" knee clearance and 38" to the spout.	ADAAG 211 & ADAAG 602	Provide two individual drinking fountain or a single hi-lo drinking fountain that provides a wheelchair accessible fountain with a spout at 36" maximum and a standing drinking fountain with a height between 38" minimum and 43" maximum. The toe clearance should be a minimum of 9".			\$4,225	2021

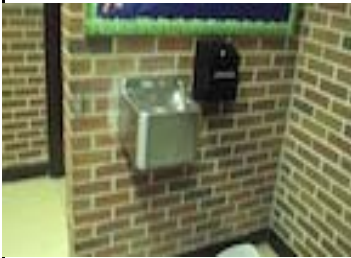
The drinking fountain 30" and knee 39" to spout.	ADAAG 211 & ADAAG 602	Provide an individual high drinking fountain or a single hi-lo drinking fountain that provides a wheelchair accessible fountain with a spout at 36" maximum and a standing drinking fountain with a height between 38" minimum and 43" maximum. The toe clearance should be a minimum of 9". This is an older model drinking fountain that would need to be replaced.			\$2,125	2021

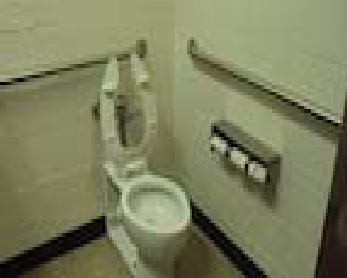
The toilet grab bars in the men's restroom are mounted at 35 1/4".	ADAAG 604.5	If these toilets are used mainly by children, then depending on the age of children, the children's grab bar at the accessible toilet should be mounted at 18" AFF to 20" AFF for children ages 3 to 4, 20" AFF to 25" AFF for children ages 5 to 8 and 25" to 27" for children ages 9 to 12. The rear grab bar should be a minimum of 36" long and 4" to 6" from the corner and the side grab bar a minimum of 42" long and a maximum of 12" from the corner.			\$300	2019

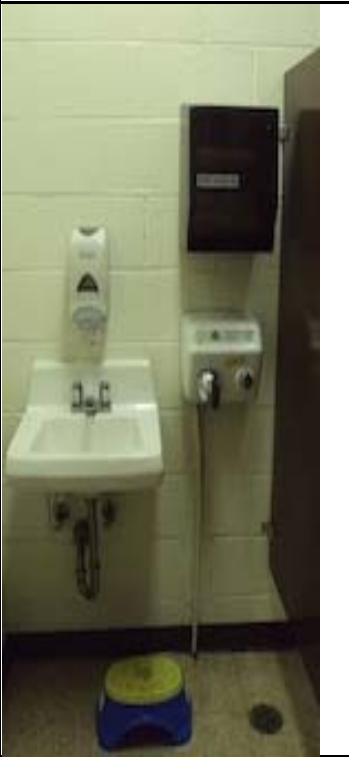
<p>The sink faucet in the men's restroom stays on for only 3 seconds.</p>	<p>ADAAG 606.4</p>	<p>Provide a lever-operated, push-type or electronically controlled faucet. Self-closing faucets should remain open for at least 10 seconds. Push-type or lever-operated faucets should require not more than 5 lbs. to operate.</p>			<p>\$100</p>	<p>2018</p>	
	<p>The soap dispenser in the men's restroom is mounted to 44".</p>	<p>ADAAG 308.1</p>	<p>It is presently not known if these restrooms are used mainly by children or adults. If mainly by children, then depending on the age of the student, provide the soap dispenser at a height between 20" to 36" for ages 3 to 4, 18" to 40" for ages 5 to 8 and 16" to 44" for ages 9 to 12.</p>			<p>\$100</p>	<p>2018</p>

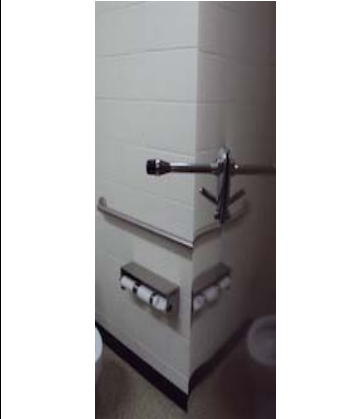
The coat hook in the men's restroom is mounted too high at 54" AFF.	ADAAG 308.1	It is presently not known if these restrooms are used mainly by children or adults. If mainly by children, then depending on the age of the student, provide the coat hook at a height between 20" to 36" for ages 3 to 4, 18" to 40" for ages 5 to 8 and 16" to 44" for ages 9 to 12.			\$50	2018

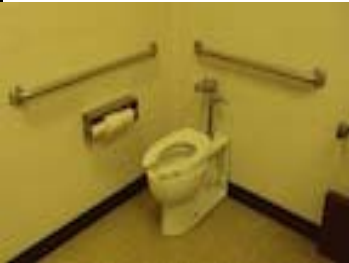
The toilet in the women's restroom is mounted at 17 3/4" to the centerline and 17 1/2" to the top of the toilet.	ADAAG 604.9	Depending on the age of the children the toilet should have a centerline of 12" and height of 11" to 12" for children ages 3 to 4, 12" to 15" and height of 12" to 15" for children ages 5 to 8 and a centerline of 15" to 18" and height of 15" to 17" for children ages 9 to 12.			\$1,500	2019

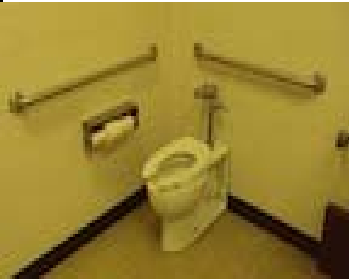
The toilet grab bars in the women's restroom are mounted at 34".	ADAAG 604.5	If these toilets are used mainly by children, then depending on the age of children, the children's grab bar at the accessible toilet should be mounted at 18" AFF to 20" AFF for children ages 3 to 4, 20" AFF to 25" AFF for children ages 5 to 8 and 25" to 27" for children ages 9 to 12. The rear grab bar should be a minimum of 36" long and 4" to 6" from the corner and the side grab bar a minimum of 42" long and a maximum of 12" from the corner.			\$300	2019

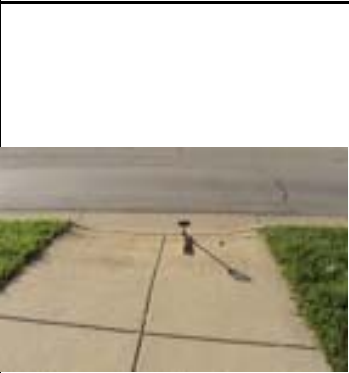
The curb ramp at the south side has a running slope too steep at 10.2%.	ADAAG 406	Provide a curb ramp with a running slope no steeper than 8.3% and a cross slope no steeper than 2% and a smooth transition to the sidewalk and street gutter.			\$1,500	Schedule around City's sidewalk replacement schedule
