# Marjorie Davis Park

Marjorie Davis Park is a medium sized neighborhood park that provides parking, two playgrounds, a ballfield, Bocce Ball area, a picnic table and checker/chess table and walkways. The main issues at this park are slopes being too steep, the need for one more accessible picnic tables, protruding branches and no access to the Bocce Ball area, . **Please Note:** When a **UD** is indicated, this is a Universal Design (**UD**) recommendation to enhance accessibility. The **UD** recommendation is not required to meet the minimum accessibility standards but it would be encouraged.

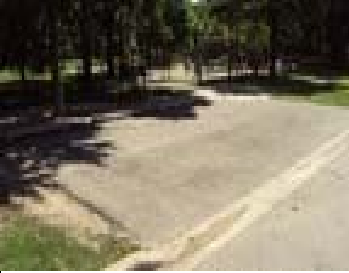
There are 8 parking spaces provided but none are of an accessible design.	IAC 400.310(c)	Provide one accessible parking space with a access aisle a minimum of 96" plus a sign with the International Symbol of Accessibility and a fine sign of \$250 at the head of the parking space. The parking space and access aisle should be no steeper than 2% in all directions. Locate the accessible parking space on the shortest accessible route.			\$750	2012	Seal coating project 2012 \$1,000
