# Maple Trail Woods Park

Maple Trail Woods Park is a large wooded area that provides a walking trail, a bench, trash can and dog waste bags. The main issues at this park are trash cans not on an accessible route, dog waste bag dispenser off the accessible route, and bench. **Please Note:** When a **UD** is indicated, this is a Universal Design (**UD**) recommendation to enhance accessibility. The **UD** recommendation is not required to meet the minimum accessibility standards but it would be encouraged.

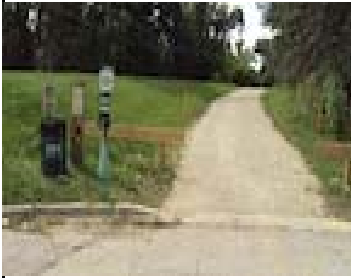
The trash can is off the accessible route for 45"	<b>Proposed</b> Outdoor Developed Areas Guidelines 1011	<b>Trash Can Recommendation:</b> Locate trash cans on an accessible route as part of your regular policy. For a forward approach provide a trash can within 24" and a minimum clear ground space of 36" by 48" or for a side approach provide a trash can within 24" and a minimum clear ground space of 30" by 60".			\$50	2012	Moved garbage can to accessible route. 3/2012

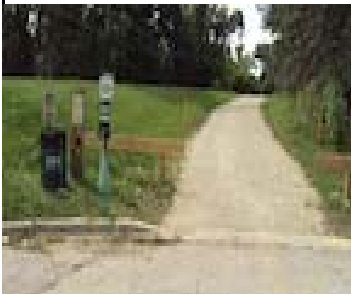
The dog waste bag dispenser is off the accessible route for 60".	ADAAG 308	Remount the dog waste bag dispenser to provide a reach range no higher than 44" AFF maximum reach range over an object 20" to a maximum of 25" deep or a side reach of 46" AFF maximum over an object 10" to a maximum of 24".			\$50	2012	Removed dog waste dispenser. 11/2012

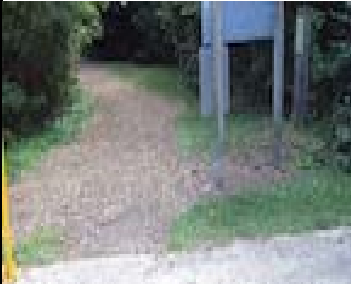
A bench at the Rex Boulevard and Crescent Avenue is located in the grass and not on the trail or accessible surface.	<u>Proposed</u> Outdoor Areas Standards ADAAG 1011	<b>Bench Recommendation:</b> Provide at least 20% but no less than two benches to provide a clear ground space of at least 30" by 48" positioned near the bench with one side adjoining the walkway. The clear ground space should not overlap the accessible route or another clear ground space. <b>UD</b> - Provide benches with armrests and no gaps between the seat and backrest.			\$1,000	2019

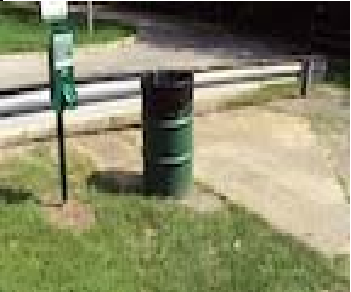
The dog waste bag dispenser is off the accessible route for 54".	ADAAG 308	Remount the dog waste bag dispenser to provide a reach range no higher than 44" AFF maximum reach range over an object 20" to a maximum of 25" deep or a side reach of 46" AFF maximum over an object 10" to a maximum of 24".			\$150	2012	Dog waste dispenser removed 4/2012
