# Pioneer Park

Pioneer Park is medium sized neighborhood park that provides parking, a portable toilet, playgrounds, picnic area, benches and open field for soccer. The main issues at this park are the parking spaces needing to be restriped, provide a fine sign, slopes, benches with companion seating, trash cans on accessible routes, and curb ramps with truncated domes. **Please Note:** When a **UD** is indicated, this is a Universal Design (**UD**) recommendation to enhance accessibility. The **UD** recommendation is not required to meet the minimum accessibility standards but it would be encouraged.

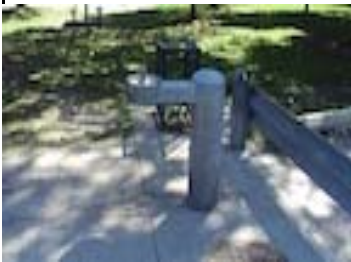
There is a wheelchair accessible drinking fountain provided but there is not a water fountain of a high/standing design.	ADAAG 211 & ADAAG 602	Provide a single individual high drinking fountain or a single hi-lo drinking fountain that provides a wheelchair accessible fountain with a spout at 36" maximum and a standing drinking fountain with a height between 38" minimum and 43" maximum. The toe clearance should be a minimum of 9".			\$2,125	2019	Scheduled in Capital repair and replacement budget

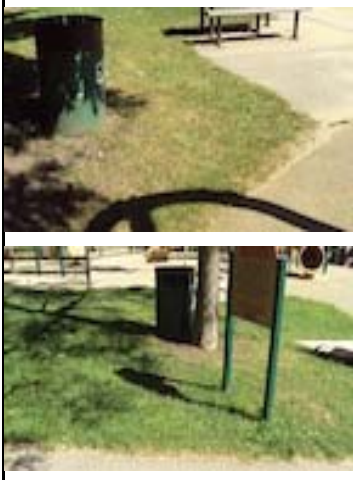
<p>The trash can near the picnic table is not on an accessible route for 6' and the trash can near the sign is not on an accessible route for 8'.</p>	<p><b>Proposed</b> Outdoor Developed Areas Guidelines 1011</p>	<p><b>Trash Can Recommendation:</b> Locate trash cans on an accessible route as part of your regular policy. For a forward approach provide a trash can within 24" and a minimum clear ground space of 36" by 48" or for a side approach provide a trash can within 24" and a minimum clear ground space of 30" by 60".</p>			\$50	2025	<p>Reorganize and replace during replacement of playground and surfacing</p>

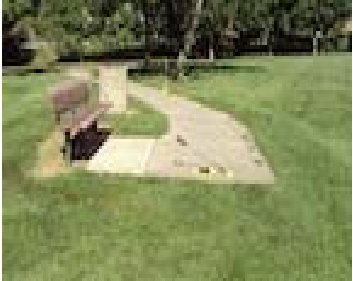
<p>There is a bench at the soccer field but it does not provide companion seating.</p>	<p><b>Proposed</b>                      Outdoor Areas                      Standards                      ADAAG 1011</p>	<p><b>Bench Recommendation:</b>                      Provide at least 20% but no less than two benches to provide a clear ground space of at least 30" by 48" positioned near the bench with one side adjoining the walkway and a slope no steeper than 2% in all directions. The clear ground space should not overlap the accessible route or another clear ground space. <b>UD</b> - Provide benches with armrests and no gaps between the seat and backrest.</p>			<p>\$250</p>	<p>2025</p>	<p>Reorganize and replace during replacement of playground and surfacing</p>

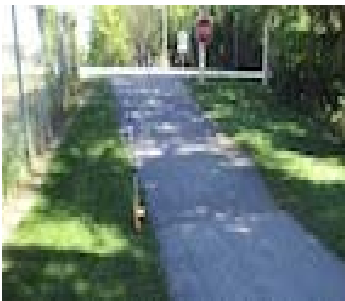
The walkway up to the stop sign has a running slope too steep at 9.6% to 16.5% for 31'.	ADAAG 403.3	Remove and regrade section to provide a running slope no greater than 5% and a cross slope no greater than 2%. Because of the slope in this area regrading to 5% may not be possible. Follow ADAAG 405 for ramps if necessary. Because of the terrain in this area, you may only be able to lessen the slope to the greatest extent possible.			\$2,575	2019	Replace paths as part of Capital project

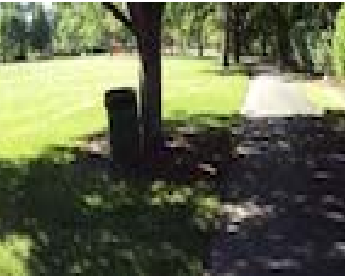
Along the walkway under the tree there is a trash can located in the grass and 7' off the accessible route.	<u>Proposed</u> Outdoor Developed Areas Guidelines 1011	<b>Trash Can Recommendation:</b> Locate trash cans on an accessible route as part of your regular policy. For a forward approach provide a trash can within 24" and a minimum clear ground space of 36" by 48" or for a side approach provide a trash can within 24" and a minimum clear ground space of 30" by 60".			\$50	2012	Moved can to accessible route 4/2012

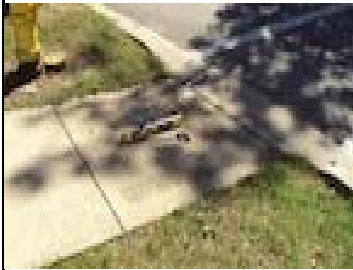
The west curb ramp does not provide truncated domes.	ADAAG 705	Provide truncated domes that go the width of the sidewalk and 24" deep where it meets the road. Provide a color that contrast with the walkway surface. Truncated dome tiles are typically a more durable solution.			\$500		Coordinate with City's sidewalk replacement schedule

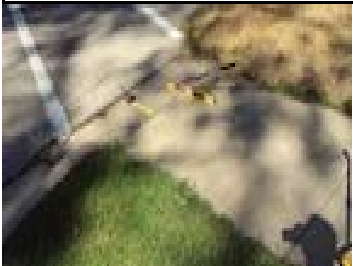
The north curb ramp of the northwest corner has no truncated domes.	ADAAG 705	Provide truncated domes that go the width of the sidewalk and 24" deep where it meets the road. Provide a color that contrast with the walkway surface. Truncated dome tiles are typically a more durable solution.			\$500	Coordinate with City's sidewalk replacement schedule
