Plunket Park

Plunket Park is large neighborhood park that provides parking, ballfield, picnic tables, playground and restrooms. The main issues at this park are not properly designed accessible parking spaces, not enough accessible parking spaces, slopes too high, protruding branches, abrupt transitions, and various elements in the restrooms not accessible. **Please Note:** When a **UD** is indicated, this is a Universal Design (**UD**) recommendation to enhance accessibility. The **UD** recommendation is not required to meet the minimum accessibility standards but it would be encouraged. When engineered wood fiber is provided at playgrounds provide a regular maintenance of the surface to maintain an accessible surface.

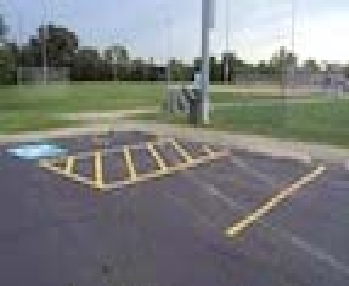
The narrow parking lot to the west has 88 parking spaces but only one is accessible.	IAC 400.310(c)	Provide three accessible parking space probably at this entrance to the ballfield, with an access aisle a minimum of 96" plus a sign with the International Symbol of Accessibility and a fine sign of \$250 at the head of the parking space. The parking space and access aisle should be no steeper than 2% in all directions. Locate the accessible parking space on the shortest accessible route.			\$2,250	2019

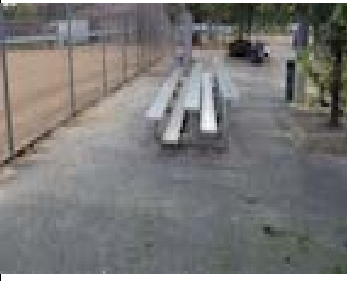
Tree branches behind the east bleachers and player bench and the west benches at Field #1 protrude at 45" AFF to 79" AFF.	ADAAG 307	Trim the branch to provide an 80" minimum clear head space and back to the edge of the walkway.			\$50	2012	Branches trimmed 7/2012

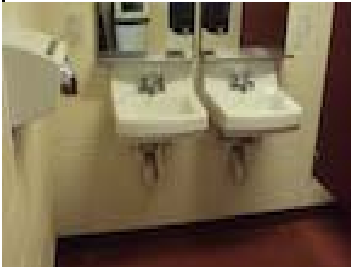
The faucets in the women's restroom shut off too quickly at 1 second.	ADAAG 606.4	Provide a lever-operated, push-type or electronically controlled faucet. Self-closing faucets should remain open for at least 10 seconds. Push-type or lever-operated faucets should require not more than 5 lbs. to operate.			\$550	2019

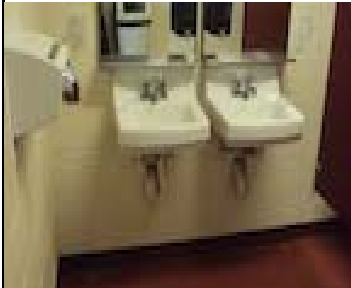
The mirror is mounted too high at 41" to the reflective surface.	ADAAG 603.3	Lower the mirror above the sink or countertop to be no higher than 40" to the reflective surface. Mirrors not mounted above the sink or a counter top should be mounted no higher than 35" to the reflective surface. UD - A full-length mirror would be a recommended option.		Bob Byrne	\$550	2013	Men's lowered to 40 1/8" (max. available); women's lowered to 40 1/4" max. available 3/13

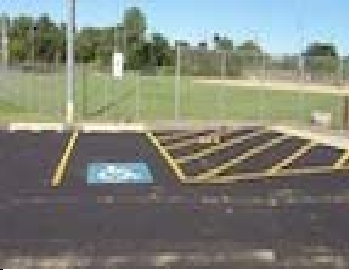
The large parking lot has 131 parking spaces but only two accessible parking spaces for this lot.	IAC 400.310(c)	Provide three more accessible parking space with a access aisle a minimum of 96" plus a sign with the International Symbol of Accessibility and a fine sign of \$250 at the head of the parking space. The parking space and access aisle should be no steeper than 2% in all directions. Locate the accessible parking space on the shortest accessible route. Probably near the present accessible parking spaces.			\$2,250	2017 Paving project	Repaved and restriped to meet ada standards. Add three hc spots 8/2017 \$5,000

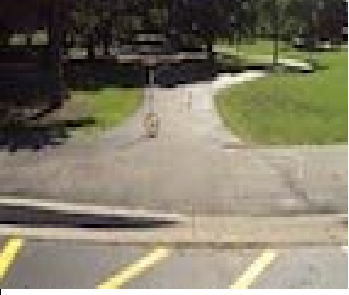
The walkway from the accessible parking to the playground has a running slope too steep at 5.6% to 9.3% for 21'.	ADAAG 403.3	Remove and regrade section to provide a running slope no greater than 5% and a cross slope no greater than 2%. Because of the slope in this area regrading to 5% may not be possible. Follow ADAAG 405 for ramps if necessary.			\$1,100	2017 Paving project	Repaved to meet ada standards. 8/2017

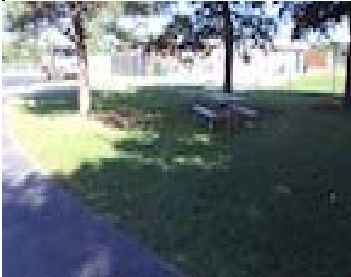
<p>Two picnic tables are provided but are not on an accessible route for 42' or of an accessible design.</p>	<p>Proposed Outdoor Developed Areas Guidelines ADAAG 245 & 1011</p>	<p>Picnic Table Recommendation: At least 20% of picnic tables, but no less than two, be of accessible design, connected to an accessible route. Relocate or purchase two accessible picnic tables and locate them on an accessible surface.</p>			\$1,500	2017	Removed Picnic table with playground redevelopment 8/2017
		<p>ADAAG 403.3</p>	<p>Provide a new accessible route with a running slope no steeper than 5% and a cross slope no steeper than 2% and a minimum clear width of 36".</p>			\$1,400	2017	Removed Picnic table with playground redevelopment 8/2017

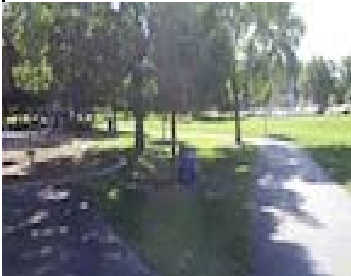
<p>The recycle can is 7' off the accessible route.</p>	<p>Proposed Outdoor Developed Areas Guidelines 1011</p>	<p>Trash Can Recommendation: Locate trash cans on an accessible route as part of your regular policy. For a forward approach provide a trash can within 24" and a minimum clear ground space of 36" by 48" or for a side approach provide a trash can within 24" and a minimum clear ground space of 30" by 60".</p>			\$50	2017	Moved trash cans to accessible route 8/2017

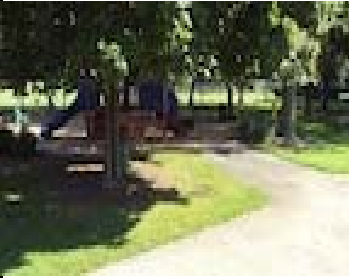
Two trash cans are located off the accessible route for 9' and 10'.	<u>Proposed</u> Outdoor Developed Areas Guidelines 1011	Trash Can Recommendation: Locate trash cans on an accessible route as part of your regular policy. For a forward approach provide a trash can within 24" and a minimum clear ground space of 36" by 48" or for a side approach provide a trash can within 24" and a minimum clear ground space of 30" by 60".			\$50	2017	Moved trash cans to accessible route 8/2017
