# Safety Town

Safety Town is a reproduction of a town including buildings, streets, curbs and traffic signs. The main issues at this park are benches with companion seating, cross slopes and running slopes too steep, no accessible route to elements, no truncated domes and abrupt transitions too high. **Please Note:** When a **UD** is indicated, this is a Universal Design (**UD**) recommendation to enhance accessibility. The **UD** recommendation is not required to meet the minimum accessibility standards but it would be encouraged.

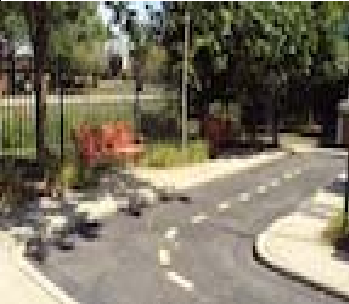
Two benches are provided but neither provide companion seating.	<u>Proposed</u> Outdoor Areas Standards ADAAG 1011	<b>Bench Recommendation:</b> Provide at least 20% but no less than two benches to provide a clear ground space of at least 30" by 48" positioned near the bench with one side adjoining the walkway. The clear ground space should not overlap the accessible route or another clear ground space. <b>UD</b> - Provide benches with armrests and no gaps between the seat and backrest.			\$2,200	2018

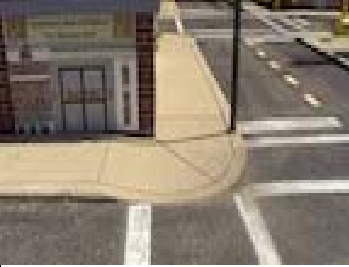
The curb ramps throughout Safety Town do not provide truncated domes.	ADAAG 705	Provide truncated domes that go the width of the sidewalk and 24" deep where it meets the road. Provide a color that contrast with the walkway surface. Truncated dome tiles are typically a more durable solution.			NA	It's not a real road
