Salt Creek Park

Salt Creek Park is medium sized neighborhood park that provides parking, a playground, picnic areas with grills, barrier with restrooms and a drinking fountain. The main issues at this park are the need for accessible parking spaces in the gravel lot, slopes too steep, playground surface slopes, need for additional accessible picnic tables and grills and updating the restrooms. **Please Note:** When a **UD** is indicated, this is a Universal Design (**UD**) recommendation to enhance accessibility. The **UD** recommendation is not required to meet the minimum accessibility standards but it would be encouraged.

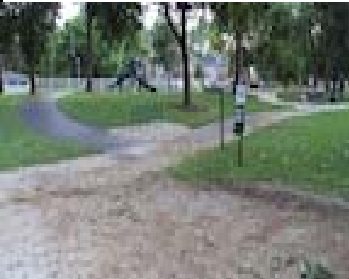
The gravel parking lot has approximately 40 spaces but none are of an accessible design.	IAC 400.310(c)	For this sized parking lot provide two accessible parking space with a access aisle a minimum of 96" plus a sign with the International Symbol of Accessibility and a fine sign of \$250 at the head of the parking space. The parking space and access aisle should be no steeper than 2% in all directions. Locate the accessible parking space on the shortest accessible route. Placing them at the walkway to the playground and picnic area would be recommended.			\$1,500	2019

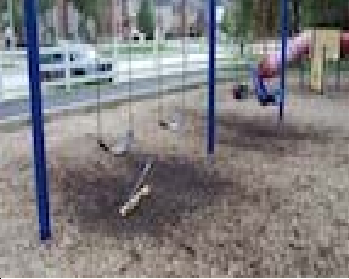
The adult/older child swings have a slope too steep at 8.5% to 20.4%	ADAAG 1008.4.4	Provide a regular maintenance to the play surface to provide a seat less than 24" off the ground and a slope under the swings no greater than 2%. Consider a mat under the swing to prevent kick-out of surface material. An accessible swing with a seat would be recommended at some point.			\$200	2019

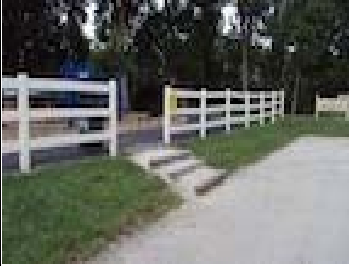
No access route is provided from the street parking to playground for 93'.	ADAAG 403.3	If new accessible parking is provided at the gravel lot then disregard. Otherwise, provide a new accessible route with a running slope no steeper than 5% and a cross slope no steeper than 2% and a minimum clear width of 36".			\$3,075	2019

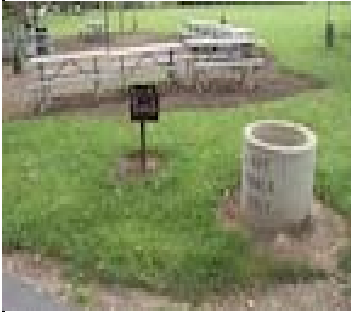
<p>There are 41 picnic tables provided under or next to the shelter, but only one is accessible.</p>	<p><u>Proposed</u> Outdoor Developed Areas Guidelines ADAAG 245 & 1011</p>	<p>Picnic Table Recommendation: At least 20% of picnic tables, or in this case 8 more tables be of accessible design, connected to an accessible route. Relocate or purchase eight accessible picnic tables and locate them on an accessible surface.</p>			\$1,650	2019

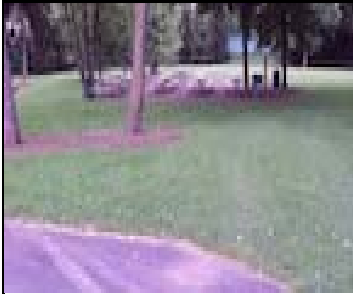
<p>There are 15 picnic tables provided but none are of an accessible design.</p>	<p>Proposed Outdoor Developed Areas Guidelines ADAAG 245 & 1011</p>	<p>Picnic Table Recommendation: At least 20% of picnic tables, but in this case no less than 3, be of accessible design, connected to an accessible route. Relocate or purchase three accessible picnic tables and locate them on an accessible surface. An new accessible surface would need to be developed at this location.</p>			\$1,650	2019	
	<p>Three trash cans are provided but are located in the grass and not on an accessible route for 60' to 68'.</p>	<p>Proposed Outdoor Developed Areas Guidelines 1011</p>	<p>Trash Can Recommendation: Locate trash cans on an accessible route as part of your regular policy. For a forward approach provide a trash can within 24" and a minimum clear ground space of 36" by 48" or for a side approach provide a trash can within 24" and a minimum clear ground space of 30" by 60".</p>			\$50	2012	<p>Moved cans to accessible route 3/2012</p>

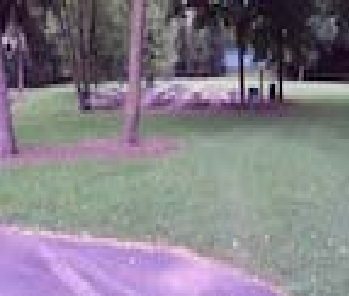
There are two grills provided but they are located in the grass and not on an accessible route for 68'.	ADAAG 403.3	Grill Recommendation: Determine which grills at these location and the other picnic area are to be accessible. Provide access to 20% or at least 2 of the grills. Provide a new accessible route with a running slope no steeper than 5% and a cross slope no steeper than 2% and a minimum clear width of 36".			\$2,250	2019	
	There are two grills that do not provide the proper accessible surface around the grills.	<u>Proposed</u> Outdoor Developed Areas Guidelines ADAAG 1011.5	Grill Recommendation: Follow Outdoor Developed Area Report that states that the grill have a 48" by 48" space centered on the usable sides of the grill. It would be recommended to provide on grill here and one grill in the picnic area located in the grass area.			\$400	2019

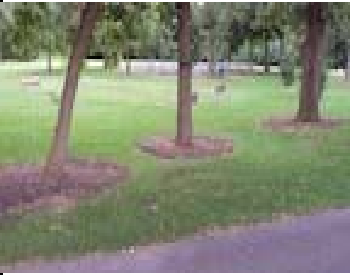
There is no accessible route to horseshoe pits 70' to 94'.	ADAAG 403.3	Provide a new accessible route with a running slope no steeper than 5% and a cross slope no steeper than 2% and a minimum clear width of 36". Provide this to at least one of the horseshoe pits.			\$2,325	2020

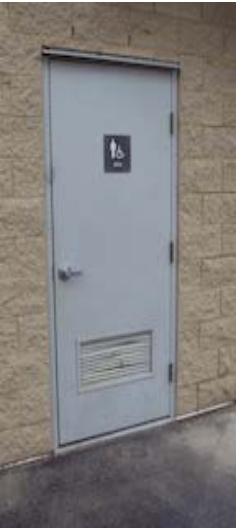
The sign for the men's restroom is mounted on the door.	ADAAG 216.2	The permanent room sign should to be mounted on the wall at the latch side of the door at 48" minimum from the baseline of the lowest tactile character to 60" maximum from the baseline of the highest character with raised lettering and numbers plus Braille.		Bob Byrne	\$50	2013	New sign mounted per specs 2/2013
	The door of the men's restroom has an opening force too high at 14 lbs. and closes too quickly at 3 seconds.	IAC 400.310(j)(10)(B)(i)	Adjust the closer so the door opening force is no heavier than 8.5 lbs. to open and takes a minimum of 5 seconds to close or provide an automatic door opener at one of the doors.		Bob Byrne	\$50	2013	Adjusted opening force to 8 lbs./adjusted closing speed to 6 sec. 2/2013

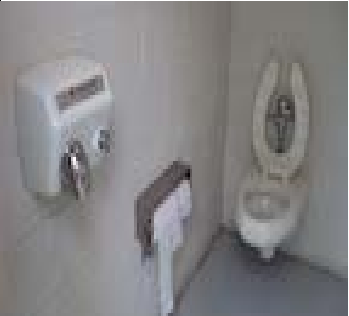
The men's restroom toilet does not provide grab bars.	ADAAG 604.5	Provide a rear grab bar a minimum of 36" long mounted 12" from the centerline of the toilet to the corner and 24" from the centerline to the open side of the toilet. Also, provide a side grab bar a minimum of 42" long and a maximum of 12" from the corner. Both grab bars should be mounted at 33" to 36" to the top of the grab bar.		Bob Byrne	\$500	2013	Installed grab bars per specs 3/2013

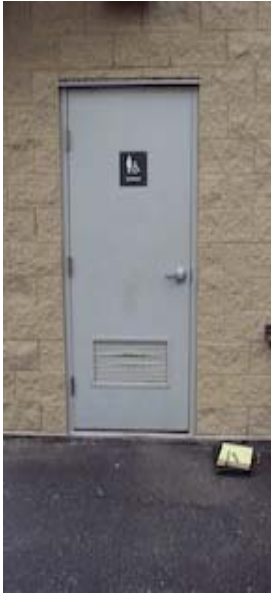
The sign for the women's restroom is mounted on the door.	ADAAG 216.2	The permanent room sign should to be mounted on the wall at the latch side of the door at 48" minimum from the baseline of the lowest tactile character to 60" maximum from the baseline of the highest character with raised lettering and numbers plus Braille.		Bob Byrne	\$50	2013	New sign mounted per specs 2/2013
	The door of the women's restroom has an opening force too high at 10 lbs. and closes too quickly at 3 seconds.	IAC 400.310(j)(10)(B)(i)	Adjust the closer so the door opening force is no heavier than 8.5 lbs. to open and takes a minimum of 5 seconds to close or provide an automatic door opener at one of the doors.		Bob Byrne	\$50	2013	Adjusted opening force to 8 lbs./adjusted closing speed to 6 sec. 2/2013

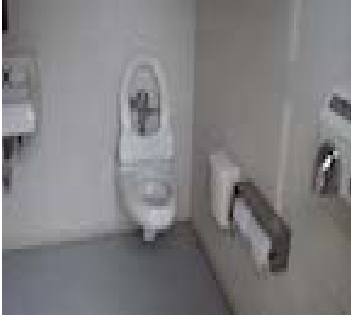
The women's restroom toilet does not provide grab bars.	ADAAG 604.5	Provide a rear grab bar a minimum of 36" long mounted 12" from the centerline of the toilet to the corner and 24" from the centerline to the open side of the toilet. Also, provide a side grab bar a minimum of 42" long and a maximum of 12" from the corner. Both grab bars should be mounted at 33" to 36" to the top of the grab bar.		Bob Byrne	\$425	2013	Installed grab bars per specs 3/2013

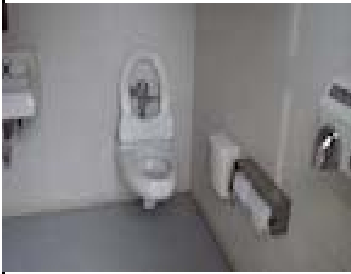
The toilet paper holder is mounted too far from the toilet at 12'.	ADAAG 604.7	Remount the toilet paper dispenser to be no lower than 15", no higher than 48" AFF and a minimum of 7" to a maximum of 9" in front of the toilet. Do not mount the toilet paper dispenser behind the side grab bar.		Bob Byrne	\$50	2013	Remounted dispenser to 9" on center from front of toilet 3/2013

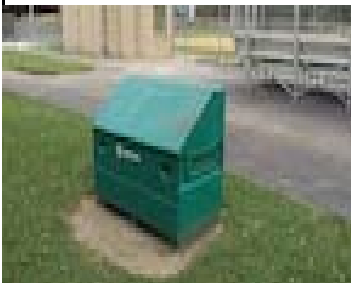
The equipment box is not on an accessible route for 13'.	ADAAG 403.3	Relocate the equipment box to an accessible route or provide a new accessible route with a running slope no steeper than 5% and a cross slope no steeper than 2% and a minimum clear width of 36".			\$425	2019

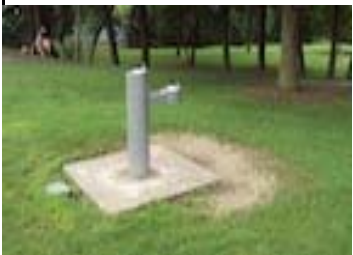
The drinking fountain wheel chair position is too low at 25 3/4" knee clearance.	ADAAG 211 & ADAAG 602	If possible, try to raise up this drinking fountain to provide the minimum 27" knee clearance under the wheelchair height drinking fountain. Otherwise, provide two individual drinking fountain or a single hi-lo drinking fountain that provides a wheelchair accessible fountain with a spout at 36" maximum and a standing drinking fountain with a height between 38" minimum and 43" maximum. The toe clearance should be a minimum of 9".			\$4,250	2019
