# Sugar Creek Golf Course

Sugar Creek Golf Course is the only golf course owned and operated by the park district. The main issues at this golf course are not having enough accessible parking, slopes being too steep, door force too high, mirrors mounted too high, coat hooks mounted too high, grab bars too high, ball washers not providing clear floor space, and not providing an accessible golf cart. **Please Note:** When a **UD** is indicated, this is a Universal Design (**UD**) recommendation to enhance accessibility. The **UD** recommendation is not required to meet the minimum accessibility standards but it would be encouraged.

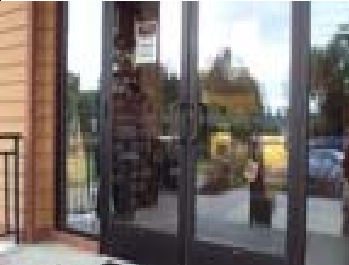
The north door into the clubhouse has an opening force too high at 15 lbs. force and the south door has an opening force too high at 10 lbs. force and closes too quickly at 4 seconds.	IAC 400.310(j)(10)(B)(i)	Adjust the closer so the door opening force is no heavier than 8.5 lbs. to open and takes a minimum of 5 seconds to close or provide an automatic door opener at one of the doors.	<b>1</b>		\$ 100.00	2018	Adjusted door opening force

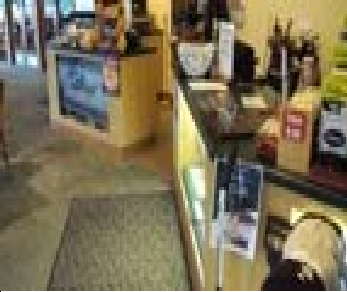
The service counter height is too high at 36 1/2".	IAC 400.320(h)(1)(A)	Provide a section of counter that is no higher than 34" and is at least 36" long. In alterations where it is technically infeasible to provide an accessible counter, an auxiliary counter meeting those requirements maybe provided.	<b>2</b>		\$ 600.00	2019	Install folding counter

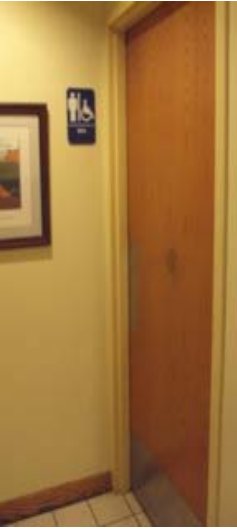
The sign for the men's restroom is mounted too high at 74 1/2" to and 64 1/2" bottom.	ADAAG 216.2	The permanent room sign should to be mounted on the wall at the latch side of the door at 48" minimum from the baseline of the lowest tactile character to 60" maximum from the baseline of the highest character with raised lettering and numbers plus Braille.	<b>4</b>		\$ 150.00	2018	Remount sign

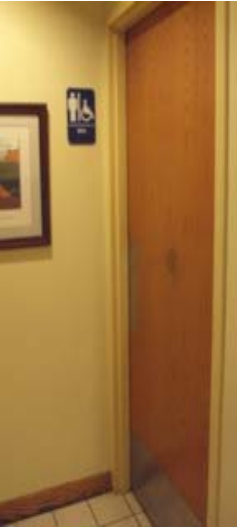
The men's restroom door has an opening force too high at 15 lbs. and closes too quickly at 4 seconds.	ADAAG 404.2.8 & ADAAG 404.2.9	Adjust the closer so the door opening force is no heavier than 5 lbs. to open and takes a minimum of 5 seconds to close or provide an automatic door opener at one of the doors.	<b>2</b>		\$ 100.00	2018	Remount sign

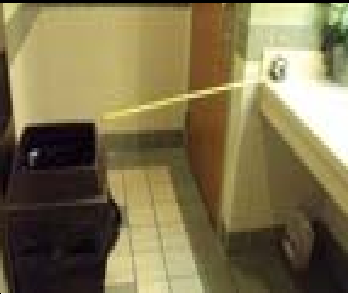
The location of the garbage can in the men's restroom narrows the route at the door down to 20 1/2".	ADAAG 606.2	Move the trash can to provide a clear accessible route that is 36" wide but can narrow down to 32" but for no more that 24". Train janitorial staff to keep trash cans out of the accessible route as a part of your policy and procedures.	<b>3</b>		<b>NA</b>		Cut hole in counter and place can under counter.

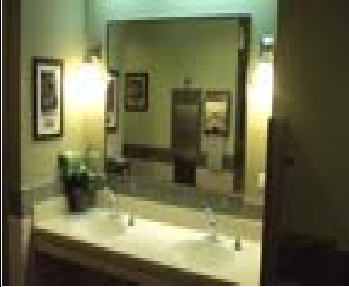
The men's restroom mirror is mounted too high at 42 1/2" to reflective surface.	ADAAG 603.3	Lower the mirror above the sink or countertop to be no higher than 40" to the reflective surface. Mirrors not mounted above the sink or a counter top should be mounted no higher than 35" to the reflective surface. <b>UD</b> - A full-length mirror would be a recommended option.	<b>4</b>		\$ 450.00	2019	Lower mirror to correct height

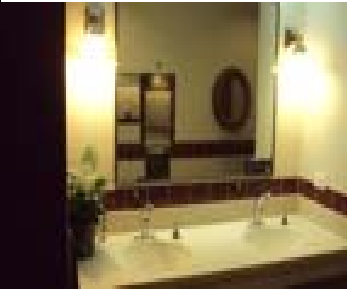
The women's restroom mirror is mounted too high at 43 1/2" to reflective surface.	ADAAG 603.3	Lower the mirror above the sink or countertop to be no higher than 40" to the reflective surface. Mirrors not mounted above the sink or a counter top should be mounted no higher than 35" to the reflective surface. <b>UD</b> - A full-length mirror would be a recommended option.	<b>4</b>		\$ 450.00	2019	Adjust mirror

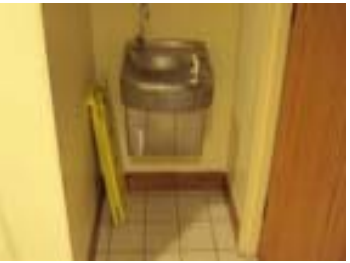
The drinking fountain at the restrooms provides a wheelchair height only.	ADAAG 211 & ADAAG 602	Provide two individual drinking fountain or a single hi-lo drinking fountain that provides a wheelchair accessible fountain with a spout at 36" maximum and a standing drinking fountain with a height between 38" minimum and 43" maximum. The toe clearance should be a minimum of 9".	<b>4</b>		\$ 4,250.00	2018	Place sign that water is available at front counter

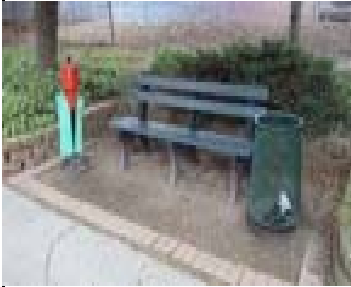
The bench does not provide a clear floor space next to it for a golf cart to pull along side.	<b>Proposed</b> Outdoor Areas Standards ADAAG 1011	<b>Bench Recommendation:</b> Provide at least 20% but no less than two benches to provide a clear ground space of at least 30" by 48" positioned near the bench with one side adjoining the walkway. The clear ground space should not overlap the accessible route or another clear ground space. <b>UD</b> - Provide benches with armrests and no gaps between the seat and backrest.	<b>2</b>		\$ 50.00	2020

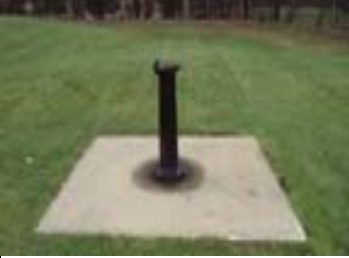
The drinking fountain at the 7th hole is not of an accessible design and is located in the grass.	ADAAG 211 & ADAAG 602	Provide two individual drinking fountain or a single hi-lo drinking fountain that provides a wheelchair accessible fountain with a spout at 36" maximum and a standing drinking fountain with a height between 38" minimum and 43" maximum. The toe clearance should be a minimum of 9".	<b>4</b>		\$ 4,250.00	2015	Fountain was removed April 2015 Water coolers replaced fountain.

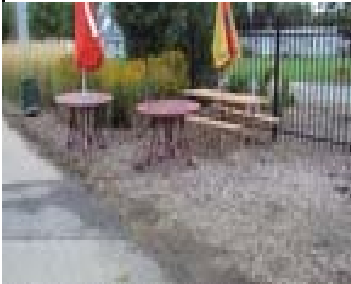
One picnic table and two regular tables are provided but none are of an accessible design.	<b>Proposed</b> Outdoor Developed Areas Guidelines ADAAG 245 & 1011	<b>Picnic Table Recommendation:</b> At least 20% of picnic tables, but no less than two, be of accessible design, connected to an accessible route. Relocate or purchase two accessible picnic tables (\$750/each) and locate them on an accessible surface (\$900).	<b>2</b>		\$ 3,300.00	2021
