Van Voorst Park

Van Voorst Park is a small neighborhood park that provides picnic table, grill and ballfield. The main issues at this park are slopes too steep, protruding branches, no accessible routes to player bench and entrance to the field, no companion seating at bleachers and bench, no accessible surface at grill and only one grill and one accessible picnic table provided. **Please Note:** When a **UD** is indicated, this is a Universal Design (**UD**) recommendation to enhance accessibility. The **UD** recommendation is not required to meet the minimum accessibility standards but it would be encouraged.

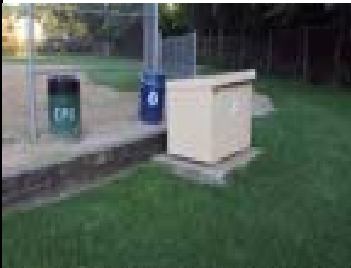
No accessible route to trash cans or equipment box for 25'.	ADAAG 403.3	Provide a new accessible route with a running slope no steeper than 5% and a cross slope no steeper than 2% and a minimum clear width of 36". Move trash cans or turn equipment box around to be on the accessible route.			\$825	2024

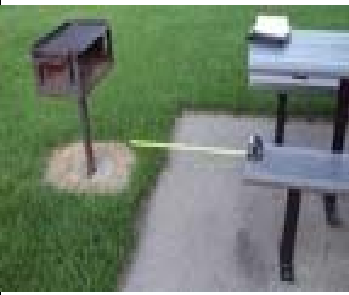
Only one accessible picnic table is provided.	<p>Proposed Outdoor Developed Areas Guidelines ADAAG 245 & 1011</p>	<p>Picnic Table Recommendation: At least 20% of picnic tables, but no less than two, be of accessible design, connected to an accessible route. Relocate or purchase one more accessible picnic tables and locate it on an accessible surface.</p>			\$1,650	2024	
	The spacing to the accessible side of the picnic table is too narrow at 28".	ADAAG 403.3	When the surface for the grill is provided a 36" minimum space should be provided. However, the location of the accessible space would put the person very near the grill when seating at the table. Consider turning the picnic table so the accessible wheelchair space is away from the grill.			\$250	2024

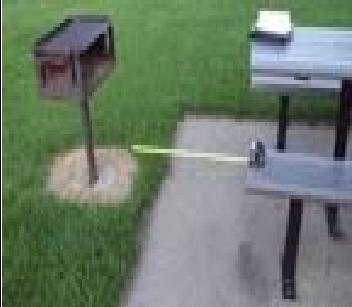
<p>Grill does not provide an accessible surface around it. And only one grill is provided.</p>	<p>Proposed Outdoor Developed Areas Guidelines ADAAG 1011.5</p>	<p>Grill Recommendation: Follow Outdoor Developed Area Report that states 20% of grills, but at least two, be of accessible design, and connected to an accessible route. The accessible grill should provide a cooking surface a minimum of 15" to 34" maximum AFF above the ground surface, a clear floor space and controls that are within a maximum reach range of 48" AFF. And a 48" by 48" space centered on the usable sides of the grill is required.</p>			<p>\$250</p>	<p>2024</p>
