Washington Park

Washington Park is a medium/large neighborhood park that provides parking, a playground, barrier and walkways. The main issues at this park are slopes being too steep, no accessible picnic tables, no accessible benches and protruding branches. **Please Note:** When a **UD** is indicated, this is a Universal Design (**UD**) recommendation to enhance accessibility. The **UD** recommendation is not required to meet the minimum accessibility standards but it would be encouraged.

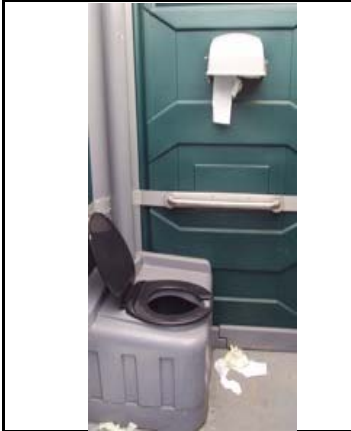
The portable toilet provided has a toilet paper dispenser mounted to high at 55 1/2" AFF.	ADAAG 308	mount the toilet paper dispenser behind the side grab bar. The hand sanitizer should be provided in a reach range no higher than 48" AFF for a forward reach over an obstruction no deeper than 20" or a side reach of 48" AFF over an object no deeper than 10". Provide a rear grab bar a minimum of 36" long mounted 12"			NA	2012	As Part of porta potty contract all rent facilities meet the standards. 4/2012

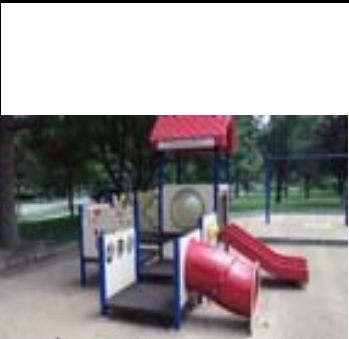
No ramp or transfer platform is provided to the eight elevated play components at the 2 to 5 year old playground	ADAAG 240.2.2 & ADAAG 1008.4	Provide a ramp or transfer platform system to at least four elevated play components. If a transfer platform or ramp system can not be installed consider replacing this playground.			\$1,900	2013	Playground and surfacing replaced as part of Capital plan \$167,000

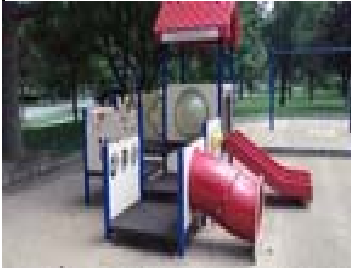
There are presently no ground level play components connected with the 2 to 5 year old playground.	ADAAG 240.2.2 & ADAAG 1008.4	If 50% of the elevated play components are connect to an accessible route and three are different types of play components then ground level play components will not be required. If a transfer system is unused then at least three ground level play components of different types must be provided. If a transfer platform or ramp system can not be installed consider replacing this playground.			\$1,900	2013	Playground and surfacing replaced as part of Capital plan \$167,000

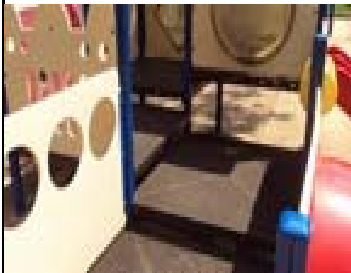
Four 3" gaps are provided on the 2 to 5 year old playground.	ADAAG 1008.3.2	If a transfer system is installed, then provide a solid piece of material that can go the full length of the steps to prevent a foot or hand from going through. If a ramping system is installed then disregard.			\$800	2013	Playground and surfacing replaced as part of Capital plan \$167,000

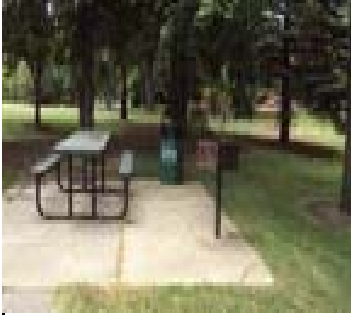
A picnic area with a grill is provided but there is only one accessible grill.	<p><u>Proposed</u> Outdoor Developed Areas Guidelines ADAAG 1011.5</p>	<p>Grill Recommendation: Follow Outdoor Developed Area Report that states 20% of grills, but at least two, be of accessible design, and connected to an accessible route. In this case provide one more accessible grill. The accessible grill should provide a cooking surface a minimum of 15" to 34" maximum AFF above the ground surface, a clear floor space and controls that are within a maximum reach range of 48" AFF. And a 48" by 48" space centered on the usable sides of the grill is required.</p>					Do not need two grills

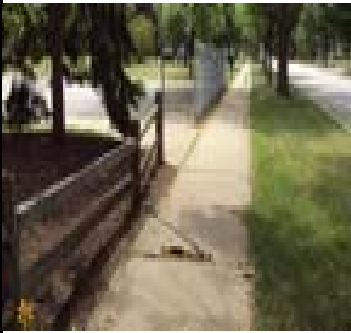
The sidewalk between the playground and basketball court has a cross slope too steep including some broken sidewalk that has a cross slope too steep at 2.6% to 3.7% for 26'.	ADAAG 403.3	Attempt a "mud jacking" technique or remove and regrade section to provide a cross slope no greater than 2%. Replace the broken sidewalk sections.			\$1,560		Staff will work with City as part of sidewalk replace program

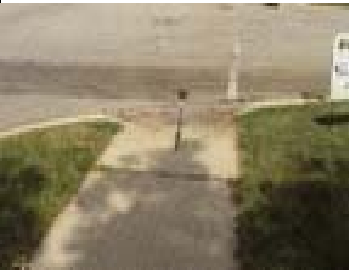
The northwest corner north curb ramp does not provide truncated domes.	ADAAG 705	Provide truncated domes that go the width of the sidewalk and 24" deep where it meets the road. Provide a color that contrast with the walkway surface. Truncated dome tiles are typically a more durable solution.			\$500		Staff will work with City as part of sidewalk replace program

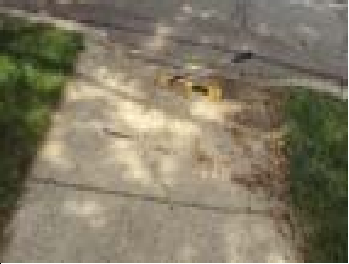
The west curb ramp does not provide truncated domes.	ADAAG 705	Provide truncated domes that go the width of the sidewalk and 24" deep where it meets the road. Provide a color that contrast with the walkway surface. Truncated dome tiles are typically a more durable solution.			\$500		Staff will work with City as part of sidewalk replace program

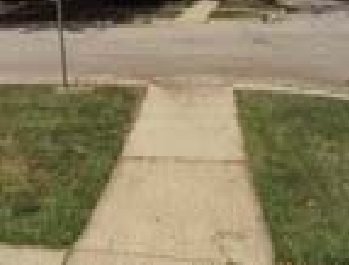
The northeast corner north curb ramp does not provide truncated domes.	ADAAG 705	Provide truncated domes that go the width of the sidewalk and 24" deep where it meets the road. Provide a color that contrast with the walkway surface. Truncated dome tiles are typically a more durable solution.			\$500		Staff will work with City as part of sidewalk replace program

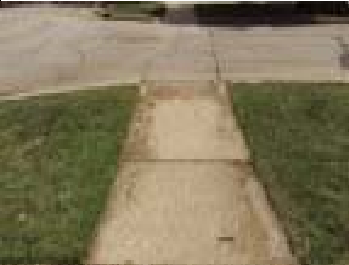
The northeast corner east curb ramp does not provide truncated domes.	ADAAG 705	Provide truncated domes that go the width of the sidewalk and 24" deep where it meets the road. Provide a color that contrast with the walkway surface. Truncated dome tiles are typically a more durable solution.			\$500		Staff will work with City as part of sidewalk replace program

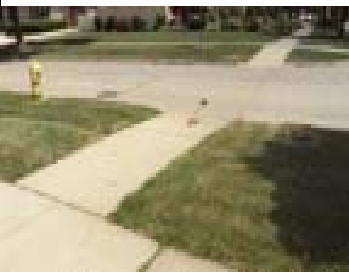
The east sidewalk northeast middle curb ramp does not have truncated domes.	ADAAG 705	Provide truncated domes that go the width of the sidewalk and 24" deep where it meets the road. Provide a color that contrast with the walkway surface. Truncated dome tiles are typically a more durable solution.			\$500		Staff will work with City as part of sidewalk replace program

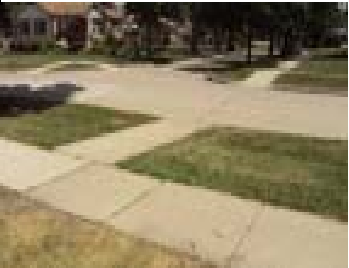
The east sidewalk southeast middle curb ramp does not provide truncated domes.	ADAAG 705	Provide truncated domes that go the width of the sidewalk and 24" deep where it meets the road. Provide a color that contrast with the walkway surface. Truncated dome tiles are typically a more durable solution.			\$500		Staff will work with City as part of sidewalk replace program
