Wild Meadows Trace Park

Wild Meadows Trace Park is natural area along the Prairie Path. The main issues at this park are curb ramps, truncated domes, slopes, benches with companion seating and an accessible surface. **Please Note:** When a **UD** is indicated, this is a Universal Design (**UD**) recommendation to enhance accessibility. The **UD** recommendation is not required to meet the minimum accessibility standards but it would be encouraged.

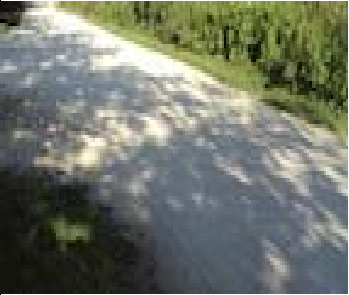
The trail is limestone standards that appears to not provide the proper mix of aggregate and limestone dust.	<u>Proposed</u> Outdoor Areas Standards ADAAG 1017	Trail Recommendation: When upgrading the trail surface, provide a surface material such as a 3/4" minus limestone with a 50% mix of dust that is firm and stable with a slope no steeper than 2% for a cross slope and no steeper than 5% for a running slope. Provide this surface at the benches, trash cans and signs along the way.			NA	2020

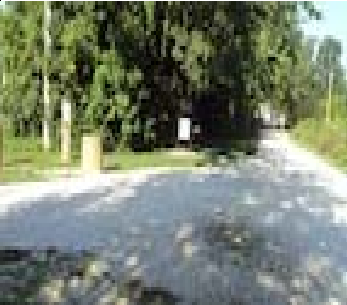
The bench at the Westside of the trail is not on an accessible route or provide companion seating.	<u>Proposed</u> Outdoor Areas Standards ADAAG 1011	<p>Bench Recommendation: Provide at least 20% but no less than two benches to provide a clear ground space of at least 30" by 48" positioned near the bench with one side adjoining the walkway. The clear ground space should not overlap the accessible route or another clear ground space. UD - Provide benches with armrests and no gaps between the seat and backrest.</p>			\$500	2022

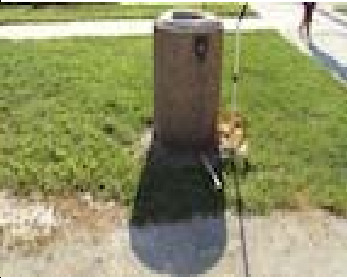
No accessible route is provided to the trash can.	<u>Proposed</u> Outdoor Developed Areas Guidelines 1011	<p>Trash Can Recommendation: Locate trash cans on an accessible route as part of your regular policy. For a forward approach provide a trash can within 24" and a minimum clear ground space of 36" by 48" or for a side approach provide a trash can within 24" and a minimum clear ground space of 30" by 60".</p>			\$50	2019

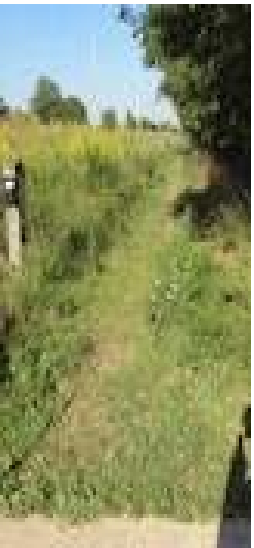
No accessible route to Shooting Star Trail brochure holder for 11'.	ADAAG 403.3	Relocate the brochure holder to an accessible route or provide a new accessible route with a running slope no steeper than 5% and a cross slope no steeper than 2% and a minimum clear width of 36".			\$375	2022	
	The Shooting Stair Trail is a natural trail that does not provide an accessible material.	<u>Proposed</u> Outdoor Areas Standards ADAAG 1017	Trail Recommendation: In this is a formal trail, when upgrading the trail surface, provide a surface material such as a 3/4" minus limestone with a 50% mix of dust that is firm and stable with a slope no steeper than 2% for a cross slope and no steeper than 5% for a running slope. Provide this surface at the benches, trash cans and signs along the way.			\$2,000	2022

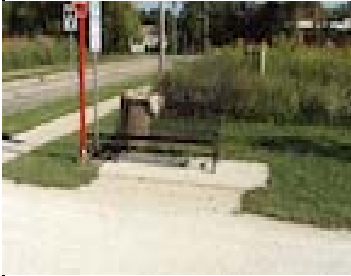
The trash can is located in the grass.	<u>Proposed</u> Outdoor Developed Areas Guidelines 1011	Trash Can Recommendation: Locate trash cans on an accessible route as part of your regular policy. For a forward approach provide a trash can within 24" and a minimum clear ground space of 36" by 48" or for a side approach provide a trash can within 24" and a minimum clear ground space of 30" by 60".			\$50	2019

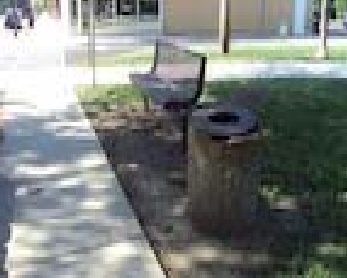
<p>The bench at the Spring Road southwest corner does not provide companion seating.</p>	<p>Proposed Outdoor Areas Standards ADAAG 1011</p>	<p>Bench Recommendation: One other accessible bench is provided at this area. At this bench, provide a clear ground space of at least 30" by 48" positioned near the bench with one side adjoining the walkway and a slope no steeper than 2% in all directions. The clear ground space should not overlap the accessible route or another clear ground space. UD - Provide benches with armrests and no gaps between the seat and backrest.</p>			\$250	2019

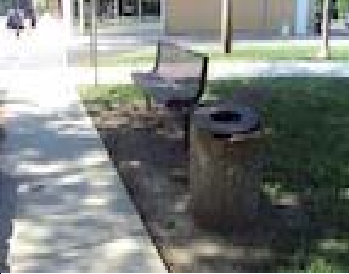
The trash can on Spring Road is located 28" off the sidewalk.	Proposed Outdoor Developed Areas Guidelines 1011	Trash Can Recommendation: Locate trash cans on an accessible route as part of your regular policy. For a forward approach provide a trash can within 24" and a minimum clear ground space of 36" by 48" or for a side approach provide a trash can within 24" and a minimum clear ground space of 30" by 60".			\$50	2019

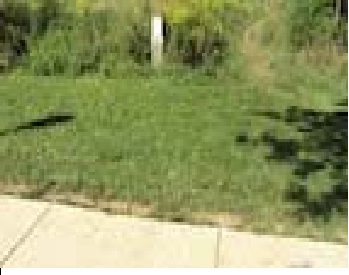
No access to brochure holder on Spring Road for 21'.	ADAAG 403.3	Relocate the brochure holder to an accessible route or provide a new accessible route with a running slope no steeper than 5% and a cross slope no steeper than 2% and a minimum clear width of 36".			\$700	2019

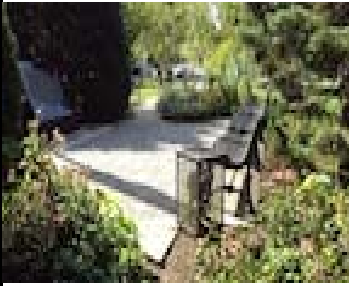
Five benches are provided at the 9/11 Memorial but none of them have companion seating.	<u>Proposed</u> Outdoor Areas Standards ADAAG 1011	Bench Recommendation: Provide at least 20% but no less than two benches to provide a clear ground space of at least 30" by 48" positioned near the bench with one side adjoining the walkway and a slope no steeper than 2% in all directions. The clear ground space should not overlap the accessible route or another clear ground space. UD - Provide benches with armrests and no gaps between the seat and backrest.			\$500	2022

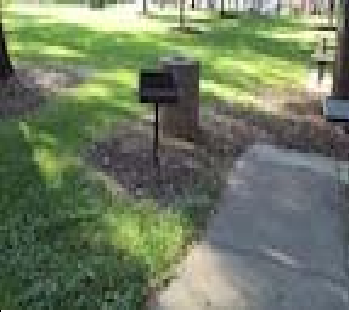
<p>No accessible surface is provided at the grill for 6'.</p>	<p>Proposed Outdoor Developed Areas Guidelines ADAAG 1011.5</p>	<p>Grill Recommendation: Follow Outdoor Developed Area Report that states 20% of grills, but at least two, be of accessible design, and connected to an accessible route. The accessible grill should provide a cooking surface a minimum of 15" to 34" maximum AFF above the ground surface, a clear floor space and controls that are within a maximum reach range of 48" AFF. And a 48" by 48" space centered on the usable sides of the grill is required.</p>			\$50	2019

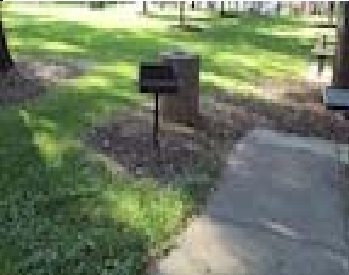
Trash can is located too far off the accessible route for 42".	<u>Proposed</u> Outdoor Developed Areas Guidelines 1011	Trash Can Recommendation: Locate trash cans on an accessible route as part of your regular policy. For a forward approach provide a trash can within 24" and a minimum clear ground space of 36" by 48" or for a side approach provide a trash can within 24" and a minimum clear ground space of 30" by 60".			\$50	2019

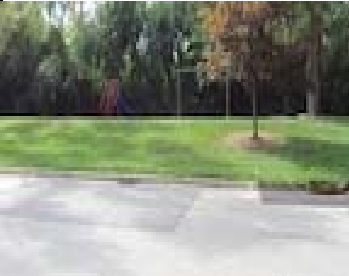
A trash can is provided at the playground but it is not on an accessible route.	Proposed Outdoor Developed Areas Guidelines 1011	Trash Can Recommendation: Locate trash cans on an accessible route as part of your regular policy. For a forward approach provide a trash can within 24" and a minimum clear ground space of 36" by 48" or for a side approach provide a trash can within 24" and a minimum clear ground space of 30" by 60".			\$50	2019	Recommend removal

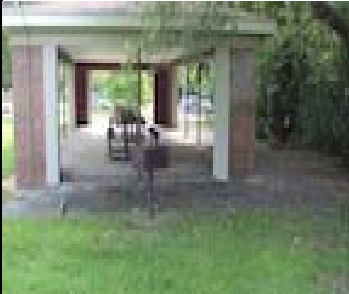
The route from York Road to the picnic shelter is very uneven and has a cross slope too steep at 2.6% to 8.0% for 102'. And has abrupt transition at the shelter between 3/4" to 1 1/2".	ADAAG 403.3	Attempt a "mud jacking" technique or remove and regrade section to provide a cross slope no greater than 2%.			\$6,215	2019	Recommend removal

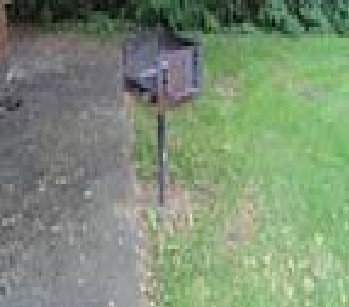
The grill at the picnic shelter does not provide accessible spacing around it.	<u>Proposed</u> Outdoor Developed Areas Guidelines ADAAG 1011.5	Grill Recommendation: Follow Outdoor Developed Area Report that states 20% of grills, but at least two, be of accessible design, and connected to an accessible route. The accessible grill should provide a cooking surface a minimum of 15" to 34" maximum AFF above the ground surface, a clear floor space and controls that are within a maximum reach range of 48" AFF. And a 48" by 48" space centered on the usable sides of the grill is required.			\$400	2019	Recommend removal

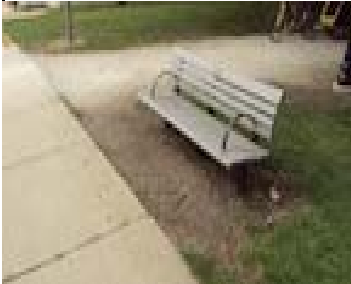
The bench at the shelter does not provide companion seating.	<u>Proposed</u> Outdoor Areas Standards ADAAG 1011	Bench Recommendation: Provide at least 20% but no less than two benches to provide a clear ground space of at least 30" by 48" positioned near the bench with one side adjoining the walkway. The clear ground space should not overlap the accessible route or another clear ground space. UD - Provide benches with armrests and no gaps between the seat and backrest.			\$250	2020

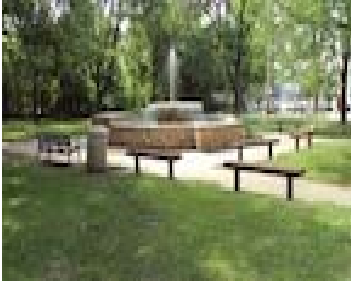
<p>There are 9 benches provided around the fountain but none provide companion seating.</p>	<p>Proposed Outdoor Areas Standards ADAAG 1011</p>	<p>Bench Recommendation: Provide at least 20% but no less than two benches to provide a clear ground space of at least 30" by 48" positioned near the bench with one side adjoining the walkway and a slope no steeper than 2% in all directions. The clear ground space should not overlap the accessible route or another clear ground space. UD - Provide benches with armrests and no gaps between the seat and backrest.</p>			\$500	2018 capital plan	Benches will be replaced and will add companion seating 3/2018 \$15,000

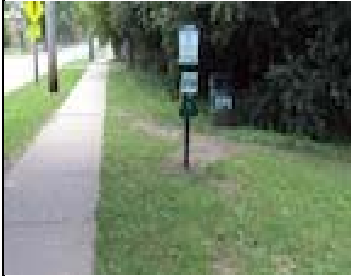
The trash can is located 10' off the accessible route.	<u>Proposed</u> Outdoor Developed Areas Guidelines 1011	Trash Can Recommendation: Locate trash cans on an accessible route as part of your regular policy. For a forward approach provide a trash can within 24" and a minimum clear ground space of 36" by 48" or for a side approach provide a trash can within 24" and a minimum clear ground space of 30" by 60".			\$50	2012	Moved closer to sidewalk

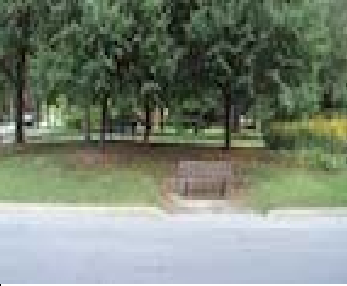
Two benches are provided but only one provides spacing for companion seating.	<u>Proposed</u> Outdoor Areas Standards ADAAG 1011	<p>Bench Recommendation: Provide at least 20% but no less than two benches to provide a clear ground space of at least 30" by 48" positioned near the bench with one side adjoining the walkway. The clear ground space should not overlap the accessible route or another clear ground space. UD - Provide benches with armrests and no gaps between the seat and backrest.</p>			\$250	2019	Recommended removing bench

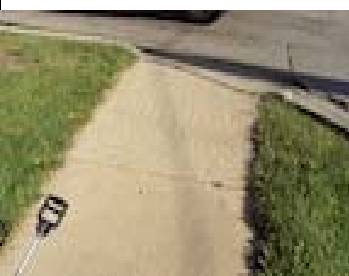
The west sidewalk northwest curb ramp at Berkley Avenue does not provide truncated domes.	ADAAG 705	Provide truncated domes that go the width of the sidewalk and 24" deep where it meets the road. Provide a color that contrast with the walkway surface. Truncated dome tiles are typically a more durable solution.					Replaced by the City 2014

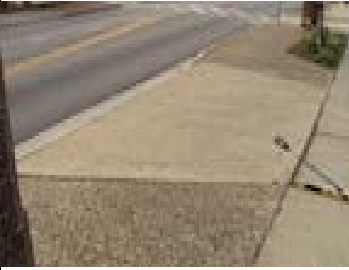
A drive is provide to the street but it does not provide truncated domes.	ADAAG 705	Provide truncated domes that go the width of the sidewalk and 24" deep where it meets the road. Provide a color that contrast with the walkway surface. Truncated dome tiles are typically a more durable solution.			\$500		Work with City's replacement schedule

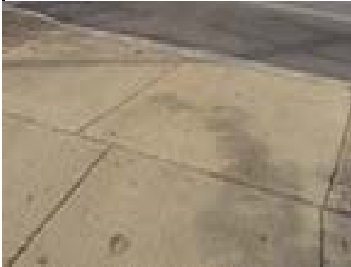
A driveway type of curb is provided on the east side of York Road but it does not provide truncated domes.	ADAAG 705	Provide truncated domes that go the width of the sidewalk and 24" deep where it meets the road. Provide a color that contrast with the walkway surface. Truncated dome tiles are typically a more durable solution.			\$500	City Replaced

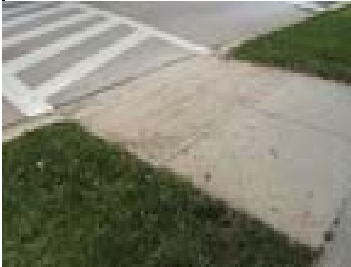
The curb ramp at Poplar Avenue does not provide truncated domes.	ADAAG 705	Provide truncated domes that go the width of the sidewalk and 24" deep where it meets the road. Provide a color that contrast with the walkway surface. Truncated dome tiles are typically a more durable solution.			\$500		Work with City's replacement schedule

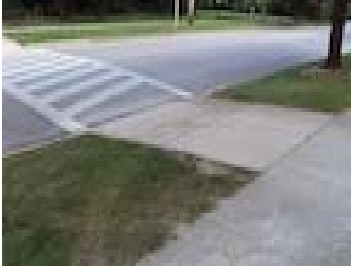
The curb ramp on the east side of Poplar Avenue does not provide truncated domes.	ADAAG 705	Provide truncated domes that go the width of the sidewalk and 24" deep where it meets the road. Provide a color that contrast with the walkway surface. Truncated dome tiles are typically a more durable solution.			\$500		Work with City's replacement schedule
