Wilder Park

Wilder Park is very large park that is centrally located in the downtown area and provides elements and programs including parking, gardens, Conservatory, a mansion, the main administration building, playground, preschool program, picnic tables and grills. The main issues at this park are slopes too steep, reach ranges too high, proper picnic table designs, protruding branches, accessible routes, and door forces. **Please Note:** When a **UD** is indicated, this is a Universal Design (**UD**) recommendation to enhance accessibility. The **UD** recommendation is not required to meet the minimum accessibility standards but it would be encouraged.

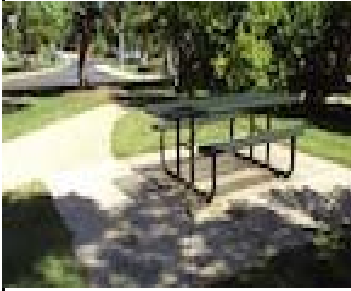
There is one accessible picnic table provided near the conservatory.	Proposed Outdoor Developed Areas Guidelines ADAAG 245 & 1011	Picnic Table Recommendation: At least 20% of picnic tables, but no less than two, be of accessible design, connected to an accessible route. Relocate or purchase one more accessible picnic tables and locate it on an accessible surface.			\$1,650	2022

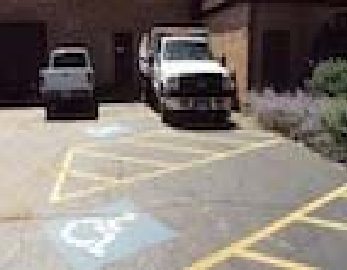
<p>The Administration Parking lot has 2 accessible spaces but at the time of the survey a staff truck was parked in one of the accessible parking spaces.</p>	<p>IAC 400.310(c)(7)</p>	<p>If this is required for staff vehicles, then mark out the old striping on the old accessible parking space, restripe the new parking space with an access aisle at least 96" and remove and remount the accessible parking space at the head of the new accessible parking space. Relocate the new accessible parking space across from the entrance to the Administration Building.</p>			\$850	2014	Moved parking spots in 2014

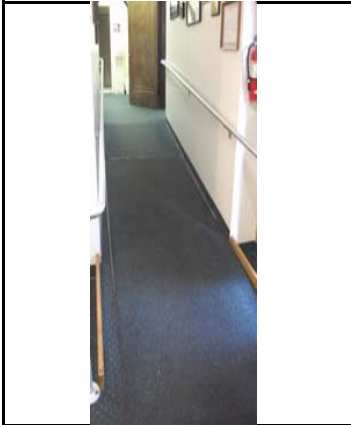
The ramp to the board room and restroom is too steep at 8.1 % to 10.4%.	ADAAG 405.8	Because of the limited space in this area when updating the ramp reduce the slope to the greatest extent possible. Try to provide a new ramp with a running slope no steeper than 8.3%, a cross slope no steeper than 2% and keep the handrails on both sides.			\$1,000	2019

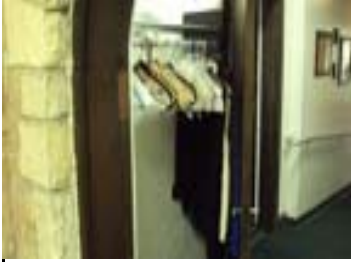
All coat hangers are at 54".	ADAAG 222.1 & ADAAG 308	Provide 5% of the coat hangers at a reach range no higher than 48" AFF for a forward reach over an obstruction no deeper than 20" or a side reach of 48" AFF over an object no deeper than 10". Consider adding additional cloths hooks at the lower height.			\$200	2018

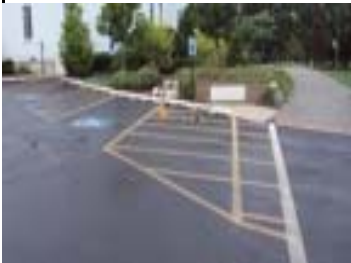
<p>Three accessible parking spaces at the Museum are provided but all have slopes issues such as running slopes too steep at 3.2% to 8.4% and cross slopes too steep at 2.7% to 2.9%.</p>	<p>IAC 400.310(c)</p>	<p>The parking lot has only 12 parking spaces so it requires only one accessible parking space. Mark out the present three accessible parking space and provide one accessible parking space across from the south walkway to the Mansion with an access aisle a minimum of 96" plus a sign with the International Symbol of Accessibility and a fine sign of \$250 at the head of the parking space. The parking space and access aisle should be no steeper than 2% in all directions.</p>			<p>\$500</p>	<p>2024</p>

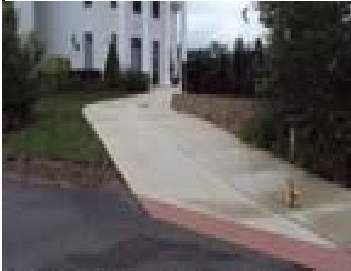
The north ramp has a cross slope too steep at 2.6% to 4.6% for 33'.	ADAAG 403.3	Consider the south ramp as the main accessible route. When updating the north ramp attempt a "mud jacking" technique or remove and regrade section to provide a cross slope no greater than 2%.			NA		Use South ramp as recommended

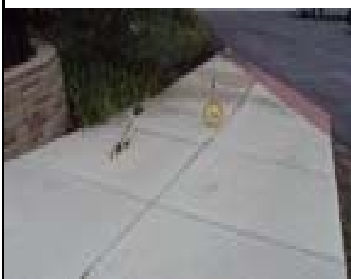
The north ramp near the parking lot has a running slope too steep at 8.8% to 9.2% for 10'.	ADAAG 403.3	Consider the south ramp as the main accessible route. Remove and regrade section to provide an accessible route with a running slope no greater than 5% and an cross slope no greater than 2%.			NA		Use South ramp as recommended

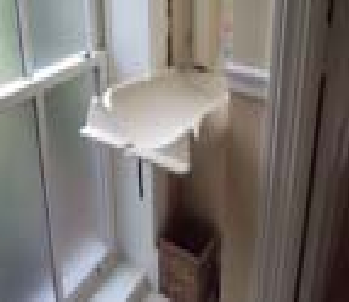
The baby changing table in the women's northwest restroom is mounted too high at 37" AFF to surface and 58" AFF to handle and is not accessible being located in an alcove.	IAC 400.320(w)	Replace or remount the baby changing table to be no higher than 34" AFF and provide a minimum knee clearance of 27". Also mount it so the handle is no higher than 48" AFF. Mount the baby changing table to a location that provides a clear floor space that complies with ADAAG 305.			\$250	2018	remounted baby changing station 6/2018

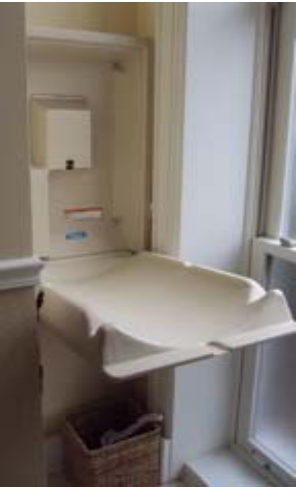
<p>The baby changing table in the northwest men's restroom is mounted too high at 36" AFF to surface and 58" AFF to handle and is not accessible being located in an alcove.</p>	<p>IAC 400.320(w)</p>	<p>Replace or remount the baby changing table to be no higher than 34" AFF and provide a minimum knee clearance of 27". Also mount it so the handle is no higher than 48" AFF. Mount the baby changing table to a location that provides a clear floor space that complies with ADAAG 305.</p>			\$250	2018	<p>Remounted baby changing station 6/2018</p>

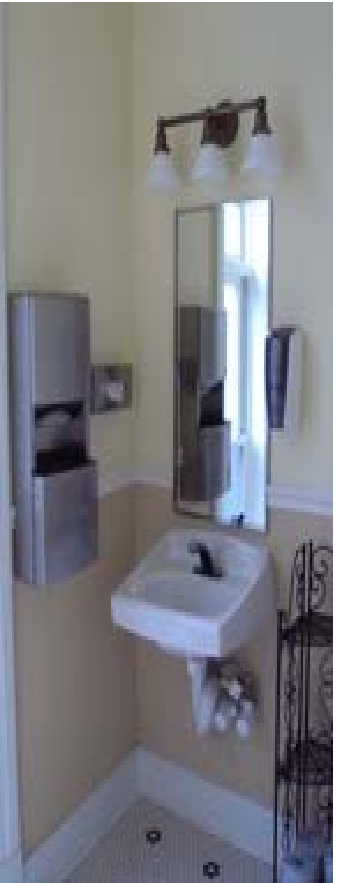
The soap dispenser in the northwest men's restroom is mounted too high at 51" AFF.	ADAAG 308	Remount the soap dispenser to provide a reach range no higher than 48" AFF for a forward reach over an obstruction no deeper than 20" or a side reach of 48" AFF over an object no deeper than 10".			\$50	2018	Remounted soap dispenser 6/2018
	The tissue dispenser in the northwest men's restroom is mounted too high at 53 1/2" AFF.	ADAAG 308	Remount the tissue dispenser to provide a reach range no higher than 48" AFF for a forward reach over an obstruction no deeper than 20" or a side reach of 48" AFF over an object no deeper than 10".			\$100	2018	Remounted tissue dispenser 6/2018
	The paper towel dispenser in the northwest men's restroom is mounted too high at 52" AFF.	ADAAG 308	Remount the paper towel dispenser to provide a reach range no higher than 48" AFF for a forward reach over an obstruction no deeper than 20" or a side reach of 48" AFF over an object no deeper than 10".			\$100	2018	Remounted paper towel dispenser 6/2018

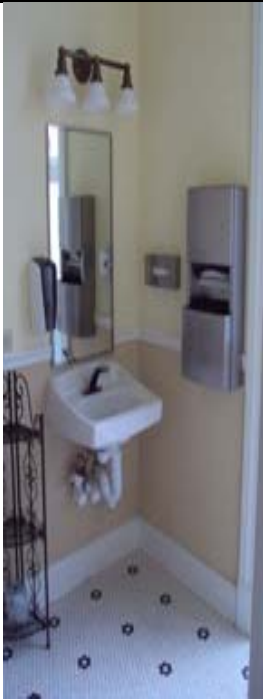
<p>The tissue dispenser in the southwest women's restroom is mounted too high at 51 1/2" AFF.</p>	ADAAG 308	<p>Remount the tissue dispenser to provide a reach range no higher than 48" AFF for a forward reach over an obstruction no deeper than 20" or a side reach of 48" AFF over an object no deeper than 10".</p>			\$100	2018	<p>Remounted tissue dispenser 6/2018</p>
	<p>The paper towel dispenser in the southwest women's restroom is mounted too high at 52" AFF.</p>	ADAAG 308	<p>Remount the paper towel dispenser to provide a reach range no higher than 48" AFF for a forward reach over an obstruction no deeper than 20" or a side reach of 48" AFF over an object no deeper than 10".</p>			\$100	2018	<p>Remounted paper towel dispenser 6/2018</p>

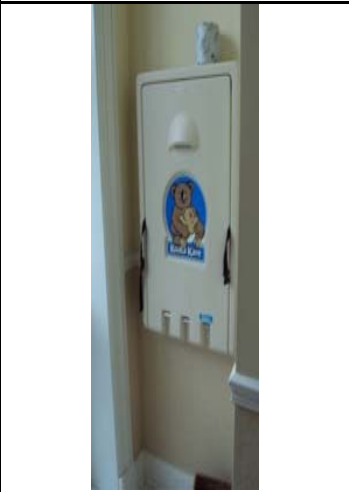
<p>The baby changing table in the southwest women's restroom is mounted too high at 37 1/2" AFF to the surface and 58" AFF to handle and is not accessible being located in an alcove.</p>	<p>IAC 400.320(w)</p>	<p>Replace or remount the baby changing table to be no higher than 34" AFF and provide a minimum knee clearance of 27". Also mount it so the handle is no higher than 48" AFF. Mount the baby changing table to a location that provide a clear floor space that complies with ADAAG 305.</p>			<p>\$250</p>	<p>2018</p>	<p>remounted baby changing station 6/2018</p>

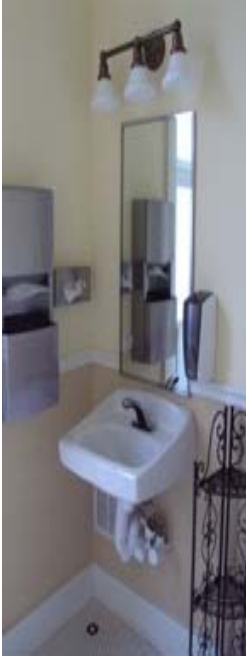
The tissue dispenser in the southwest men's restroom is mounted too high at 51" AFF.	ADAAG 308	Remount the tissue dispenser to provide a reach range no higher than 48" AFF for a forward reach over an obstruction no deeper than 20" or a side reach of 48" AFF over an object no deeper than 10".			\$50	2018	Remounted tissue dispenser 6/2018
	The paper towel dispenser in the southwest men's restroom is mounted too high at 52" AFF.	ADAAG 308	Remount the paper towel dispenser to provide a reach range no higher than 48" AFF for a forward reach over an obstruction no deeper than 20" or a side reach of 48" AFF over an object no deeper than 10".			\$100	2018	Remounted paper towel dispenser 6/2018

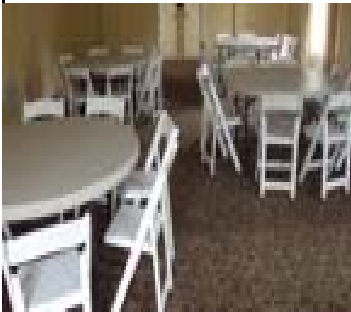
The tables set up for the wedding dinner has knee spaces of 26 1/2".	ADAAG 226 & ADAAG 902	Provide at least 5% of the tables but not less than one, with a minimum knee clearance or 27" AFF, 17" to 25" knee and toe clearance and located on the shortest accessible route. UD - Purchase only tables that provide the proper accessibility dimensions.			\$750	2023

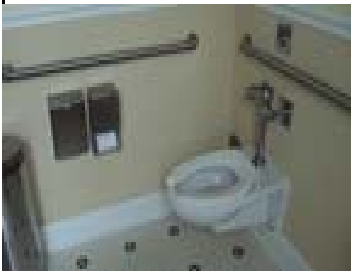
The toilet paper holder in the 2nd floor northwest women's restroom is mounted too far from the toilet at 10 1/2".	ADAAG 604.7	Remount the toilet paper dispenser to be no lower than 15", no higher than 48" AFF and a minimum of 7" to a maximum of 9" in front of the toilet. Do not mount the toilet paper dispenser behind the side grab bar.			\$100	2018	Remount toilet paper holder 6/2018

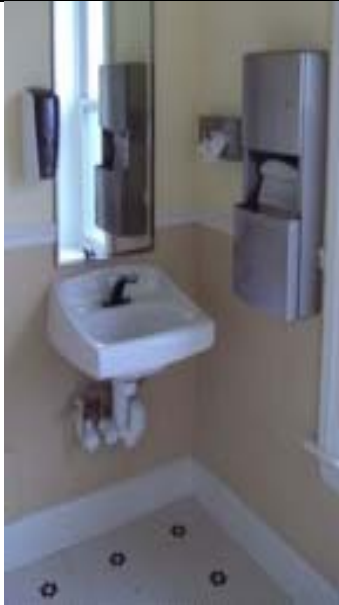
<p>The tissue dispenser in the 2nd floor northwest women's restroom is mounted too high at 53 1/2" AFF.</p>	ADAAG 308	<p>Remount the tissue dispenser to provide a reach range no higher than 48" AFF for a forward reach over an obstruction no deeper than 20" or a side reach of 48" AFF over an object no deeper than 10".</p>			\$50	2018	<p>Remount tissue dispenser 6/2018</p>
	<p>The paper towel dispenser in the 2nd floor northwest women's restroom is mounted too high at 52" AFF.</p>	ADAAG 308	<p>Remount the paper towel dispenser to provide a reach range no higher than 48" AFF for a forward reach over an obstruction no deeper than 20" or a side reach of 48" AFF over an object no deeper than 10".</p>			\$100	2018	<p>Remount paper towel dispenser 6/2018</p>

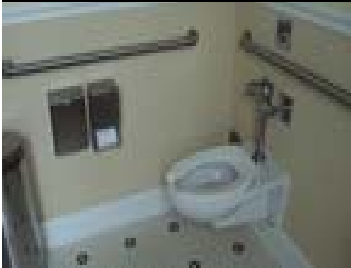
The toilet paper dispenser is mounted too far in front of the toilet at 10 1/2".	ADAAG 604.7	Remount the toilet paper dispenser to be no lower than 15", no higher than 48" AFF and a minimum of 7" to a maximum of 9" in front of the toilet. Do not mount the toilet paper dispenser behind the side grab bar.			\$50	2018	Remount toilet paper holder 6/2018

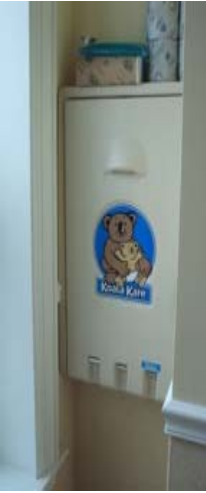
The baby changing table in the 2nd floor northwest women's restroom is mounted too high at 37 1/4" AFF to surface and 58" AFF to handle and is not accessible being located in an alcove.	IAC 400.320(w)	Replace or remount the baby changing table to be no higher than 34" AFF and provide a minimum knee clearance of 27". Also mount it so the handle is no higher than 48" AFF. Mount the baby changing table to a location that provide a clear floor space that complies with ADAAG 305.			\$250	2018	Remount baby changing station 6/2018

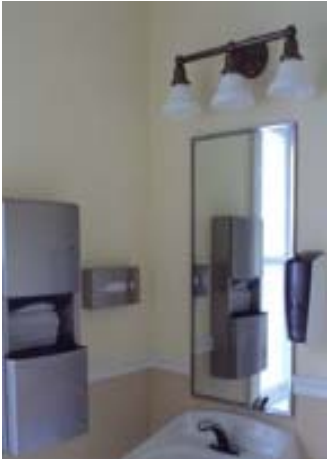
The soap dispenser in the 2nd floor northwest men's restroom is mounted too high at 50" AFF.	ADAAG 308	Remount the soap dispenser to provide a reach range no higher than 48" AFF for a forward reach over an obstruction no deeper than 20" or a side reach of 48" AFF over an object no deeper than 10"			\$50

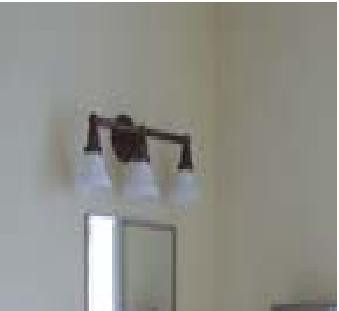
The soap dispenser in the 2nd floor southwest women's restroom is mounted too high at 50 1/2" AFF.	ADAAG 308	Remount the soap dispenser to provide a reach range no higher than 48" AFF for a forward reach over an obstruction no deeper than 20" or a side reach of 48" AFF over an object no deeper than 10".			\$100	2018	Remount soap dispenser 6/2018

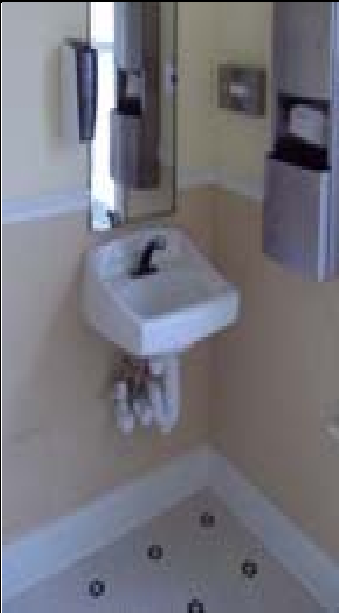
<p>The tissue dispenser in the 2nd floor southwest women's restroom is mounted too high at 54" AFF.</p>	ADAAG 308	<p>Remount the tissue dispenser to provide a reach range no higher than 48" AFF for a forward reach over an obstruction no deeper than 20" or a side reach of 48" AFF over an object no deeper than 10".</p>			\$100	2018	<p>Remount tissue dispenser 6/2018</p>
	<p>The paper towel dispenser in the 2nd floor southwest women's restroom is mounted too high at 52" AFF.</p>	ADAAG 308	<p>Remount the paper towel dispenser to provide a reach range no higher than 48" AFF for a forward reach over an obstruction no deeper than 20" or a side reach of 48" AFF over an object no deeper than 10".</p>			\$100	2018	<p>Remount paper towel dispenser 6/2018</p>

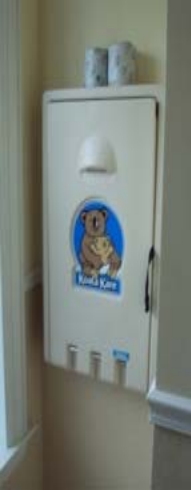
<p>The baby changing table in the 2nd floor southwest women's restroom is mounted to high at 37 1/4" AFF to surface and 58" AFF to handle and is not accessible being located in an alcove.</p>	<p>IAC 400.320(w)</p>	<p>Replace or remount the baby changing table to be no higher than 34" AFF and provide a minimum knee clearance of 27". Also mount it so the handle is no higher than 48" AFF. Mount the baby changing table to a location that provide a clear floor space that complies with ADAAG 305.</p>			<p>\$250</p>	<p>2018</p>	<p>Remount baby changing station 6/2018</p>

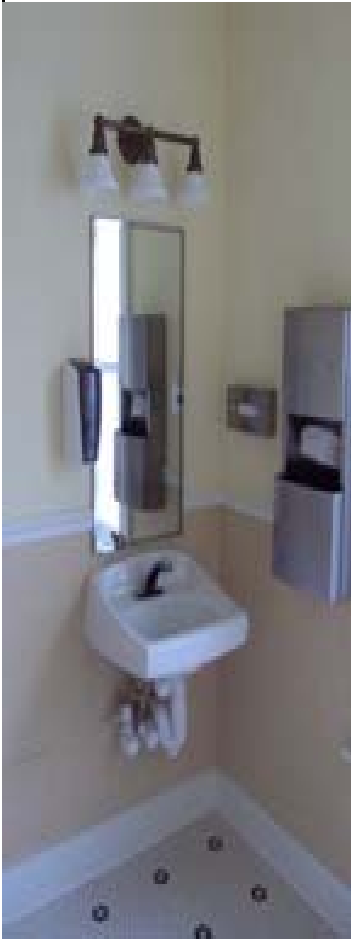
<p>The soap dispenser in the 2nd floor southwest women's restroom is mounted too high at 50 1/2" AFF.</p>	ADAAG 308	<p>Remount the soap dispenser to provide a reach range no higher than 48" AFF for a forward reach over an obstruction no deeper than 20" or a side reach of 48" AFF over an object no deeper than 10".</p>			\$100	2018	<p>Remount soap dispenser 6/2018</p>
	<p>The paper towel dispenser in the 2nd floor southwest women's restroom is mounted too high at 52 1/2" AFF.</p>	ADAAG 308	<p>Remount the paper towel dispenser to provide a reach range no higher than 48" AFF for a forward reach over an obstruction no deeper than 20" or a side reach of 48" AFF over an object no deeper than 10".</p>			\$150	2018	<p>Remount paper towel dispenser 6/2018</p>
	<p>The tissue dispenser in the 2nd floor southwest women's restroom is mounted too high at 54" AFF.</p>	ADAAG 308	<p>Remount the tissue dispenser to provide a reach range no higher than 48" AFF for a forward reach over an obstruction no deeper than 20" or a side reach of 48" AFF over an object no deeper than 10".</p>			\$100	2018	<p>Remount tissue dispenser 6/2018</p>

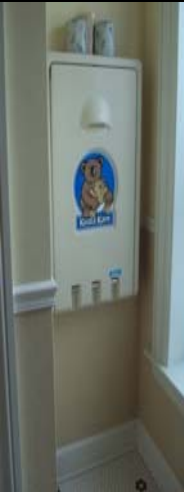
The baby changing table in the 2nd floor southwest men's restroom is mounted too high at 37 1/2" AFF to surface and 58" AFF to handle and is not accessible being located in an alcove.	IAC 400.320(w)	Replace or remount the baby changing table to be no higher than 34" AFF and provide a minimum knee clearance of 27". Also mount it so the handle is no higher than 48" AFF. Mount the baby changing table to a location that provides a clear floor space that complies with ADAAG 305.			\$250	2018	Remount baby changing station 6/2018

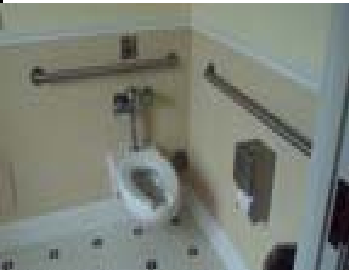
The toilet paper holder in the 2nd floor southwest men's restroom is mounted too far from the toilet at 10".	ADAAG 604.7	Remount the toilet paper dispenser to be no lower than 15", no higher than 48" AFF and a minimum of 7" to a maximum of 9" in front of the toilet. Do not mount the toilet paper dispenser behind the side grab bar.			\$50	2018	Remount toilet paper holder 6/2018

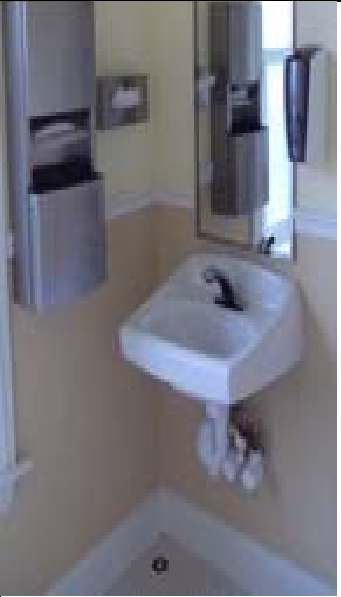
<p>The paper towel dispenser in the 2nd floor southwest men's restroom is mounted too high at 52" AFF.</p>	ADAAG 308	<p>Remount the paper towel dispenser to provide a reach range no higher than 48" AFF for a forward reach over an obstruction no deeper than 20" or a side reach of 48" AFF over an object no deeper than 10".</p>			\$100	2018	<p>Remount paper towel dispenser 6/2018</p>
	<p>The tissue dispenser in the 2nd floor southwest men's restroom is mounted too high at 53" AFF.</p>	ADAAG 308	<p>Remount the tissue dispenser to provide a reach range no higher than 48" AFF for a forward reach over an obstruction no deeper than 20" or a side reach of 48" AFF over an object no deeper than 10".</p>			\$50	2018	<p>Remount tissue dispenser 6/2018</p>

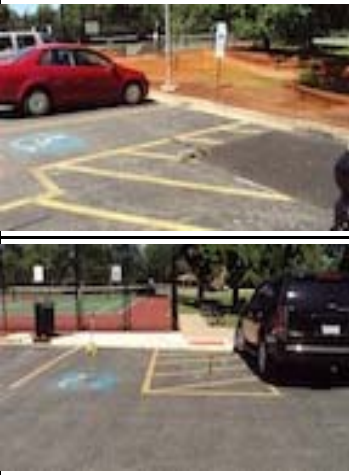
Two accessible parking spaces are provided on the north parking lot. A total of 18 spaces are provided. Both accessible spaces have running slopes that are steeper than 3.6% to 6.3%.	ADAAG 502.4	For this sized parking lot only one accessible parking space is required. Select one of the accessible parking spaces and then mark out the other space. Remove the parking sign and post from the accessible parking space converted to regular parking. Regrade the accessible parking space to be no steeper than 2% in all directions.			\$1,200	2024

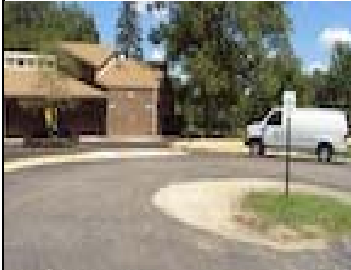
There is no accessible parking is provided at the preschool building.	IAC 400.310(c)	Provide one accessible parking space with a access aisle a minimum of 96" plus a sign with the International Symbol of Accessibility and a fine sign of \$250 at the head of the parking space. The parking space and access aisle should be no steeper than 2% in all directions. Locate the accessible parking space on the shortest accessible route. If possible locate it near the curb ramp.			\$750	2014	Accessible spot added in 2014 as part of paving project

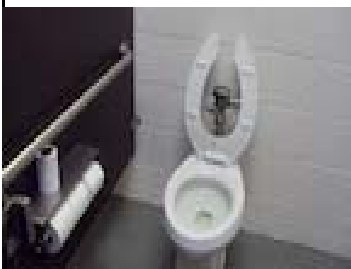
The men's restroom toilet does not provide rear grab bars.	ADAAG 604.5.2 & ADAAG 609	Provide a rear grab bar a minimum of 36" long mounted 12" from the centerline of the toilet to the corner and 24" from the centerline to the open side of the toilet. The grab bar should be mounted at a centerline of 33" to 36" AFF.			\$400	2020

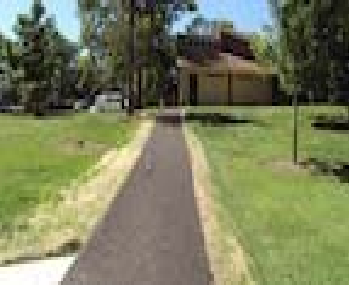
<p>The walkway up to the back of the building has a running slope too steep at 5.6% to 12.2% for 62'.</p>	ADAAG 403.3	<p>Remove and regrade section to provide a running slope no greater than 5% and a cross slope no greater than 2%. Because of the slope in this area regrading to 5% may not be possible. Follow ADAAG 405 for ramps if necessary. If the terrain is still an issue, lessen to the greatest extent possible. Make sure other routes are accessible even if they require a long distance to travel.</p>			\$3,750	2024

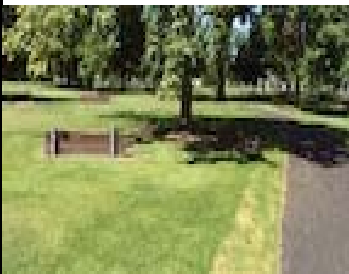
<p>There is no accessible route to the horse shoe pit for 56'.</p>	ADAAG 403.3	<p>To at least the nearest horseshoe pit to the walkway, provide a new accessible route with a running slope no steeper than 5% and a cross slope no steeper than 2% and a minimum clear width of 36".</p>			\$1,850	2013	Removed horse shoe pit was not used by any park patrons

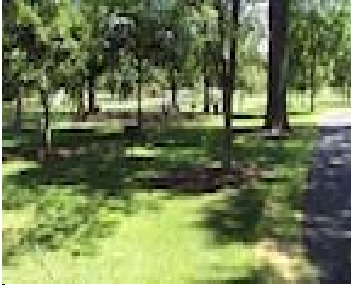
Picnic area #5 has 9 tables provided but none are of an accessible design or on an accessible route for 25'.	<u>Proposed</u> Outdoor Developed Areas Guidelines ADAAG 245 & 1011	Picnic Table Recommendation: At least 20% of picnic tables, but no less than two, be of accessible design, connected to an accessible route. Relocate or purchase two accessible picnic tables and locate them on an accessible surface.			\$1,650	2022	
		ADAAG 403.3	Provide a new accessible route with a running slope no steeper than 5% and a cross slope no steeper than 2% and a minimum clear width of 36".			\$825	2022

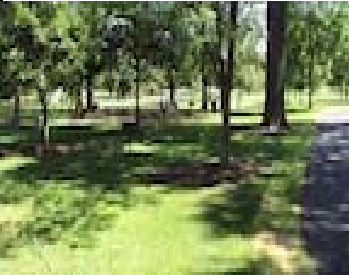
Picnic area #5 has 4 trash cans provided but none are on an accessible route for 37' to 90'.	<u>Proposed</u> Outdoor Developed Areas Guidelines 1011	Trash Can Recommendation: Locate trash cans on an accessible route as part of your regular policy. For a forward approach provide a trash can within 24" and a minimum clear ground space of 36" by 48" or for a side approach provide a trash can within 24" and a minimum clear ground space of 30" by 60".			\$50	2022

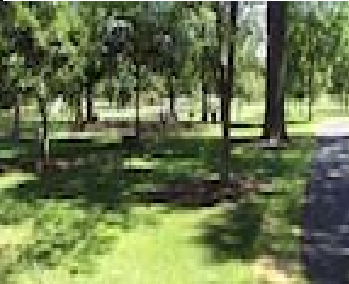
The coal pit area at Picnic area 5 is not on an accessible route for 96'.	ADAAG 403.3	Relocate the coal pit to be near an accessible route or provide a new accessible route with a running slope no steeper than 5% and a cross slope no steeper than 2% and a minimum clear width of 36".			\$3,175	2022

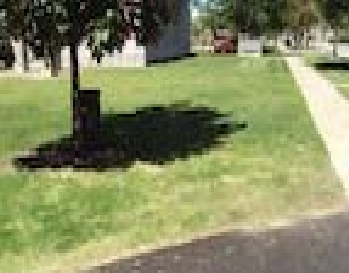
<p>There is a trash can near the museum that is located in the grass for 15'.</p>	<p><u>Proposed</u> Outdoor Developed Areas Guidelines 1011</p>	<p>Trash Can Recommendation: Locate trash cans on an accessible route as part of your regular policy. For a forward approach provide a trash can within 24" and a minimum clear ground space of 36" by 48" or for a side approach provide a trash can within 24" and a minimum clear ground space of 30" by 60".</p>			\$50	2012	<p>Relocated trash can to accessible route 5/2012</p>

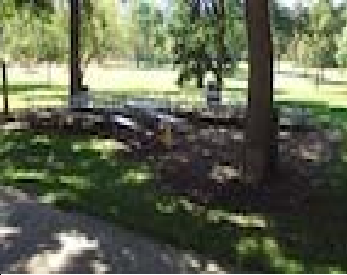
Picnic area #6 has 3 trash cans provided but none are on an accessible route for 11' to 49'.	<u>Proposed</u> Outdoor Developed Areas Guidelines 1011	Trash Can Recommendation: Locate trash cans on an accessible route as part of your regular policy. For a forward approach provide a trash can within 24" and a minimum clear ground space of 36" by 48" or for a side approach provide a trash can within 24" and a minimum clear ground space of 30" by 60".			\$50	2024

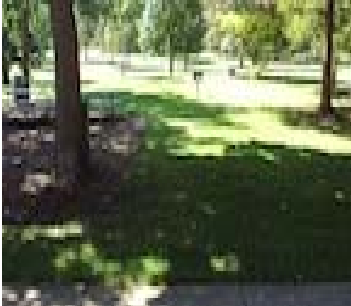
Picnic area #6 has one grill that is not on an accessible route for 50' and is mounted too high at 35".	<p style="text-align: center;"><u>Proposed</u> Outdoor Developed Areas Guidelines ADAAG 1011.5</p>	<p>Grill Recommendation: Follow Outdoor Developed Area Report that states 20% of grills, but at least two, be of accessible design, and connected to an accessible route. The accessible grill should provide a cooking surface a minimum of 15" to 34" maximum AFF above the ground surface, a clear floor space and controls that are within a maximum reach range of 48" AFF. And a 48" by 48" space centered on the usable sides of the grill is required.</p>			\$400	2024	
		<p style="text-align: center;">ADAAG 403.3</p>	Provide a new accessible route with a running slope no steeper than 5% and a cross slope no steeper than 2% and a minimum clear width of 36".			\$1,150	\$2,024

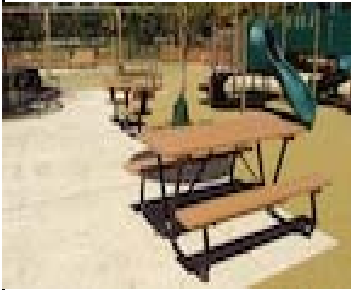
There are two picnic tables provided at the playground but only one is of an accessible design.	<u>Proposed</u> Outdoor Developed Areas Guidelines ADAAG 245 & 1011	Picnic Table Recommendation: At least 20% of picnic tables, but no less than two, be of accessible design, connected to an accessible route. Relocate or purchase one more accessible picnic table and locate it on an accessible surface.			\$750	2019

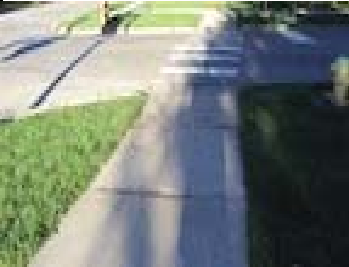
The west curb ramp at the southwest corner does not have truncated domes.	ADAAG 705	Provide truncated domes that go the width of the sidewalk and 24" deep where it meets the road. Provide a color that contrast with the walkway surface. Truncated dome tiles are typically a more durable solution.			\$500		Coordinate with City's sidewalk replacement program

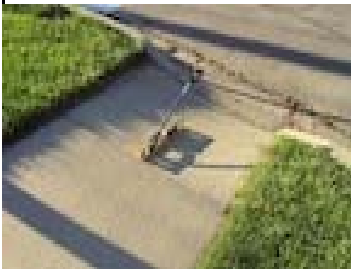
The south curb ramp at the southwest corner does not provide truncated domes.	ADAAG 705	Provide truncated domes that go the width of the sidewalk and 24" deep where it meets the road. Provide a color that contrast with the walkway surface. Truncated dome tiles are typically a more durable solution.			\$500		Coordinate with City's sidewalk replacement program

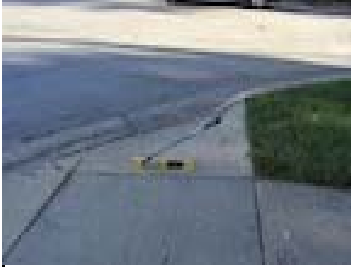
The south curb ramp at the southeast corner does not provide truncated domes.	ADAAG 705	Provide truncated domes that go the width of the sidewalk and 24" deep where it meets the road. Provide a color that contrast with the walkway surface. Truncated dome tiles are typically a more durable solution.			\$500		Coordinate with City's sidewalk replacement program

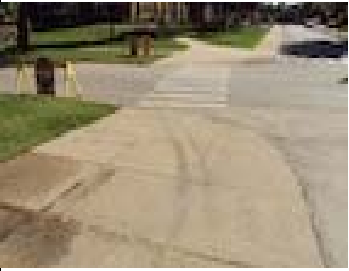
The curb ramp at the east sidewalk to cross near the elementary school does not provide truncated domes.	ADAAG 705	Provide truncated domes that go the width of the sidewalk and 24" deep where it meets the road. Provide a color that contrast with the walkway surface. Truncated dome tiles are typically a more durable solution.			\$275	Coordinate with City's sidewalk replacement program

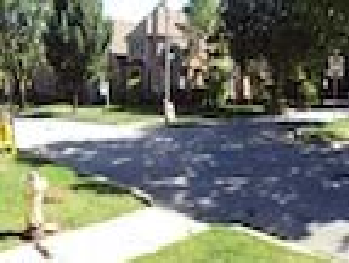
The south curb ramp at Virginia Street and Cottage Hill Avenue does not provide truncated domes.	ADAAG 705	Provide truncated domes that go the width of the sidewalk and 24" deep where it meets the road. Provide a color that contrast with the walkway surface. Truncated dome tiles are typically a more durable solution.			\$3,900		Domes were added by the City

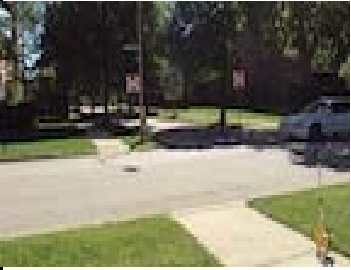
The south curb ramp at Virginia Street and Cottage Hill Avenue does not provide truncated domes	ADAAG 705	Provide truncated domes that go the width of the sidewalk and 24" deep where it meets the road. Provide a color that contrast with the walkway surface. Truncated dome tiles are typically a more durable solution.			\$500		Domes added by the City

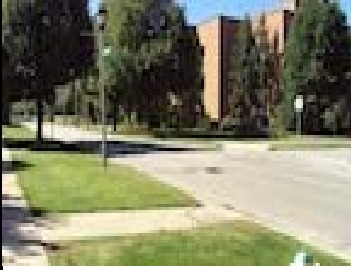
The north curb ramp of the west sidewalk at Prospect Avenue and Alexander Boulevard does not provide truncated domes	ADAAG 705	Provide truncated domes that go the width of the sidewalk and 24" deep where it meets the road. Provide a color that contrast with the walkway surface. Truncated dome tiles are typically a more durable solution.			\$500		City added domes

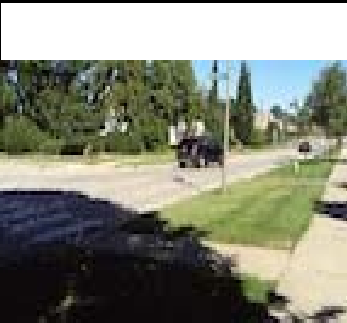
The south curb ramp at the intersection of Prospect Avenue and Alexander Boulevard does not provide truncated domes.	ADAAG 705	Provide truncated domes that go the width of the sidewalk and 24" deep where it meets the road. Provide a color that contrast with the walkway surface. Truncated dome tiles are typically a more durable solution.			\$500		Coordinate with City's sidewalk replacement program

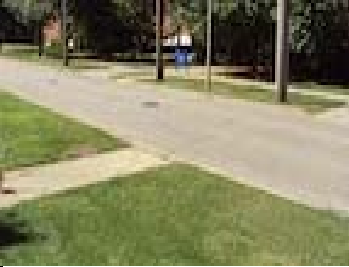
The north curb ramp across from Daniels Hall does not provide truncated domes.	ADAAG 705	Provide truncated domes that go the width of the sidewalk and 24" deep where it meets the road. Provide a color that contrast with the walkway surface. Truncated dome tiles are typically a more durable solution.			\$500		City added domes

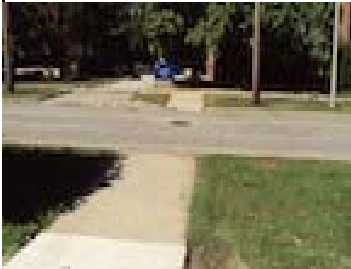
The south curb ramp across from Daniels Hall does not provide truncated domes.	ADAAG 705	Provide truncated domes that go the width of the sidewalk and 24" deep where it meets the road. Provide a color that contrast with the walkway surface. Truncated dome tiles are typically a more durable solution.			\$500		City added domes
