# York Commons Park

York Commons Park large neighborhood park that provides parking, a skate park, pool, playground and soccer field. The main issues at this park are having slopes in the accessible parking spaces too high, slopes too steep in general, protruding branches, drinking fountains not of a proper design, no second means of access into the pool, improperly mounted grab bars and showers and toilets, lack of pipe protections, various issues at sinks, and not properly designed. sinks. **Please Note:** When a **UD** is indicated, this is a Universal Design (**UD**) recommendation to enhance accessibility. The **UD** recommendation is not required to meet the minimum accessibility standards but it would be encouraged.

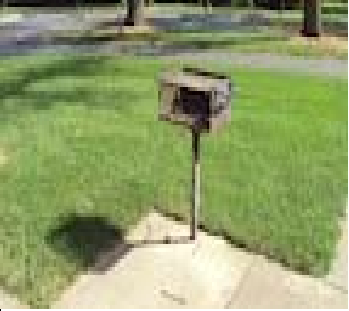
<p>The grill provided to the west of the pool and at the parking lot is mounted too high at 38" and needs spacing on the east side.</p>	<p><b>Proposed</b> Outdoor Developed Areas Guidelines ADAAG 1011.5</p>	<p><b>Grill Recommendation:</b> Follow Outdoor Developed Area Report that states 20% of grills, but at least two, be of accessible design, and connected to an accessible route. The accessible grill should provide a cooking surface a minimum of 15" to 34" maximum AFF above the ground surface, a clear floor space and controls that are within a maximum reach range of 48" AFF. And a 48" by 48" space centered on the usable sides of the grill is required.</p>			<p>\$400</p>	<p>2016</p>	<p>Grill removed 5/2016 as part of City storm water project</p>

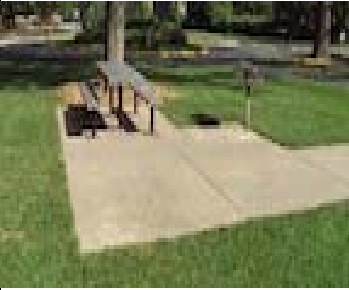
Only one picnic table of accessible design is provided.	<b>Proposed</b> Outdoor Developed Areas Guidelines ADAAG 245 & 1011	<b>Picnic Table Recommendation:</b> At least 20% of picnic tables, but no less than two, be of accessible design, connected to an accessible route. Relocate or purchase one more accessible picnic tables and locate it on an accessible surface.			\$1,650	2016	Picnic table was removed as part of the City's storm water project 5/2016.

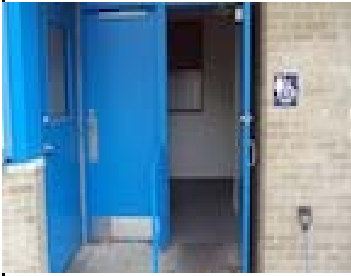
The women's locker room IN door has an opening force too high at 17 lbs. and the OUT door has an opening force too high at 13 lbs. and closes too quickly at 4 seconds.	IAC 400.310(j)(10)(B)(i)	Adjust the closer so the door opening force is no heavier than 8.5 lbs. to open and takes a minimum of 5 seconds to close or provide an automatic door opener at one of the doors.		Bob Byrne	\$100	2012	In-8 lbs. Out 7.5 lbs. & 7 seconds 6/2012

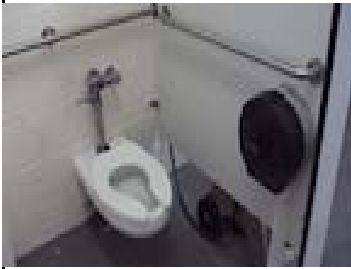
The toilet paper dispenser in the women's locker-room stall is mounted too far from the toilet at 16".	ADAAG 604.7	Remount the toilet paper dispenser to be no lower than 15", no higher than 48" AFF and a minimum of 7" to a maximum of 9" in front of the toilet. Do not mount the toilet paper dispenser behind the side grab bar.		Bob Byrne	\$100	2012	Mounted to 7 1/2" from toilet 6/2012

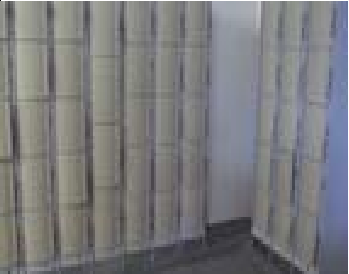
No accessible benches are provided at the women's locker-room.	ADAAG 222 & 903	Provide a bench that is a minimum 42" long, and a minimum of 20" to a maximum of 24" deep. The bench should be affixed to a wall or have a back support that extends at least 42" the length of the bench at a point a maximum of 2" above the seat. The accessible bench should be adjacent to the accessible lockers and have a seat between 17" to 19" AFF.			\$700	2020

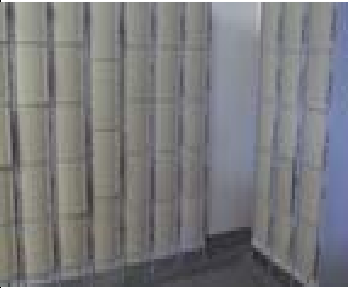
<p>The lockers are provided all require a key to open.</p>	<p>ADAAG 225.1 &amp; 811</p>	<p>Provide at least 5% of the lockers with a clear floor space, with the coat hook and shelf no higher than 48" for a side approach or front approach. The base should be no lower than 15" and provide accessible door hardware. A 30" by 48" clear floor space should be provided at the accessible lockers with accessible locker door hardware. Provide these at or near the accessible bench.</p>			<p>\$500</p>	<p>2020</p>

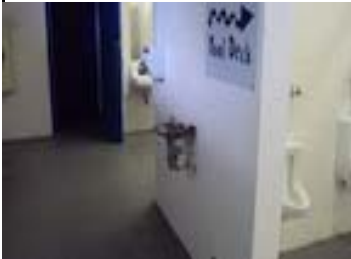
The drinking fountain in the men's locker room has a 36 1/2" to the spout.	ADAAG 211 & ADAAG 602	Provide two individual drinking fountain or a single hi-lo drinking fountain that provides a wheelchair accessible fountain with a spout at 36" maximum and a standing drinking fountain with a height between 38" minimum and 43" maximum. The toe clearance should be a minimum of 9".			\$4,250	2020

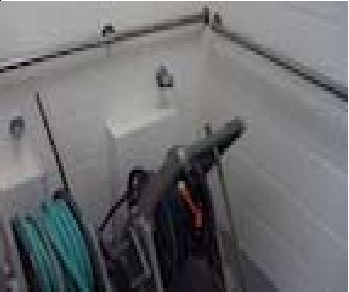
<p>The area where the accessible toilet would be had been removed at the time of the survey.</p>	<p>ADAAG 604</p>	<p>Provide an accessible stall that is a minimum of 60" wide and a minimum of 56" deep with a minimum 42" side grab bar mounted 12" maximum from the corner and a 36" rear grab bar mounted 12" minimum from the centerline and 24" from the centerline to the transfer side of the toilet. The toilet centerline should be 16" to 18" from the nearest wall and a minimum 17" to a maximum 19" to the top of the seat. This will require remove of the adjacent toilet and taking over that space.</p>			<p>\$1,500</p>	<p>2020</p>

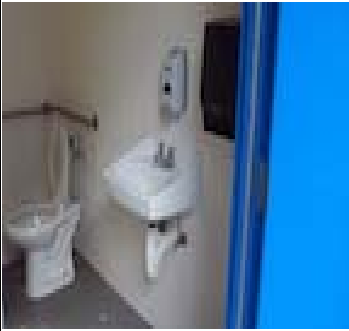
The family changing room paper towel dispenser is mounted too high at 56 1/2" AFF.	ADAAG 308	Remount the paper towel dispenser to provide a reach range no higher than 48" AFF for a forward reach over an obstruction no deeper than 20" or a side reach of 48" AFF over an object no deeper than 10".		Bob Byrne	\$100	2012	Remounted to 48" AFF 6/2012

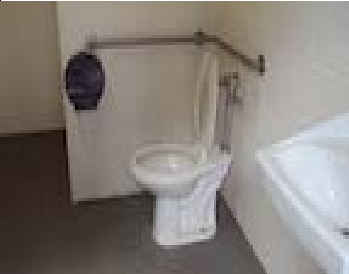
The grab bars at the toilet are too short at 2' for the rear grab bar and 3' for the side grab bar.	ADAAG 604.5	Provide a rear grab bar a minimum of 36" long mounted 12" from the centerline of the toilet to the corner and 24" from the centerline to the open side of the toilet. Also, provide a side grab bar a minimum of 42" long and a maximum of 12" from the corner. Both grab bars should be mounted at 33" to 36" to the top of the grab bar.			\$925	2018

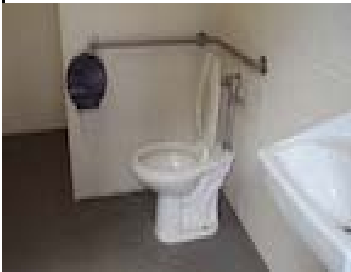
The toilet paper dispenser in the family changing room is mounted too far from the toilet at 13".	ADAAG 604.7	Remount the toilet paper dispenser to be no lower than 15", no higher than 48" AFF and a minimum of 7" to a maximum of 9" in front of the toilet. Do not mount the toilet paper dispenser behind the side grab bar.		Bob Byrne	\$100	2012	Mounted 8" to centerline 6.2912

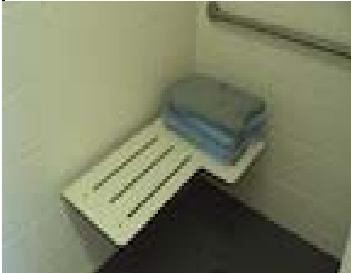
The shower in the family changing room is intended as a transfer shower but the dimensions are too big at 42" wide and 48" deep.	ADAAG 608	Create a transfer type shower compartment that is 36" by 36" and provides a shower seat, grab bars and shower sprayer head on a hose. A shower head mounted permanently at 48" AFF can be provided in unsupervised shower-rooms. If this is not possible consider an roll-in shower or alternate roll-in shower.			\$1,930	2020

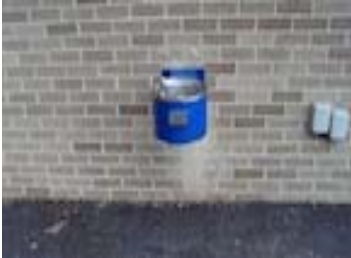
The drinking fountain located outside the restrooms has a knee clearance of only 23" and is 31" to the spout.	ADAAG 211 & ADAAG 602	Remove or remount to provide two individual drinking fountain or a single hi-lo drinking fountain that provides a wheelchair accessible fountain with a spout at 36" maximum and a standing drinking fountain with a height between 38" minimum and 43" maximum. The toe clearance should be a minimum of 9".			\$4,250	2020

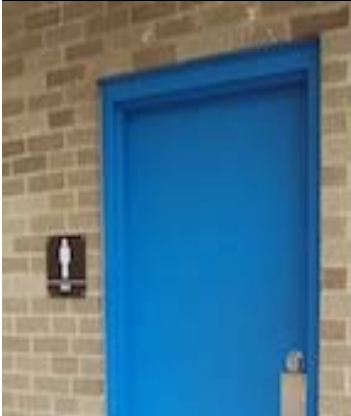
The outdoor men's restroom door has an opening force too high at 17 lbs. and closes too quickly at 4 seconds. 29" CO sign not on latch side	IAC 400.310(j)(10)(B)(i)	Adjust the closer so the door opening force is no heavier than 8.5 lbs. to open and takes a minimum of 5 seconds to close or provide an automatic door opener at one of the doors		Bob Byrne	\$100	2012	Adjusted to 8 lbs.; 9 sec. to close 4/2012

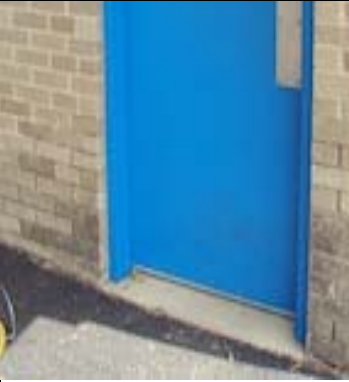
<p>The sign for the men's outdoor restroom is mounted on the hinge side and not on the latch side.</p>	<p>ADAAG 216.2</p>	<p>The permanent room sign should to be mounted on the wall at the latch side of the door at 48" minimum from the baseline of the lowest tactile character to 60" maximum from the baseline of the highest character with raised lettering and numbers plus Braille.</p>		<p>Bob Byrne</p>	<p>\$150</p>	<p>2012</p>	<p>Installed sign at 48" 4/2012</p>

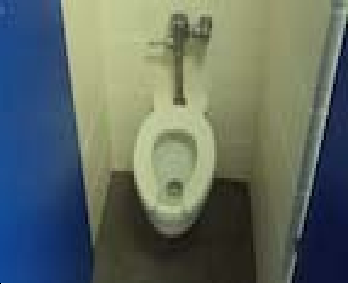
<p>The outdoor men's restroom does not provide an accessible stall.</p>	<p>ADAAG 604</p>	<p>The design of this toilet room may not allow for an accessible stall. Consider creating both stalls and single users with the present women's restroom as the accessible restroom. Otherwise to the greatest extent possible, provide an accessible stall that is a minimum of 60" wide and a minimum of 56" deep with a minimum 42" side grab bar mounted 12" maximum from the corner and a 36" rear grab bar mounted 12" minimum from the centerline and 24" from the centerline to the transfer side of the toilet. The toilet centerline should be 16" to 18" from the nearest wall and a minimum 17" to a maximum 19" to the top of the seat. This will require remove of the adjacent toilet and taking over that space.</p>			<p>\$3,500</p>	<p>2020</p>

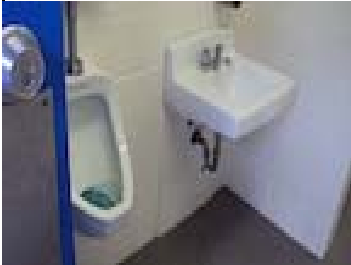
The sink provided in the men's outdoor restroom has a knee clearance of 26".	ADAAG 606	Remount the sink to provide a minimum 27" knee clearance and a rim height of no higher than 34" AFF.			\$1,800	2020	
	The sink provided in the men's outdoor restroom has a faucet shuts off too quickly at 5 seconds.	ADAAG 606.4	Provide a lever-operated, push-type or electronically controlled faucet. Self-closing faucets should remain open for at least 10 seconds. Push-type or lever-operated faucets should require not more than 5 lbs. to operate.			\$550	2020

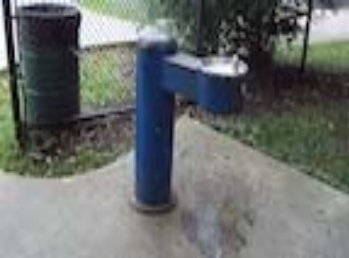
The drinking fountain located at the skate park has a knee clearance of 28 1/4" and is 36 1/2" to the spout.	ADAAG 211 & ADAAG 602	Provide a high individual drinking fountain or a single hi-lo drinking fountain that provides a wheelchair accessible fountain with a spout at 36" maximum and a standing drinking fountain with a height between 38" minimum and 43" maximum. The toe clearance should be a minimum of 9".			\$2,125	2014	Fountain removed

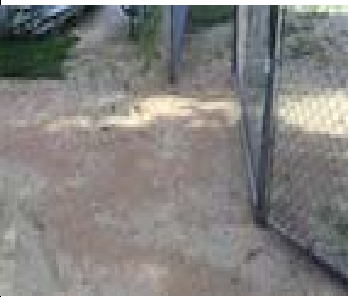
The walkway at the east ballfield entrance was covered with soil washed out from the field surface.	ADAAG 403.3	Determine if an accessible route is provided. If so, clear the soil from this area. Otherwise, provide a new accessible route with a running slope no steeper than 5% and a cross slope no steeper than 2% and a minimum clear width of 36".			\$150	2020

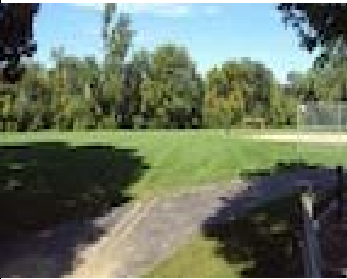
There is no access route to the trash can at the soccer field.	<b>Proposed</b> Outdoor Developed Areas Guidelines 1011	<b>Trash Can Recommendation:</b> Locate trash cans on an accessible route as part of your regular policy. For a forward approach provide a trash can within 24" and a minimum clear ground space of 36" by 48" or for a side approach provide a trash can within 24" and a minimum clear ground space of 30" by 60".			\$50	2012	Move trash can to accessible route

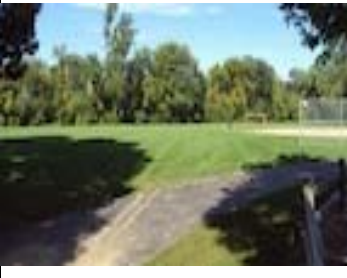
No accessible route is provided to a viewing area for a soccer game or practice.	ADAAG 403.3	Relocate practices or games to an accessible field as needed. If it is determined to install an accessible route, provide a new accessible route with a running slope no steeper than 5% and a cross slope no steeper than 2% and a minimum clear width of 36".			\$250	2022
