# Sugar Creek Restoration Project

**For:**  
**Sugar Creek Golf Course**  
**Villa Park, Illinois**  
**June 26, 2018**

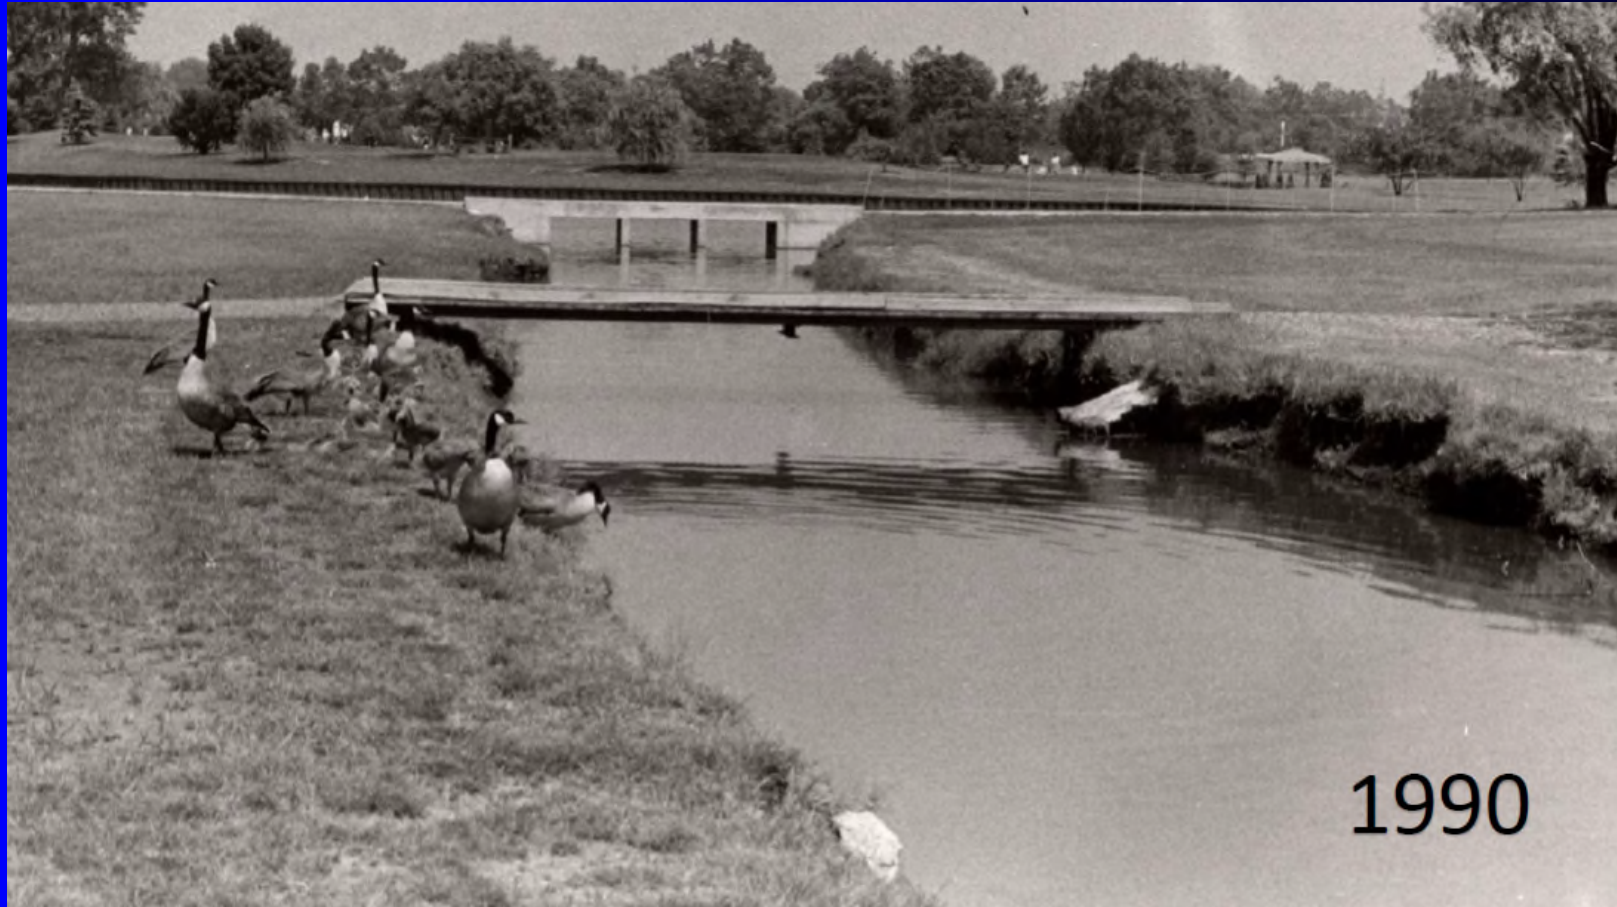
# 1990 Shoreline Erosion

- Early Shoreline Erosion (1990)
- Pond Built in 1975

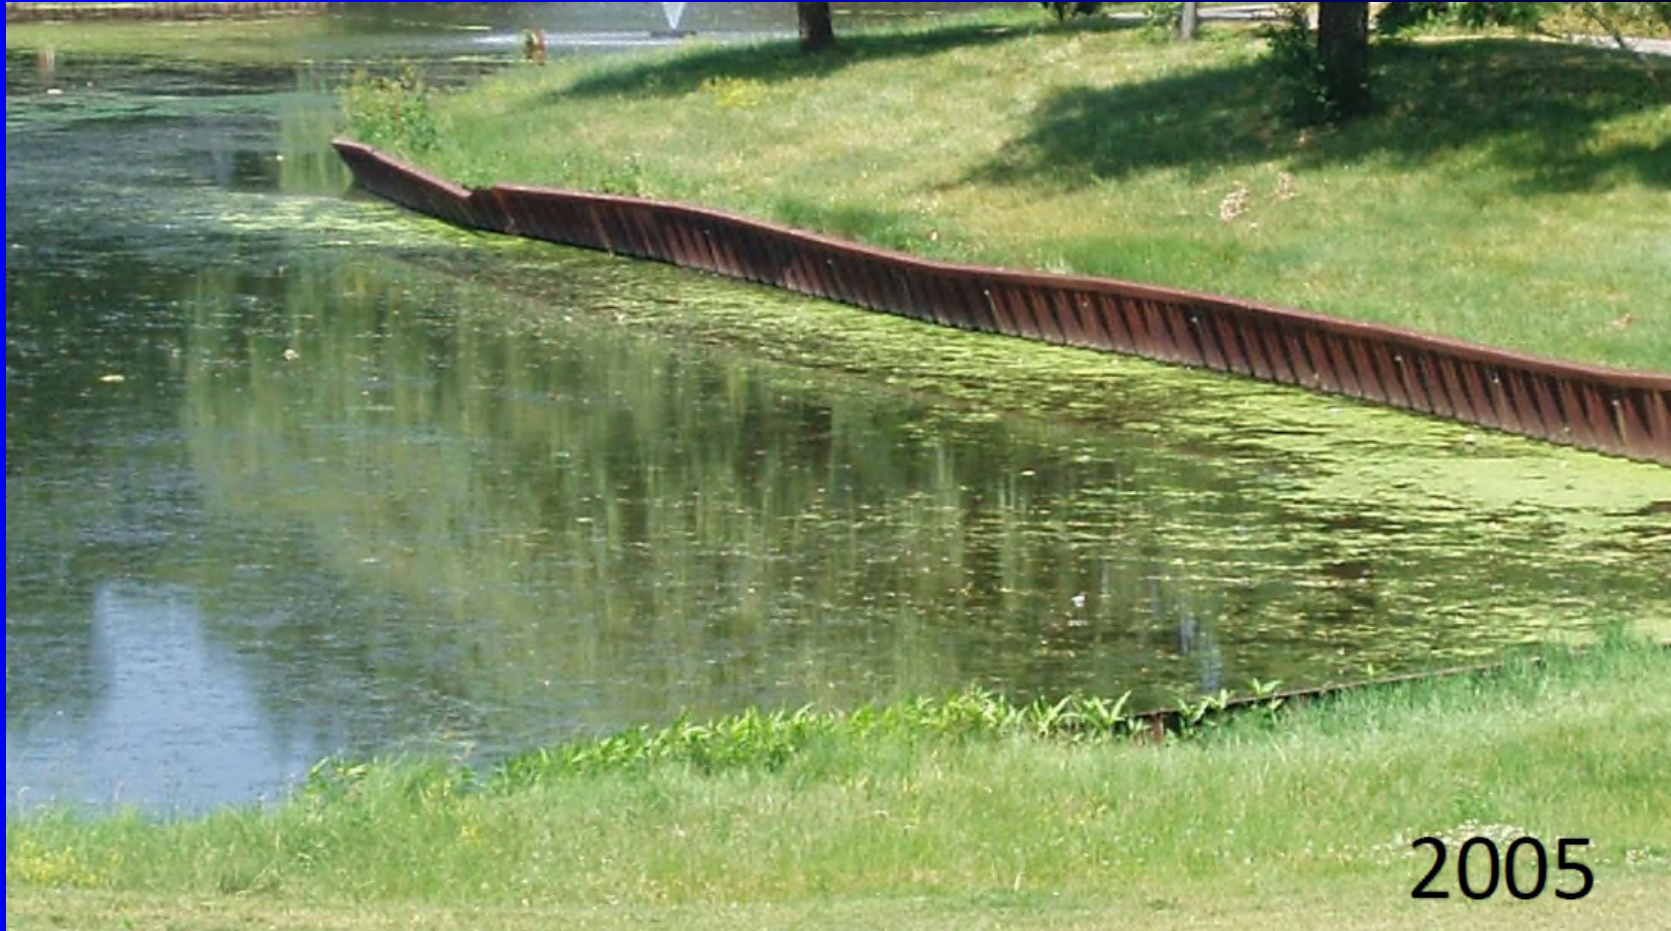
## 2005: Sheet Pile Heaving

- Sheet Pile Heaving
- 2700 Linear Feet

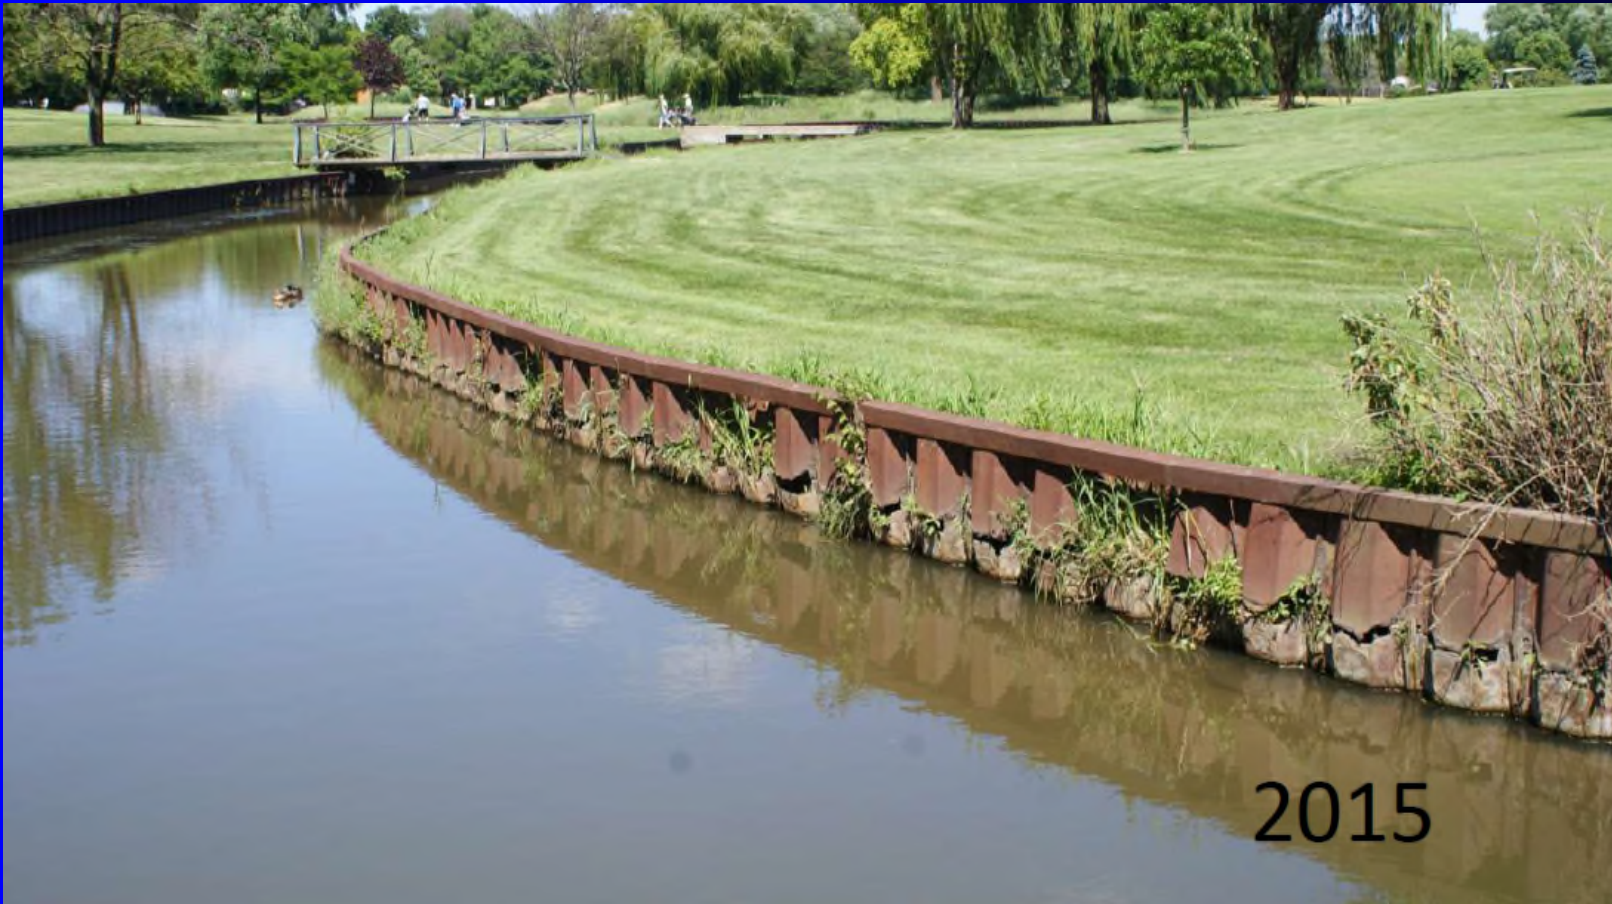
# 2015: Some Sheet Pile Failure

- Holes # 1 and # 2 (300+ Linear Feet)
- Rusting and Corrosion

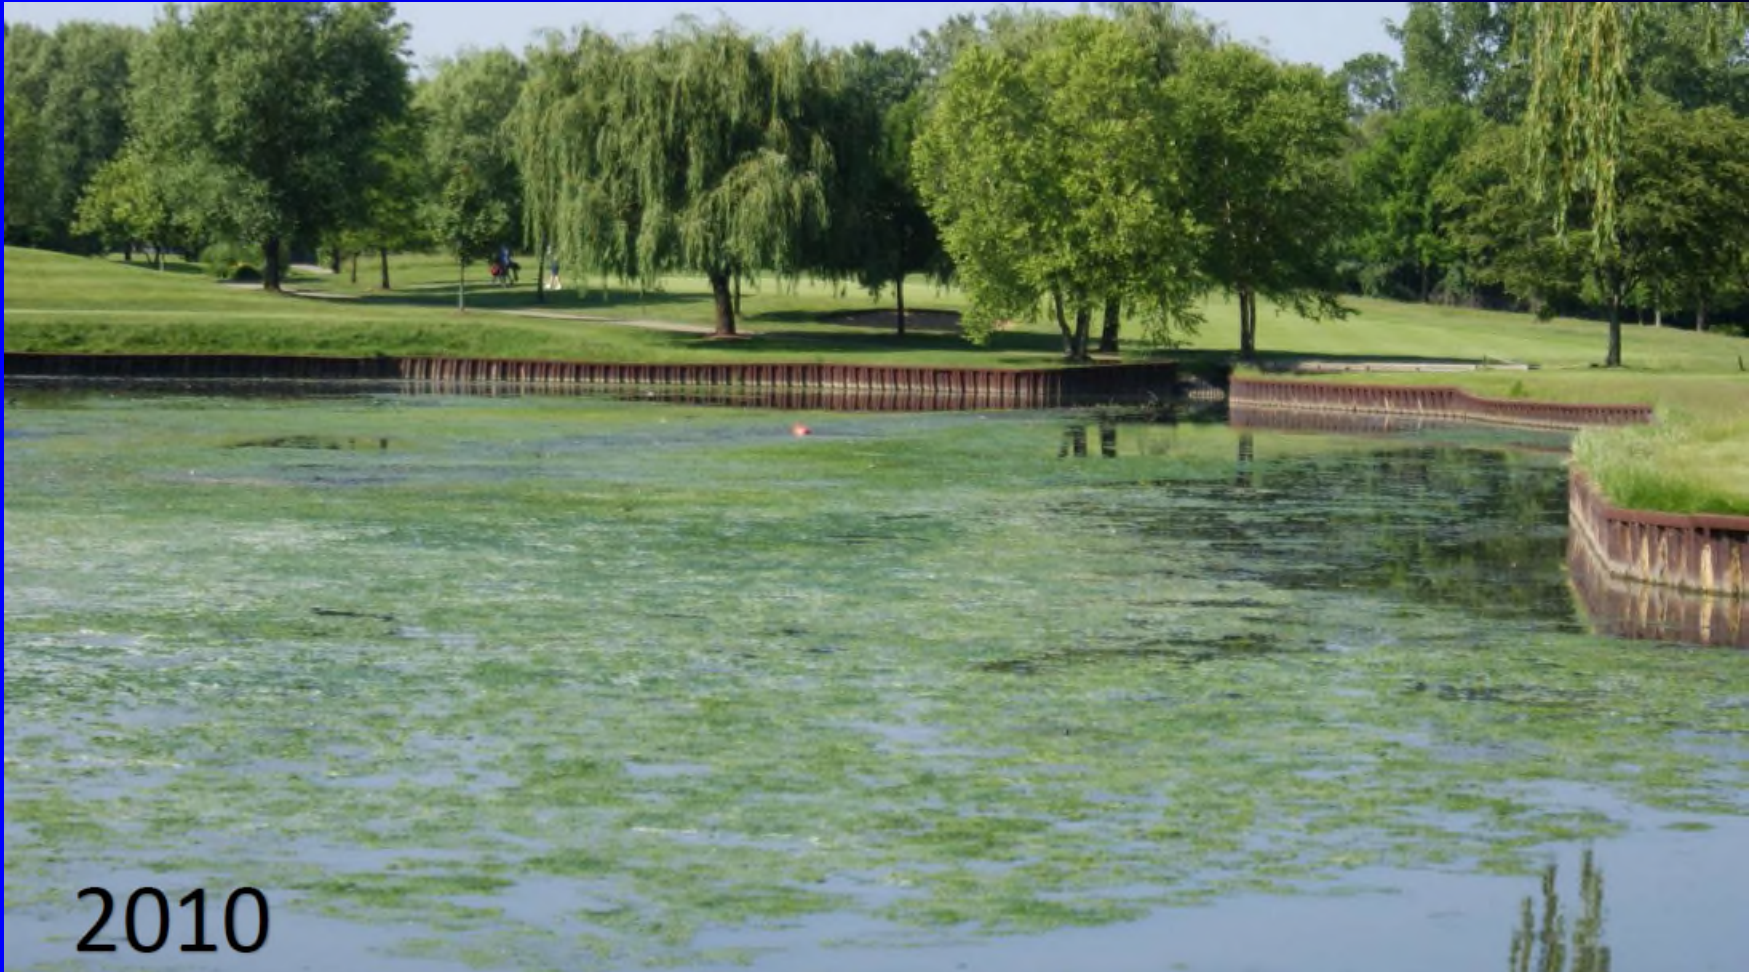
# 2010: Algae Blooms

- Algae Blooms
- Aesthetic Impacts

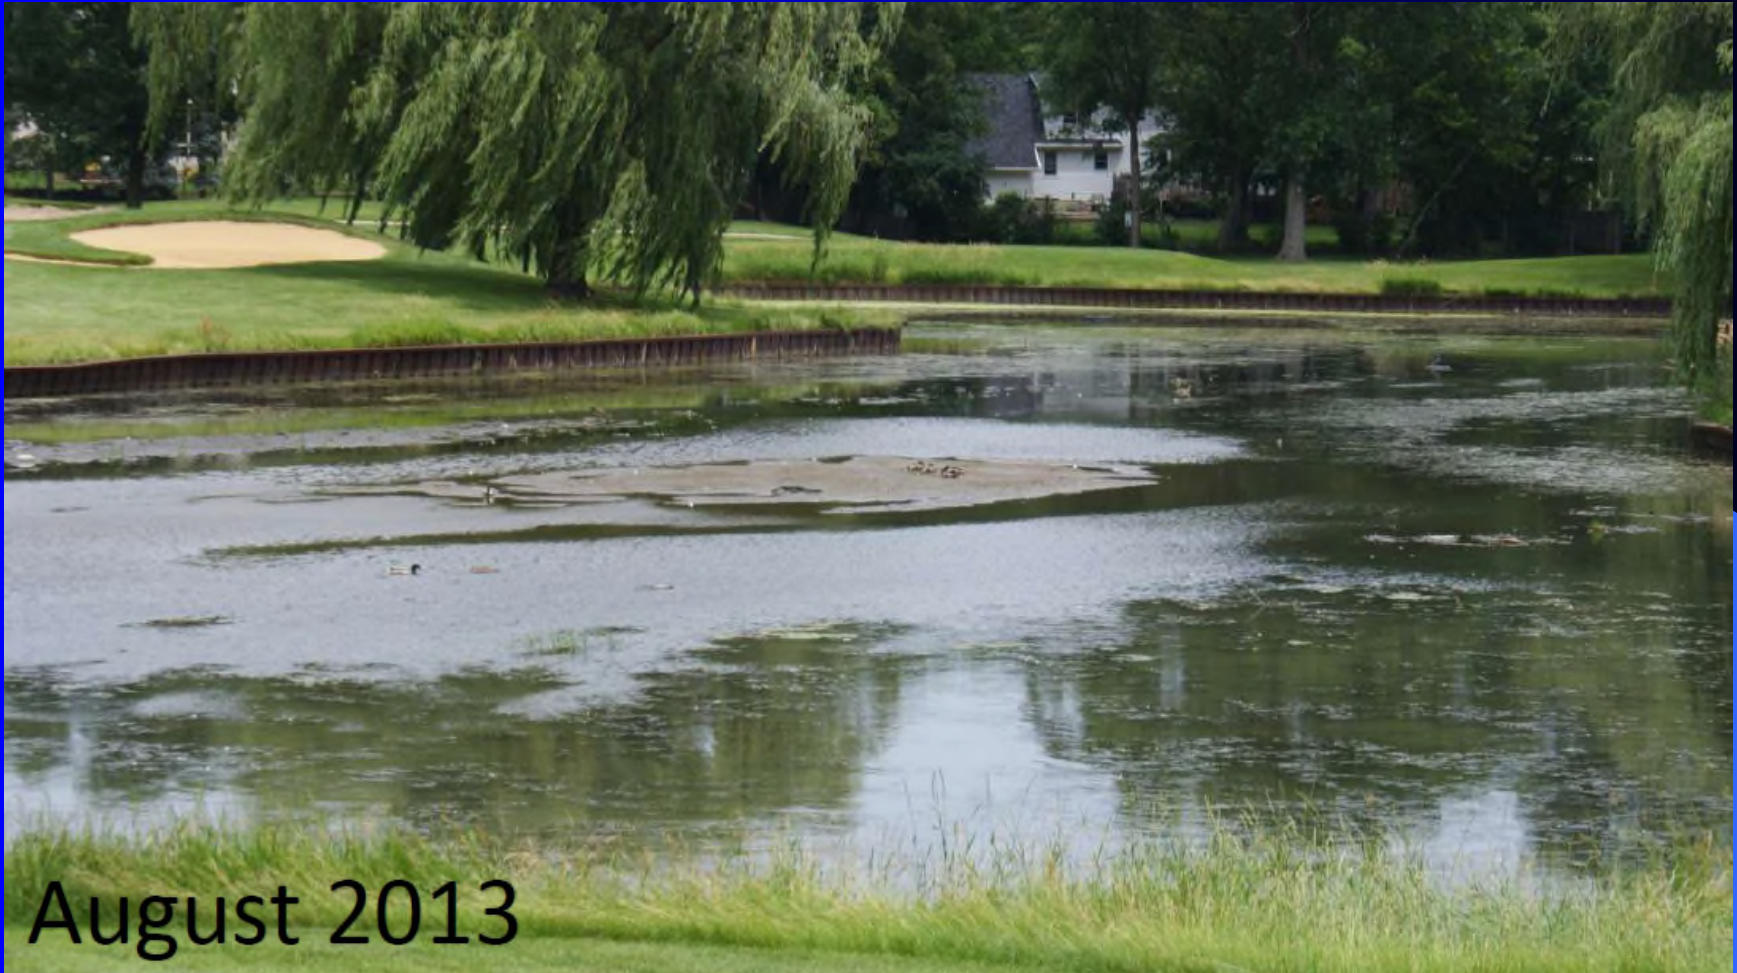
# 2013: Silt Impacts

- Exposed Mud Flats (2013)

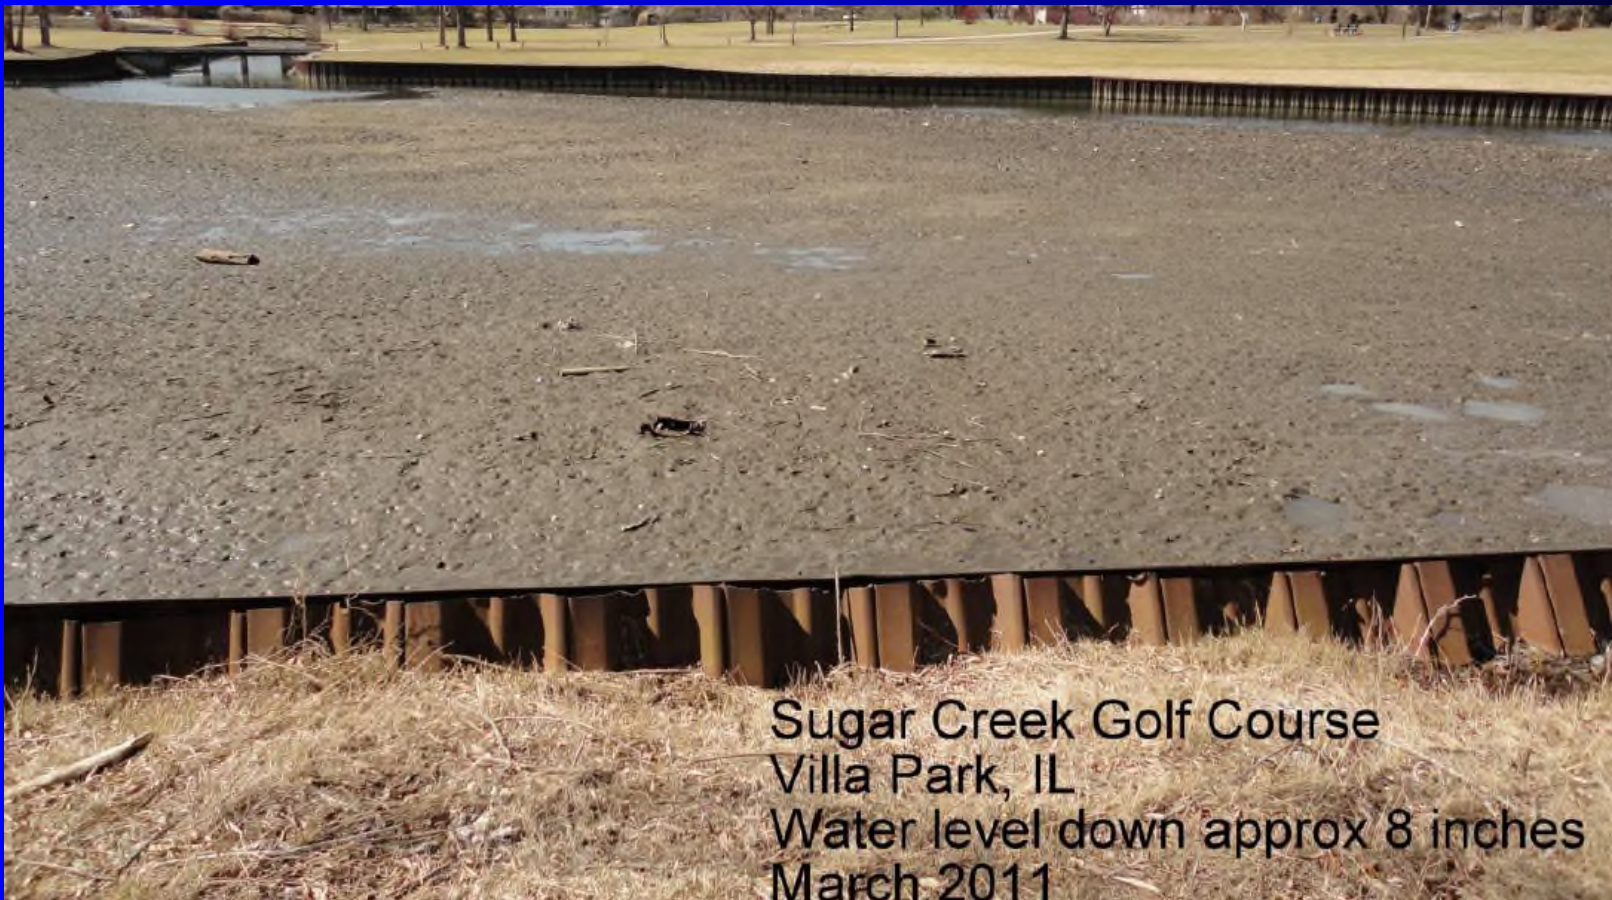
# Shallow Water Depths (2011) (Water Level Lowered 0.7 Foot)

- Loss of Water Irrigation Volume (2011)

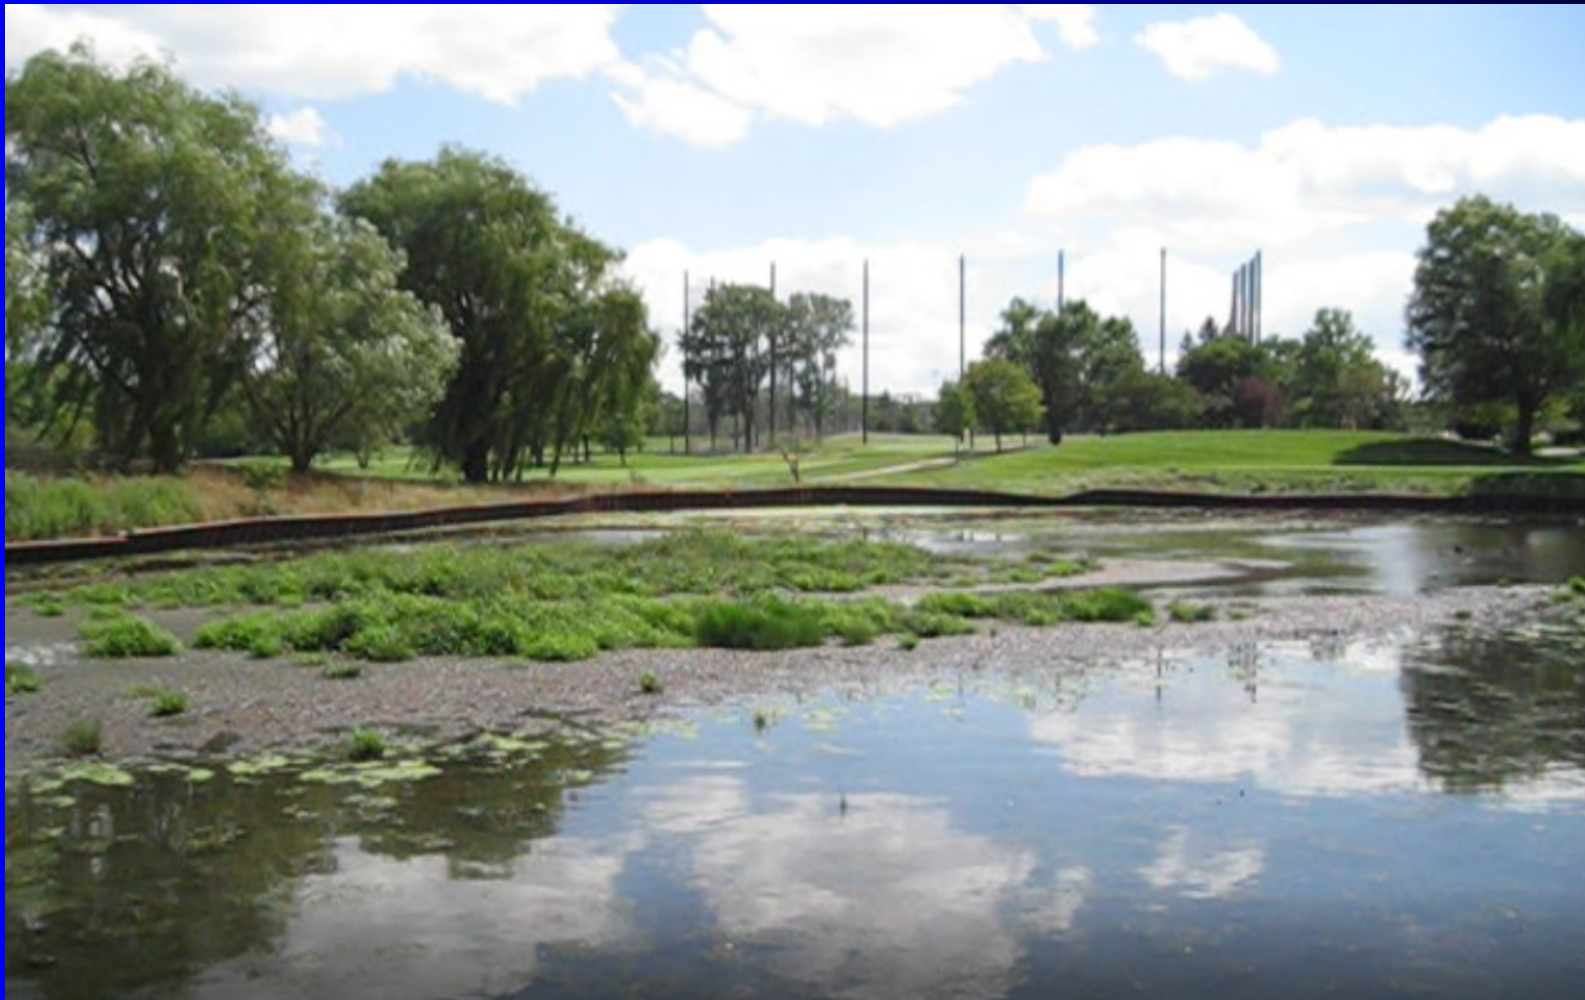
# 2017: Exposed Mud Flats

- Expansion of Mud Flats (2017)

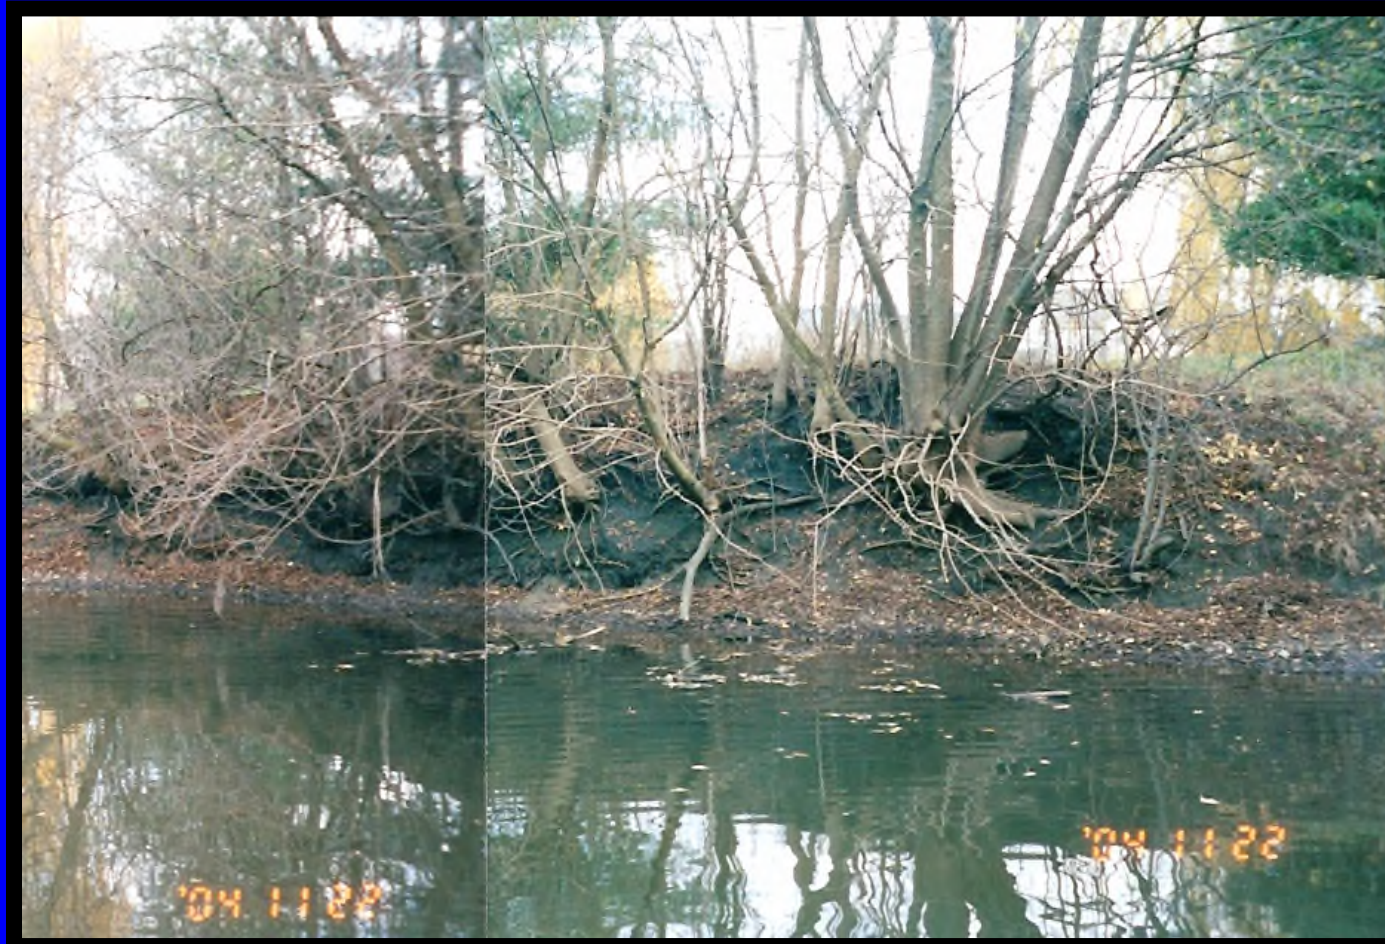
# Before: Aesthetic & Safety Impairment, Debris Jams, Poor Water Quality, Erosion

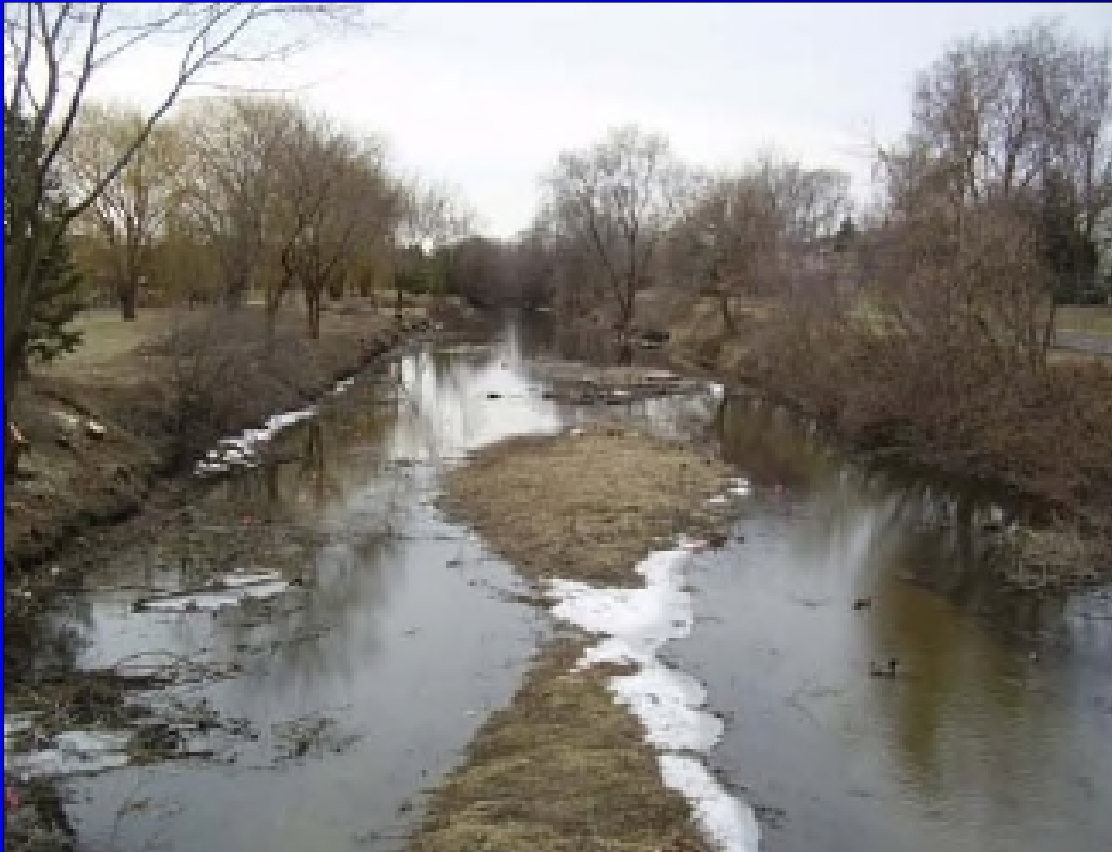
# Before – Partially Vegetated

- Partially Vegetated Sediment Deposits
- Carp Habitat / Carp Population
- Water Quality Impacts
- Odors
- Dying Mussels

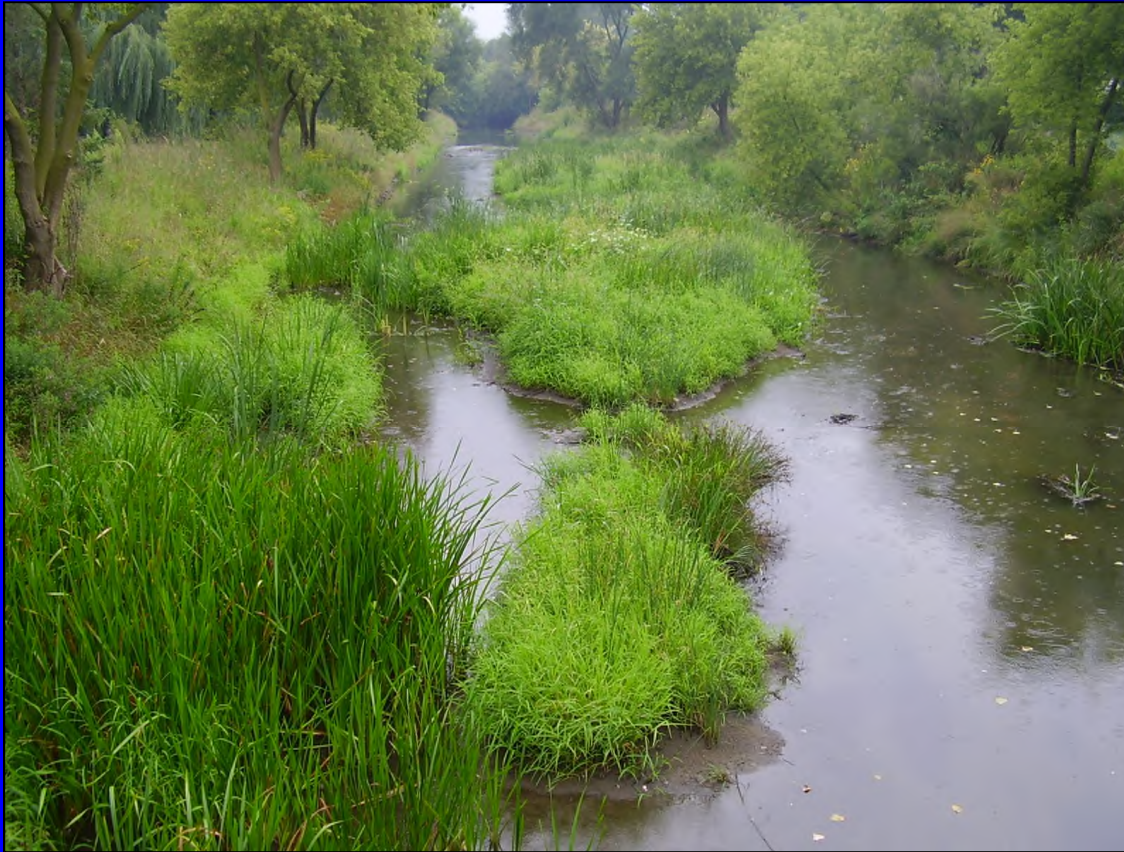
# After - Wetlands

- Narrow Channel
- Floodplain Connectivity
- Water Quality Filtration
- Wildlife Diversity
- Less Carp Habitat
- Sediment Stabilization

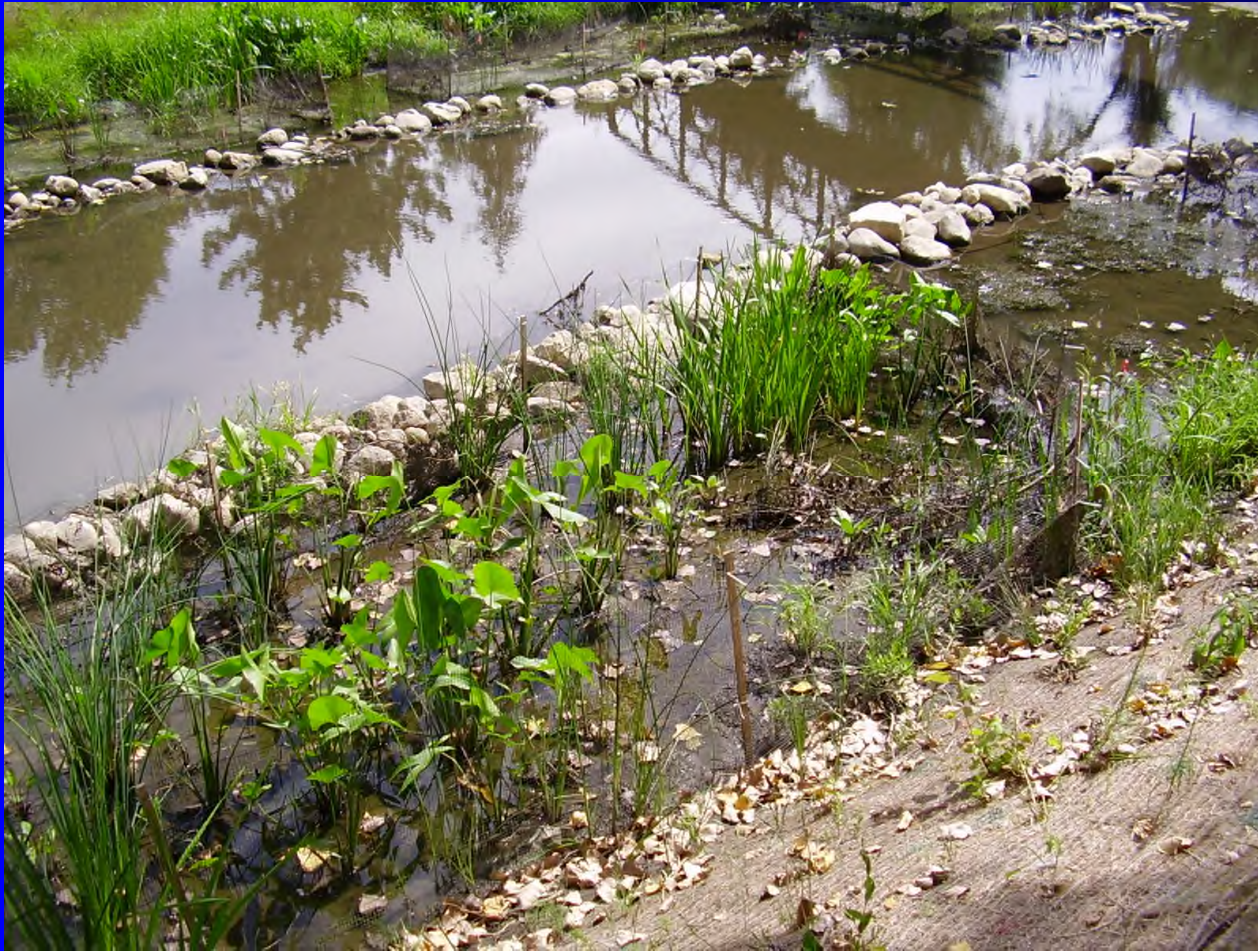
# Wetlands: Off-Bank Rock Toe

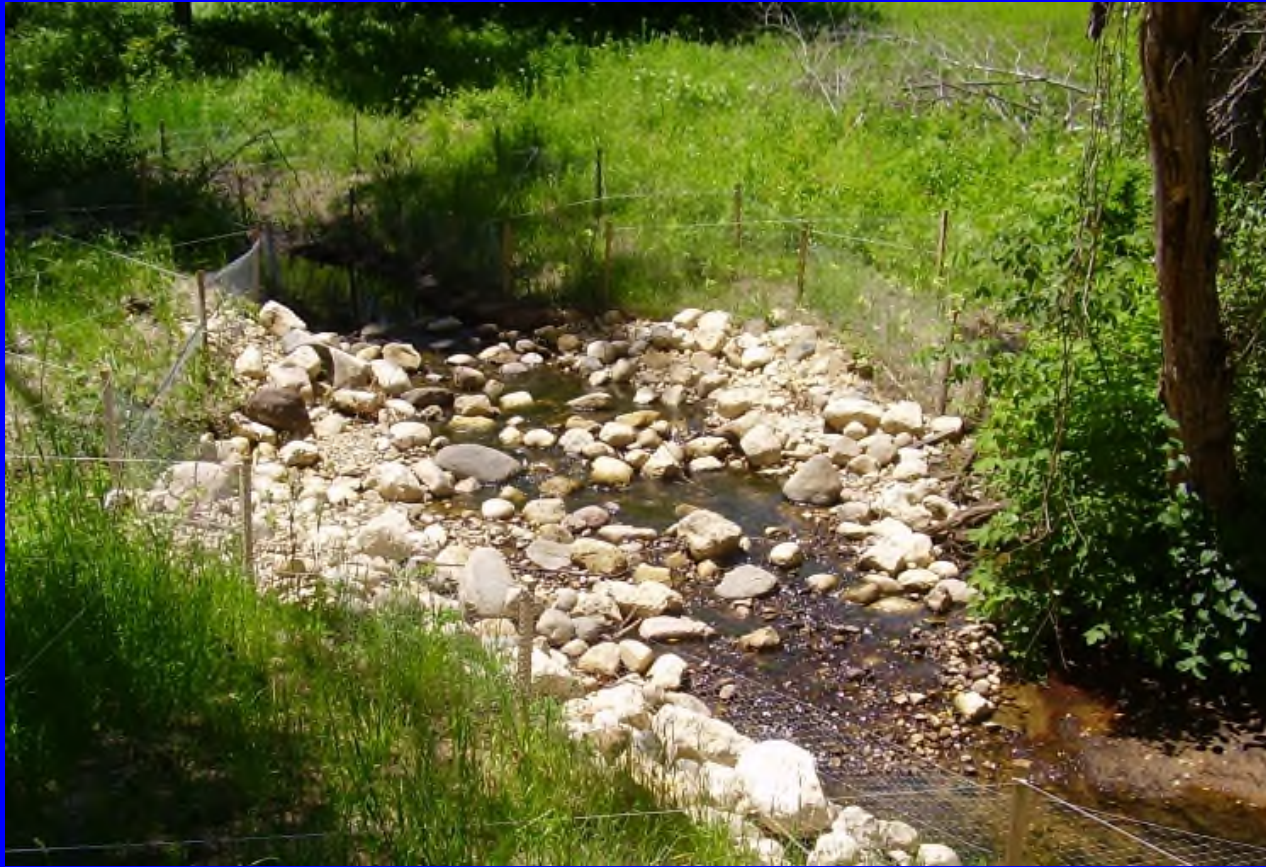
# Rock Riffle Structures - Examples

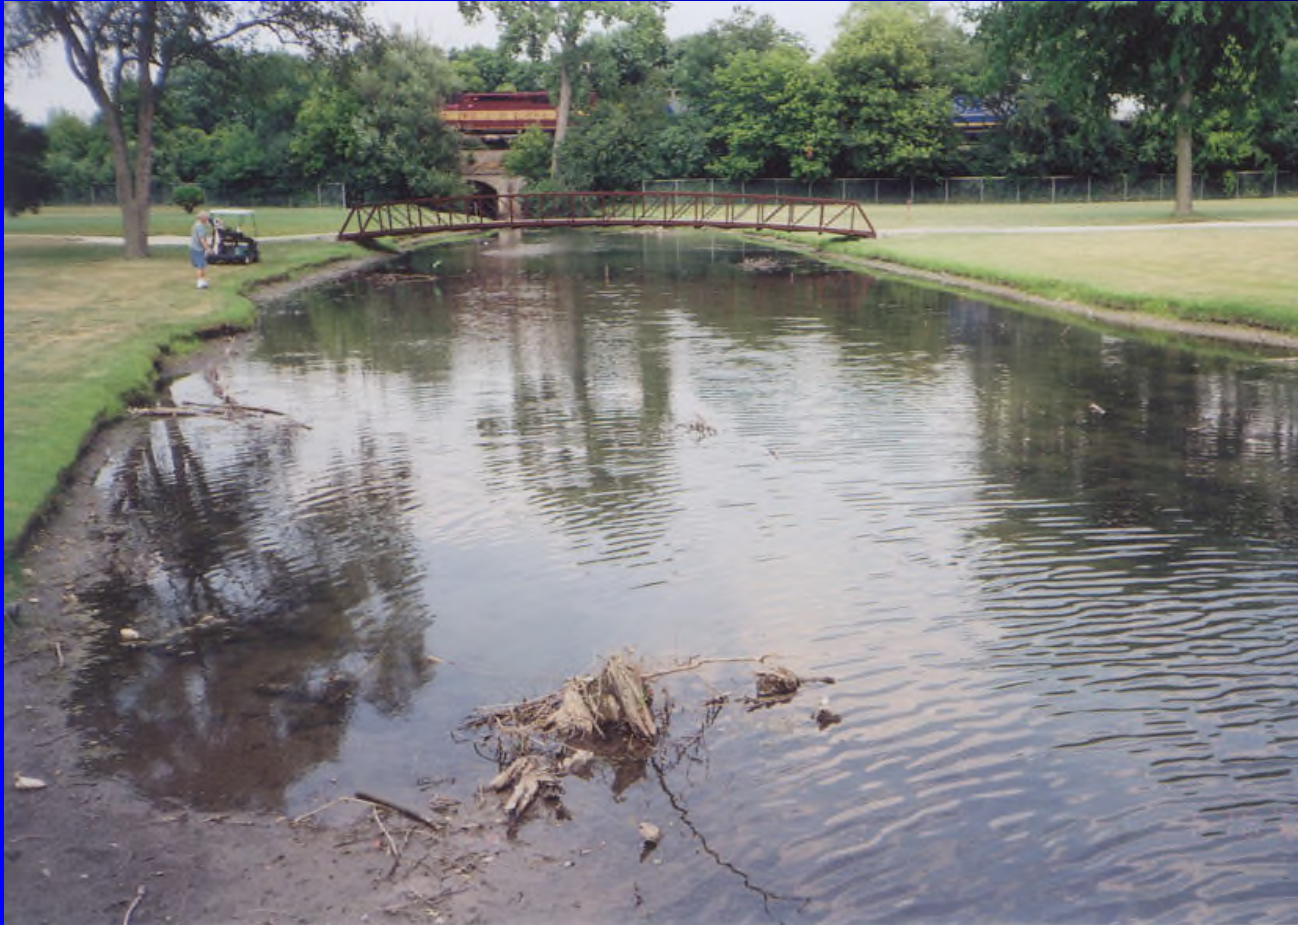
# Before: Mud Flats, Flooding, Poor Water Quality, Carp

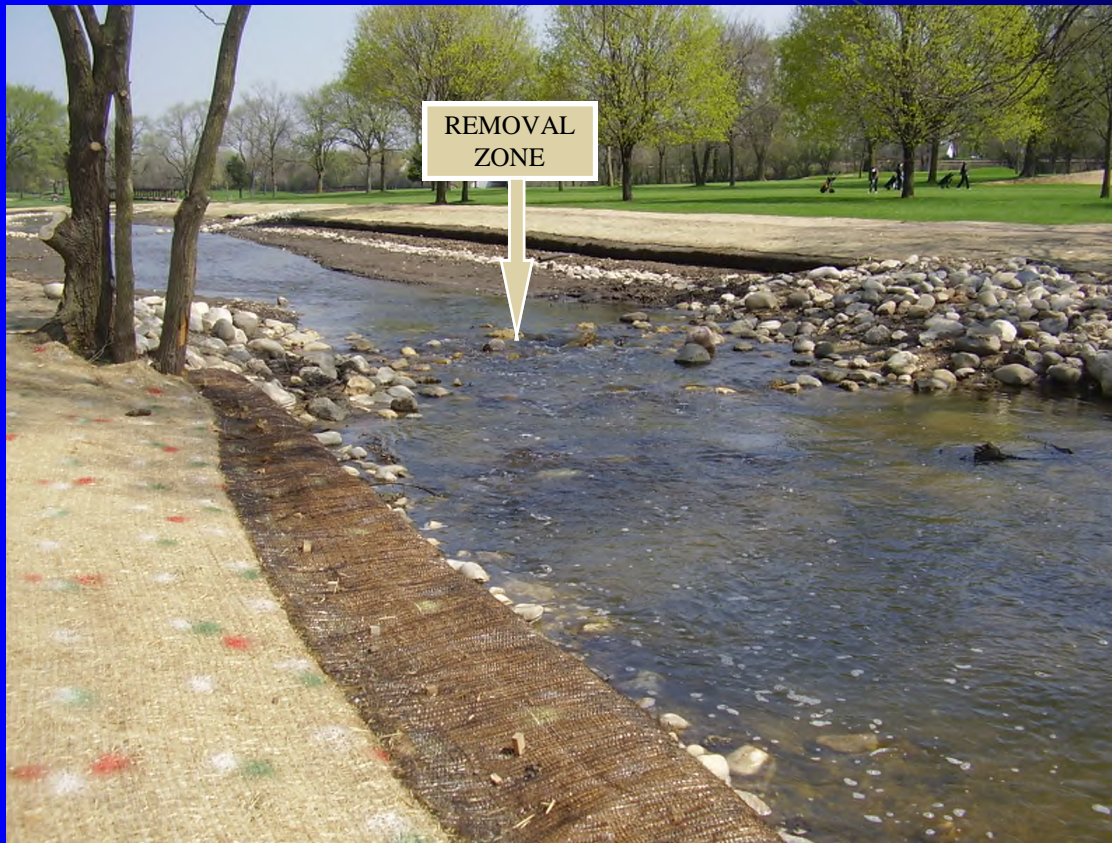
**After:** Fish migration, mussel survival, lower water levels, better water quality, sediment control, aesthetics, reduced odors, flood storage.

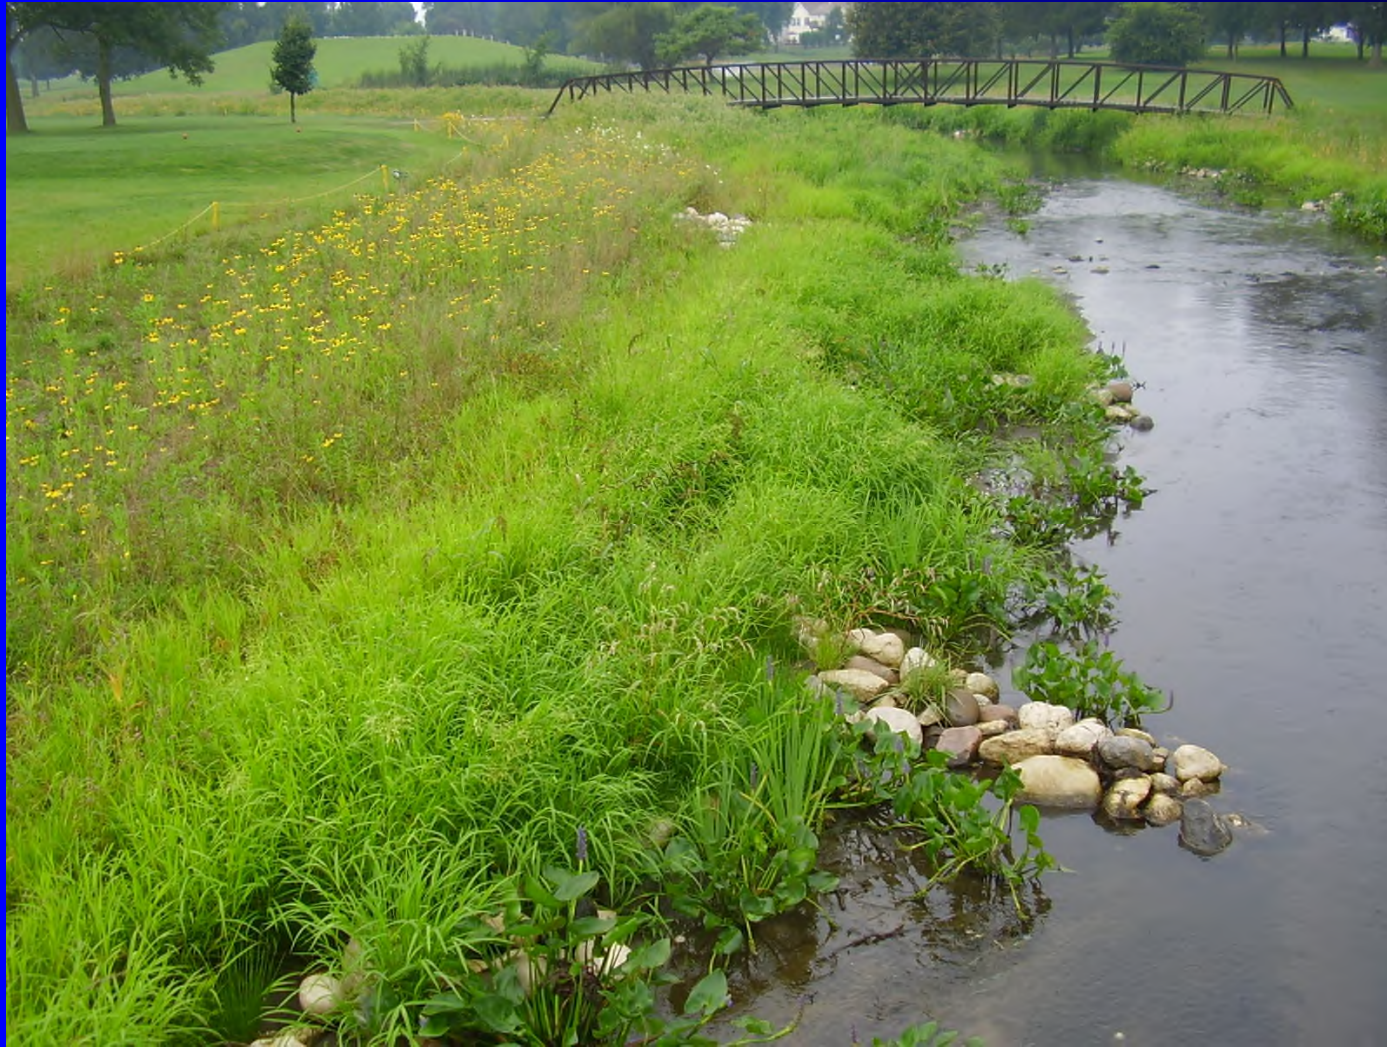
# Prairie / Wetland Streambanks

-Rock  
Points

- Off-Bank  
Rock Toe

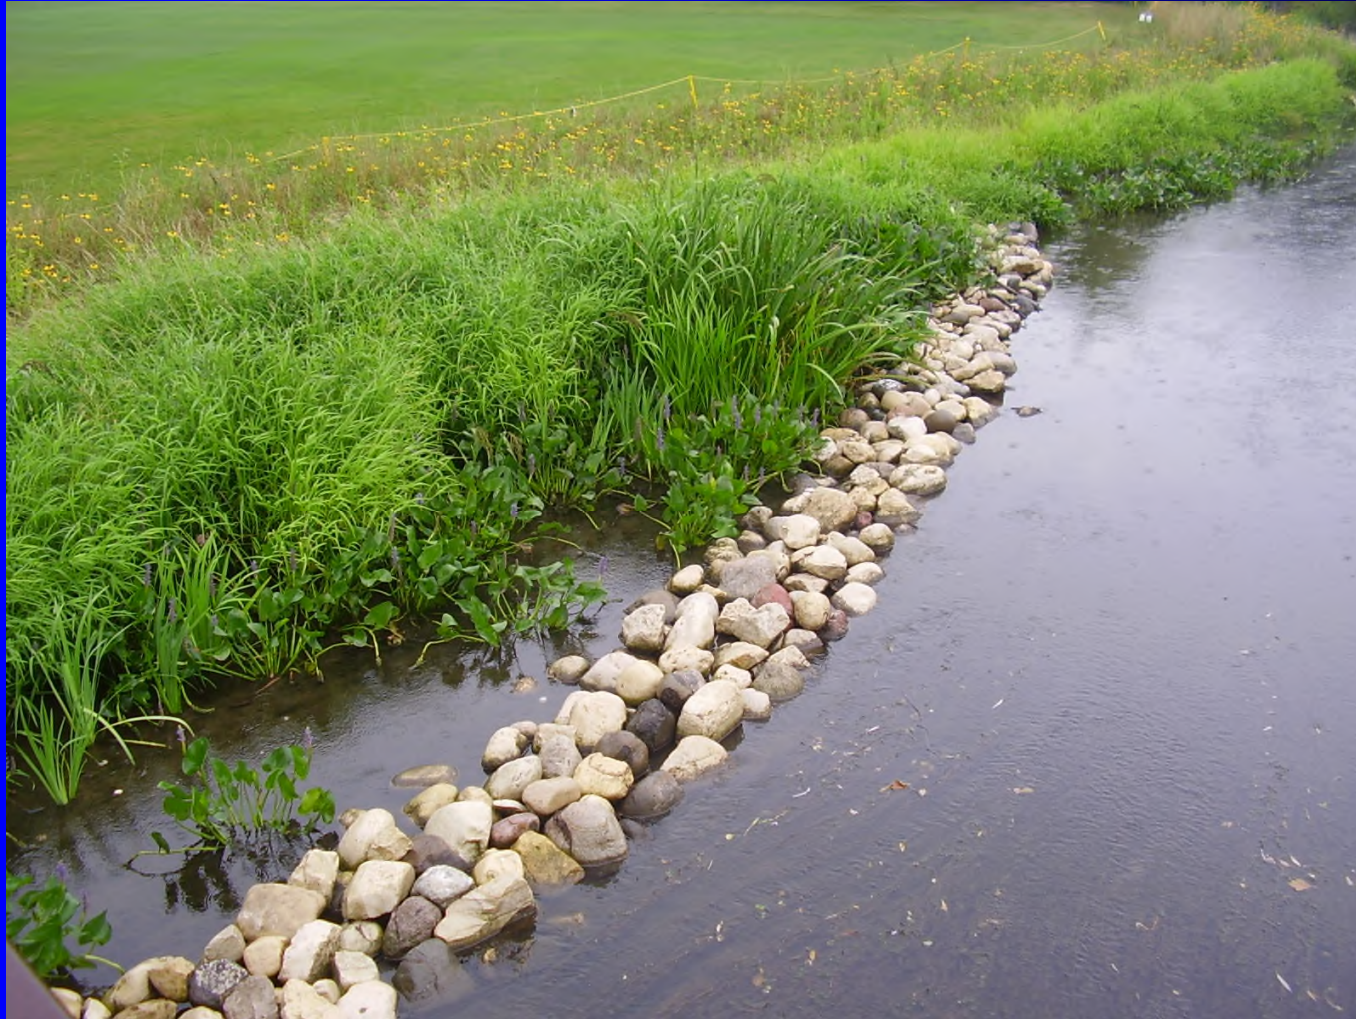
# Off-Bank Rock Toe / Wetland
