**Overview:**

The 3.41 acre site is located at 0S761 Old York Road and was formally a trailer park with a small management office (building #1) and a two car garage (building #2). The site is located in unincorporated York Township, DuPage County, Illinois, and currently falls under DuPage County permitting requirements.

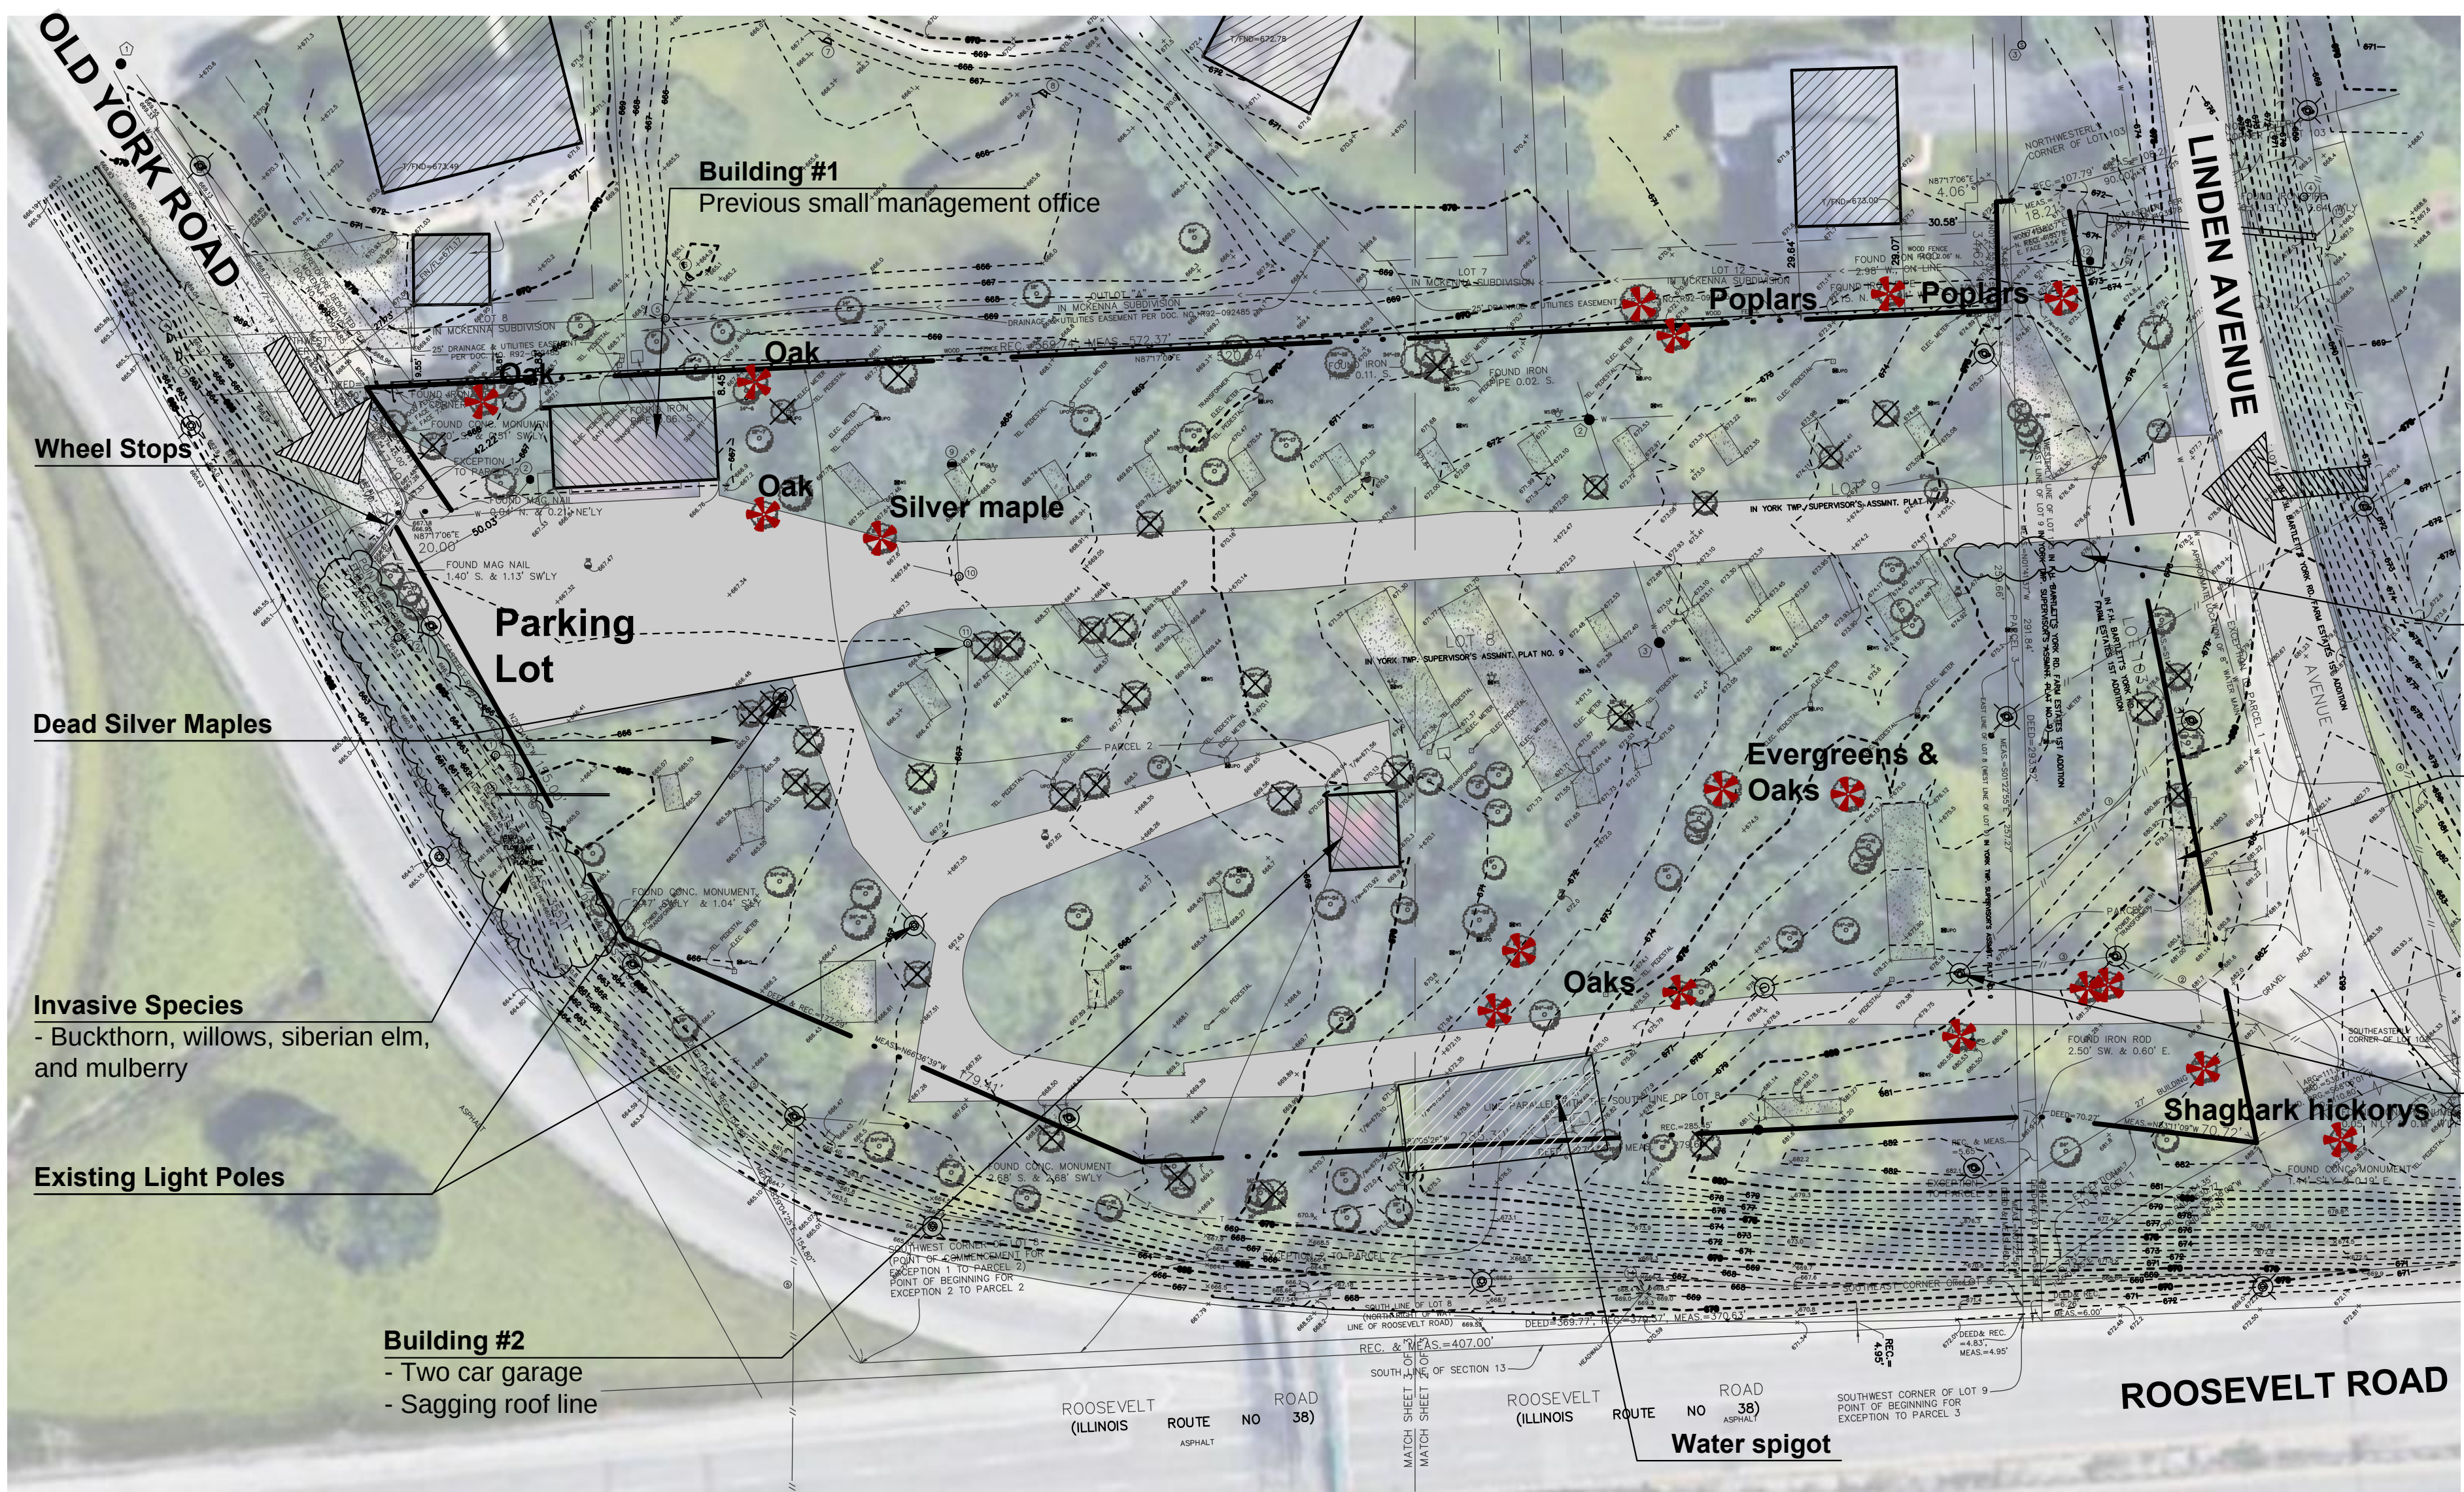
- Property Line
- Access Point
- Concrete wall with fill
- Electrical poles
- Dead trees
- High Quality Trees

The existing vegetation is overgrown and thick with understory brush. Clearing out the invasive plant species will enhance site lines and shape views throughout the site. The higher quality trees have been identified and are shown in red on the map. Most other trees are in poor condition, dead, or are undesired invasive species.
