# Table of Contents

# Executive Summary

# Project Description

Dewberry Architects Inc. (DAI) were commissioned on June 17, 2019, by the Elmhurst Park District to complete a facility assessment for the Redeemer Center at 345 Kenilworth Avenue in Elmhurst, Illinois. The facility assessment serves as a roadmap that establishes a direction for the facility's future, while maintaining the flexibility needed to respond to changing needs, conditions and resources.

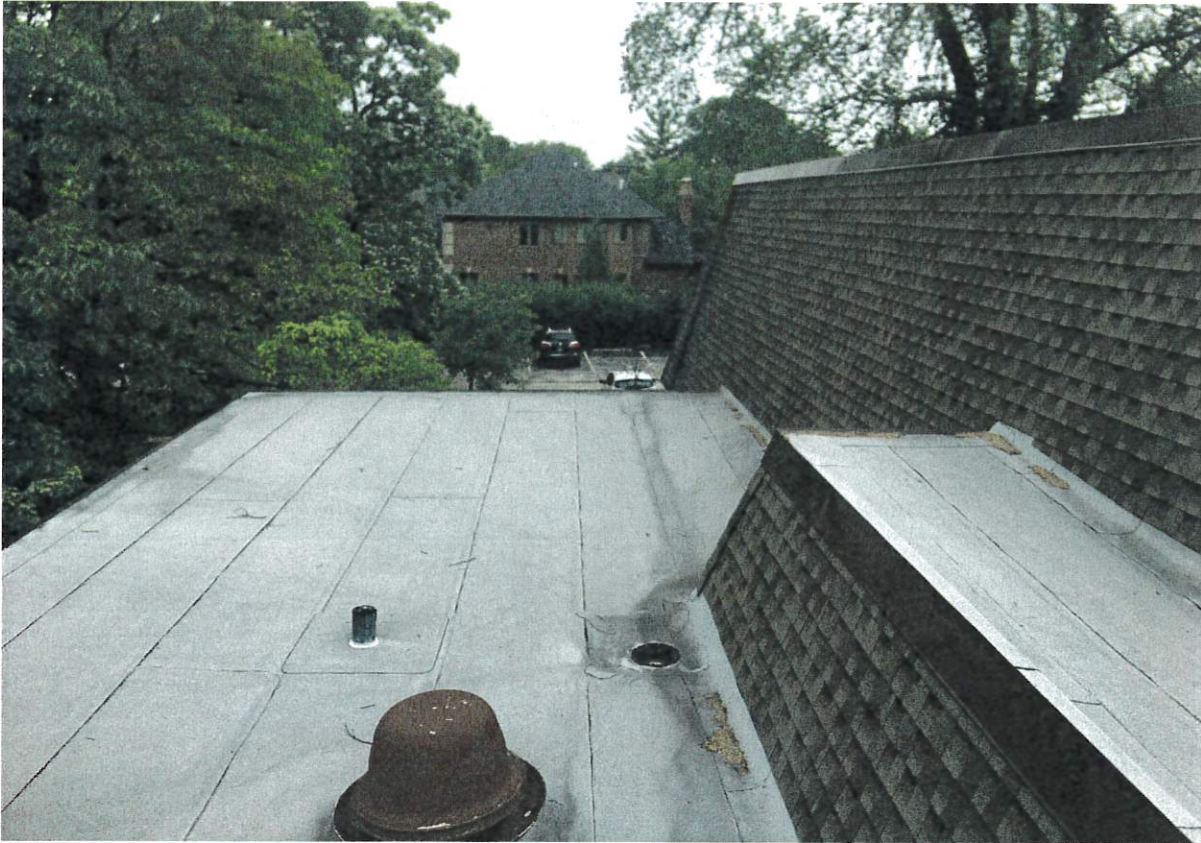
The ten year old roof is in good condition and well maintained. One roof drain cover was missing during the inspection. Roof slopes are adequate to avoid ponding. The higher roof lacked a ladder for access.

Roof looking north @ lower section

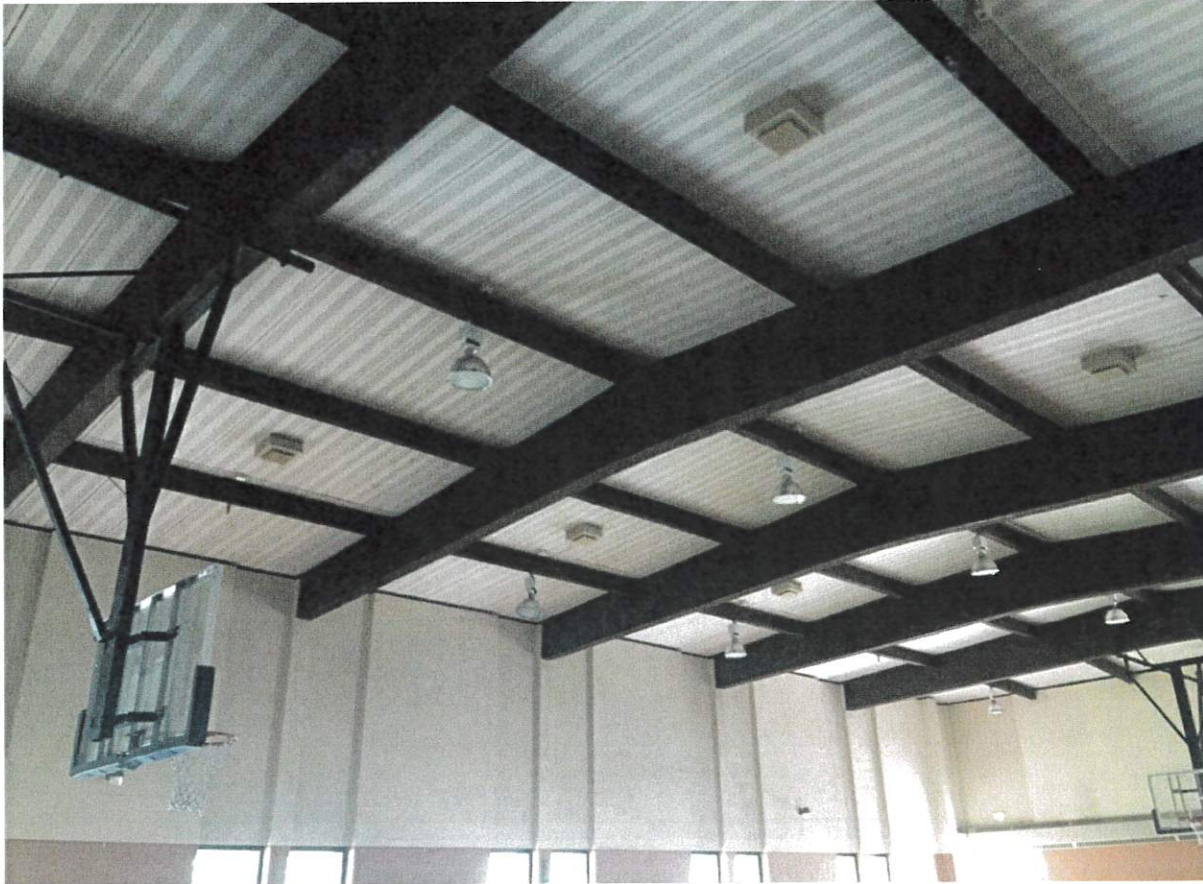
Exposed wood beam framing

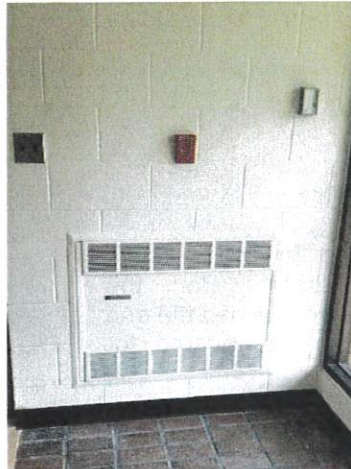
Figure 7: Recessed cabinet unit heater

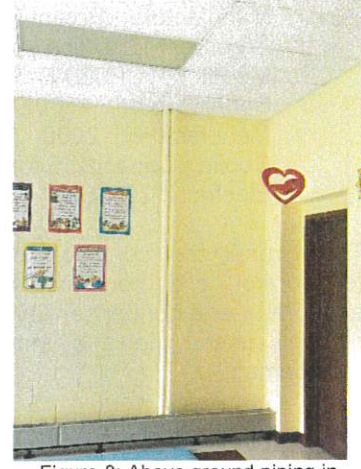
The building utilizes heating hot water provided by the boiler system to serve recessed and semi-recessed cabinet unit heaters and perimeter fin tube radiators (pedestal mount and slope top). In the office spaces, the fin tube radiators have a Danfoss valve to provide occupants temperature control. Piping is routed above ground.

Figure 8: Above ground piping in Music Room

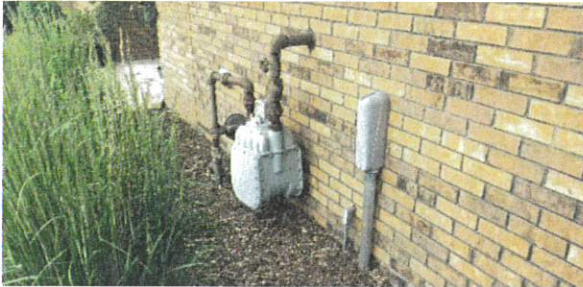
The existing service appears to be low (residential) pressure (5" to 7" WC) and no pressure regulators were observed to indicate pressure being reduced from the incoming service.

Figure 10: Gas meter

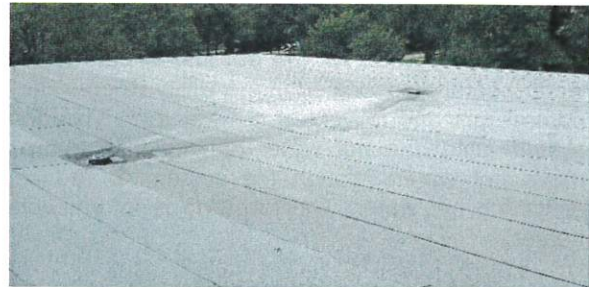
Figure 11: Roof drain

There are (3) main roof drains on the roof. All appear to be clear and operational. The gym roof is sloped to allow for drainage to the south to discharge to the lower flat roof and storm water removed by the roof drains.

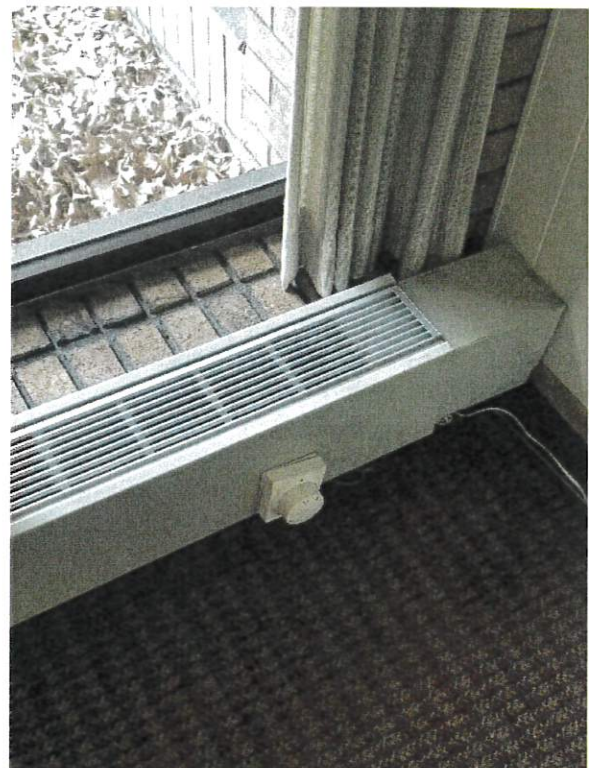
Figure 13: Danfoss valve on FTR in office

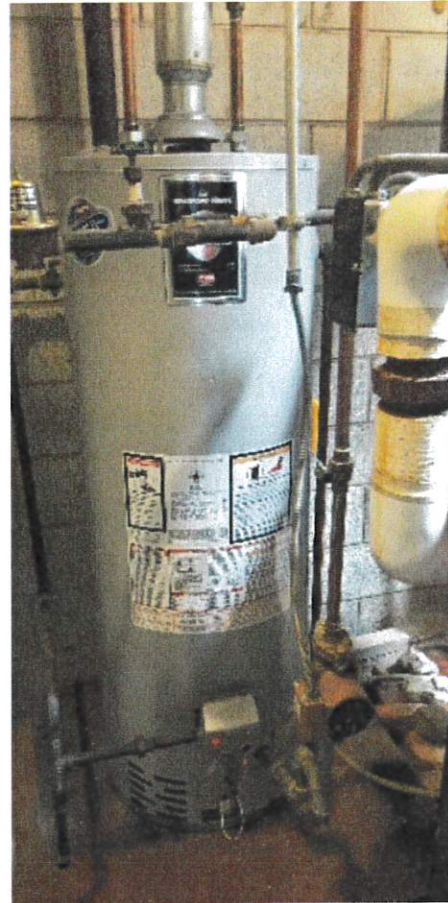
Figure 14: Domestic water heater

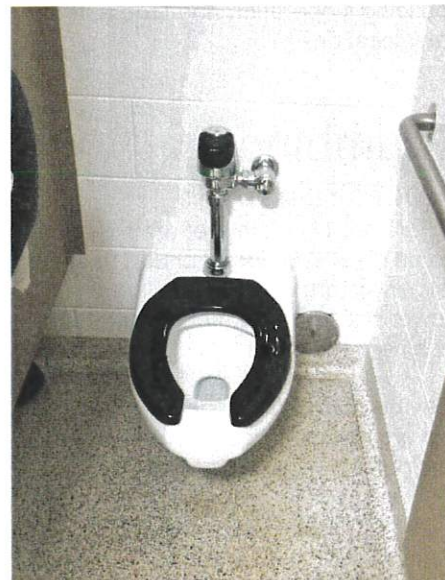
Figure 15: Typical toilet fixture

City water, hot water and hot water recirculation piping within the boiler room and above ceilings appears to be primarily copper and has likely been replaced since the facility was originally built. The piping within the wet wall of the toilet rooms remains galvanized and appears original. Piping within the wet walls is uninsulated.

Galvanized piping, over time, is likely to develop pin hole leaks which will require patches or full replacement. When the toilet room was remodeled it appears the piping within the wall remained and was reused.

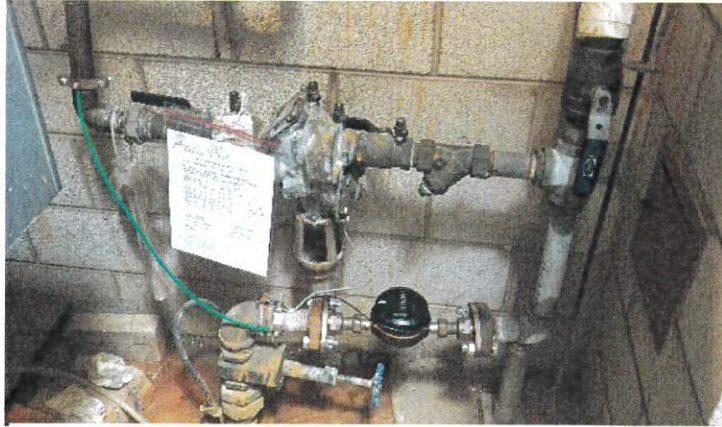
The city water service enters the building in the boiler room and is 2". It reduces in size to 1" as it goes through the meter then increases again back to 2". There are two takeoffs after the meter. The first, goes through a reduced pressure back flow preventer and serves the boiler make up as well as other devices in the building. A second riser, which has no back-flow device goes to additional fixtures.

Figure 16: Water meter

Depending on the Authority Having Jurisdiction (AHJ), the entire city water service may be required to be protected by a means of back flow prevention. This would require the unprotected riser to be connected to the downstream side of the existing back flow preventer or a new back flow device installed.

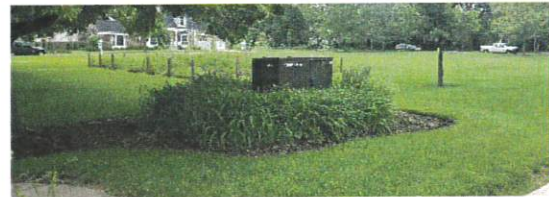
Figure 20: Transformer on east side of building

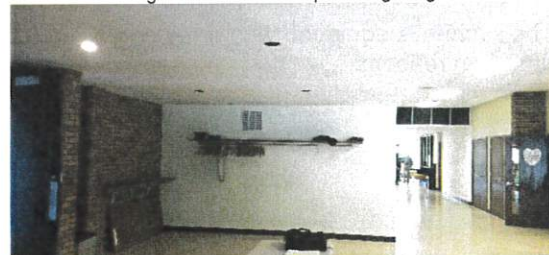
Lighting for the building is mainly a mix of recessed troffers and can lights. The gym has mercury vapor lights and the bathrooms are equipped with LED lighting that was installed recently. The troffers throughout the building are using T12 bulbs. These lamps are no longer manufactured and will / have become difficult to obtain. Consideration should be given to replacing the lay-in troffer fixtures with T-8, T-5, or LED fixtures. There are incentives available through Commonwealth Edison that can greatly offset the cost of lighting replacement. The remainder of the cost is generally offset by the operational savings.

Figure 22: Troffer and can lights
